Report on the investigation into
the grounding of
Pride of Canterbury
“The Downs” – off Deal, Kent
31 January 2008

Marine Accident Investigation Branch
Carlton House
Carlton Place
Southampton
United Kingdom
SO15 2DZ

**Report No 2/2009
January 2009**

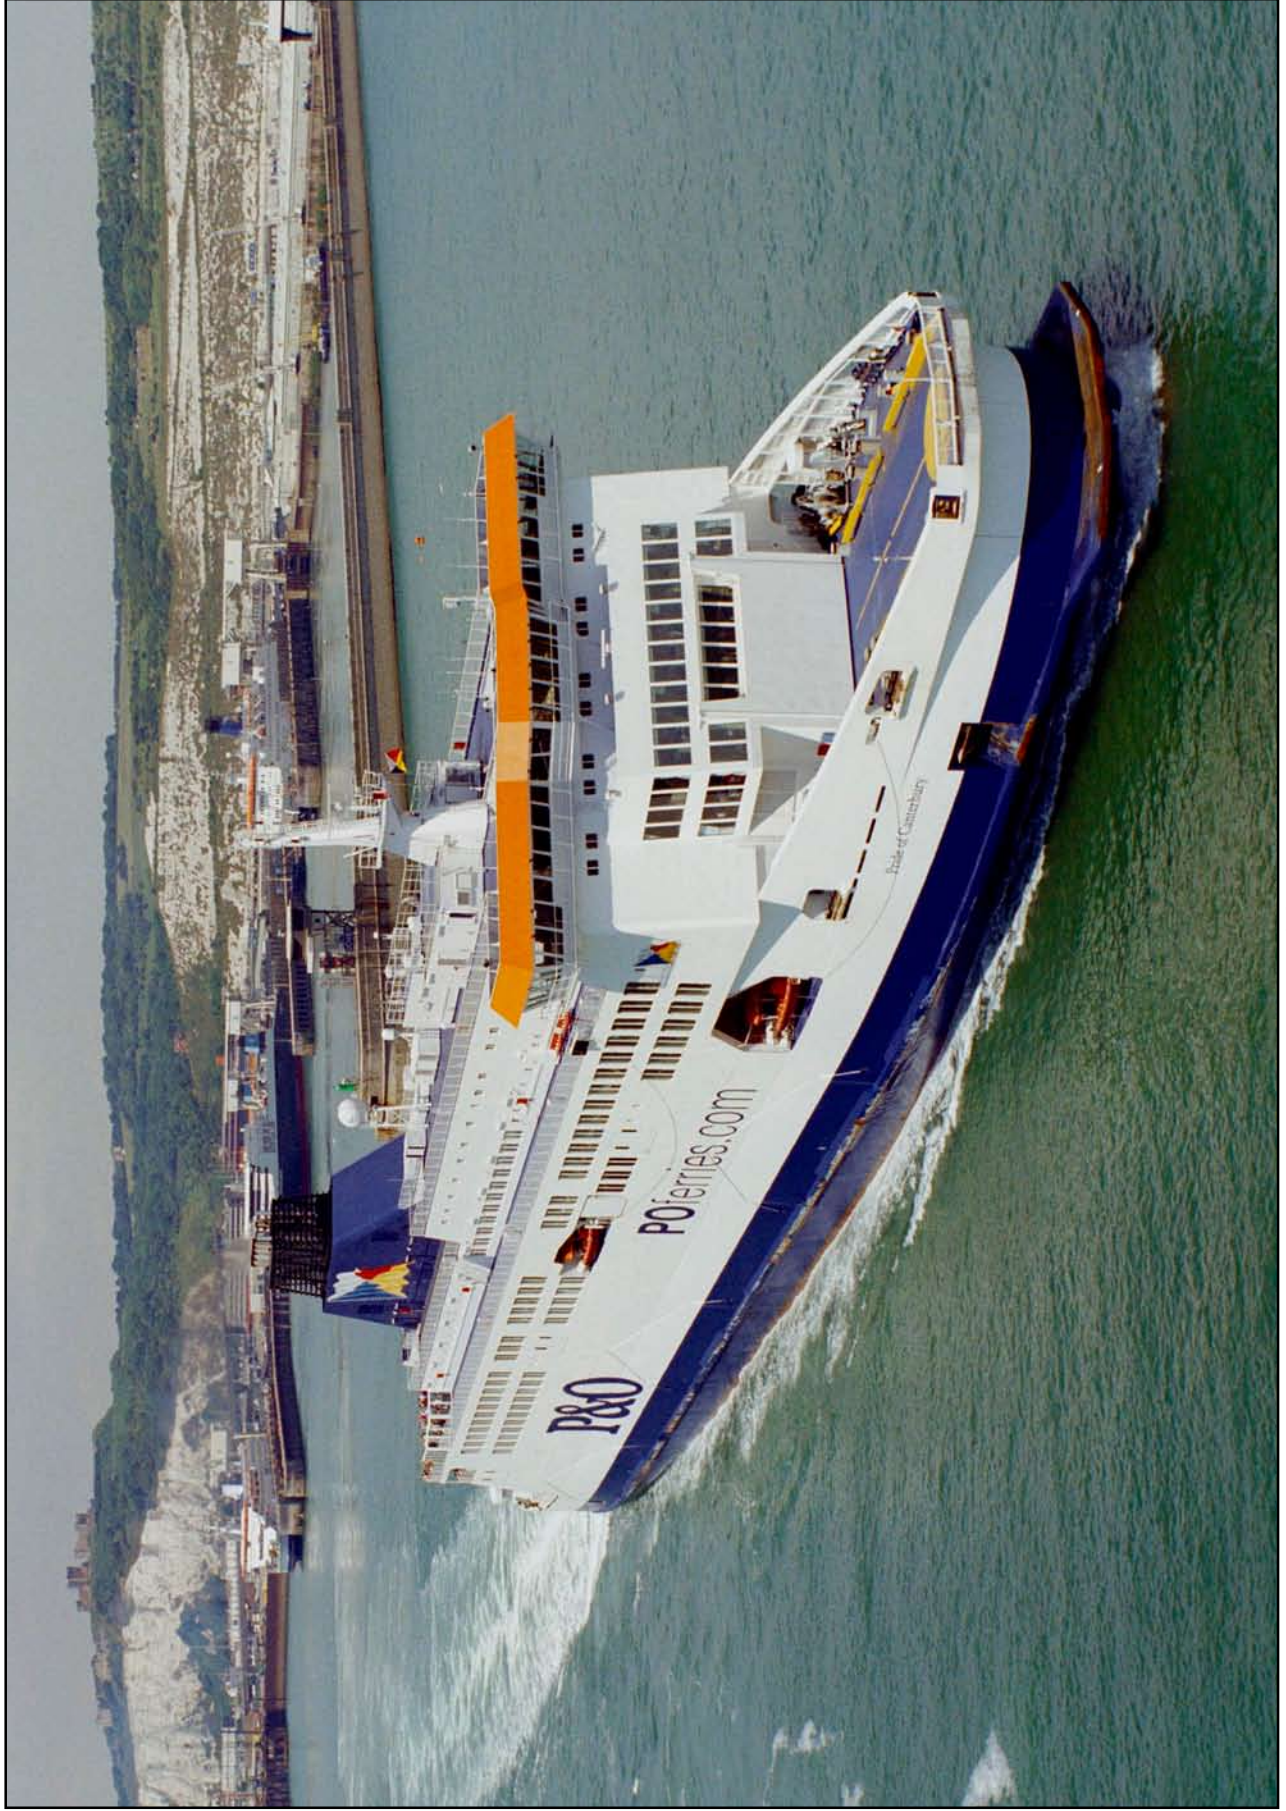
Figure 1

Pride of Canterbury

On 31 January 2008, the Roll on Roll off Passenger ferry, *Pride of Canterbury* (**Figure 1**), grounded on a charted wreck while sheltering from heavy weather in an area known as 'The Downs' off Deal, Kent. The vessel suffered severe damage to her port propeller system but was able to proceed unaided to Dover, where she berthed with the assistance of two tugs.

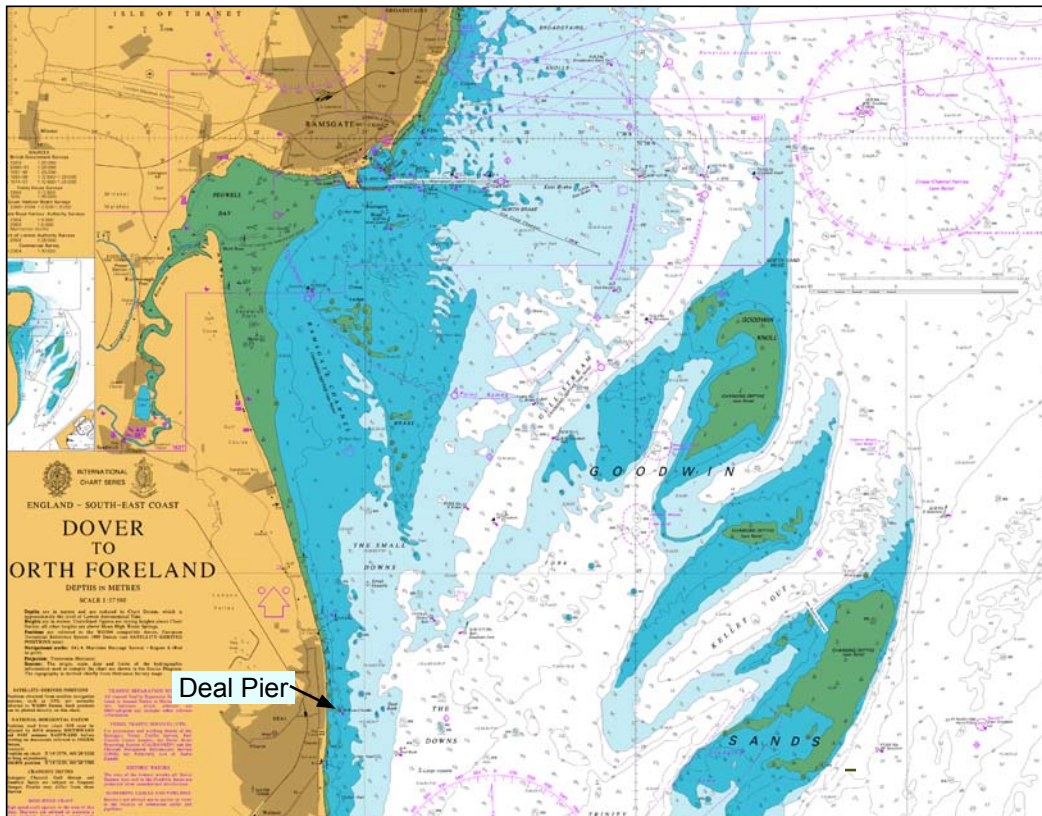
Figure 2

At 0815 *Pride of Canterbury* left the south west lane of the Dover Straits Traffic Separation Scheme and headed towards The Downs, an area off Deal in Kent, which P&O and other ferries use as a holding station when Dover Harbour is closed, due to the shelter provided there from the heavy seas experienced during storm force south-westerly winds. **(Figure 2)**

Chart showing general detail of The Downs area off Deal

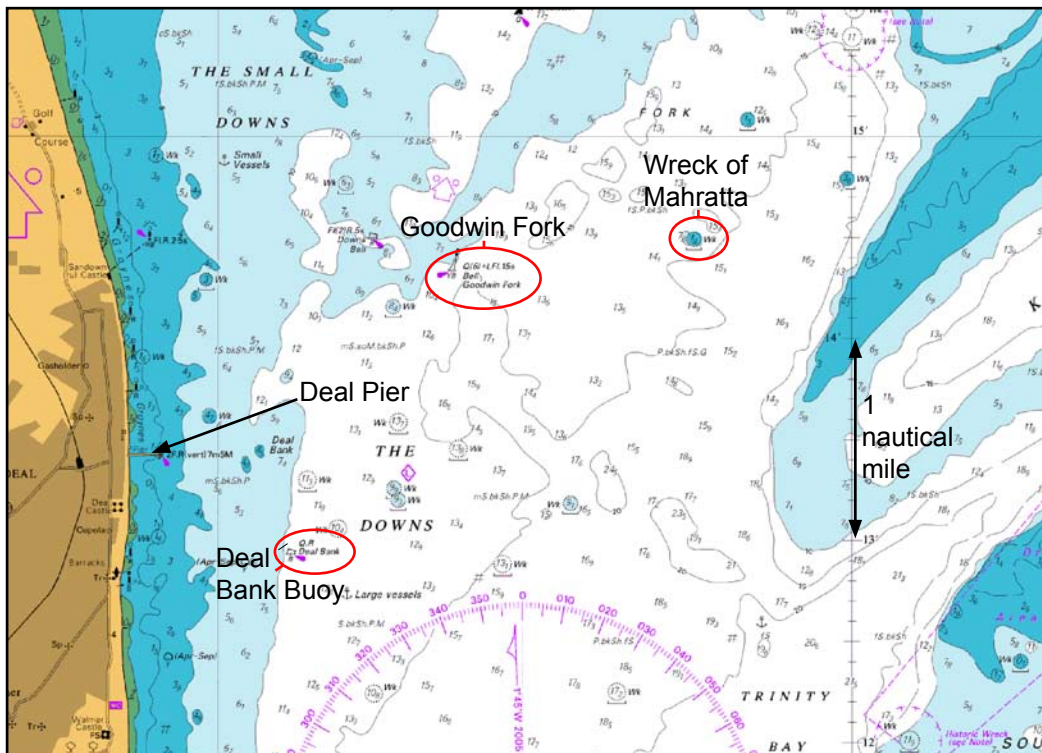
Figure 3

As the vessel approached The Downs, the master explained to the OOW that he wished for the vessel to steam slowly in the area, keeping 1 mile from the coast and clear of the other ferries that were already there. He did not specify any other limits, but it was the normal custom for ferries to avoid passing to the north of a line extending eastwards from Deal Pier and to avoid getting closer than 9 cables¹ to Goodwin Fork buoy. A little later, the master had clarified that he wished the turn on the northern leg to occur when off Deal Bank buoy **(Figure 3)**, and for the vessel to stay at least 1 mile clear of any shallows **(Figure 4)**.

Detail of figure 2

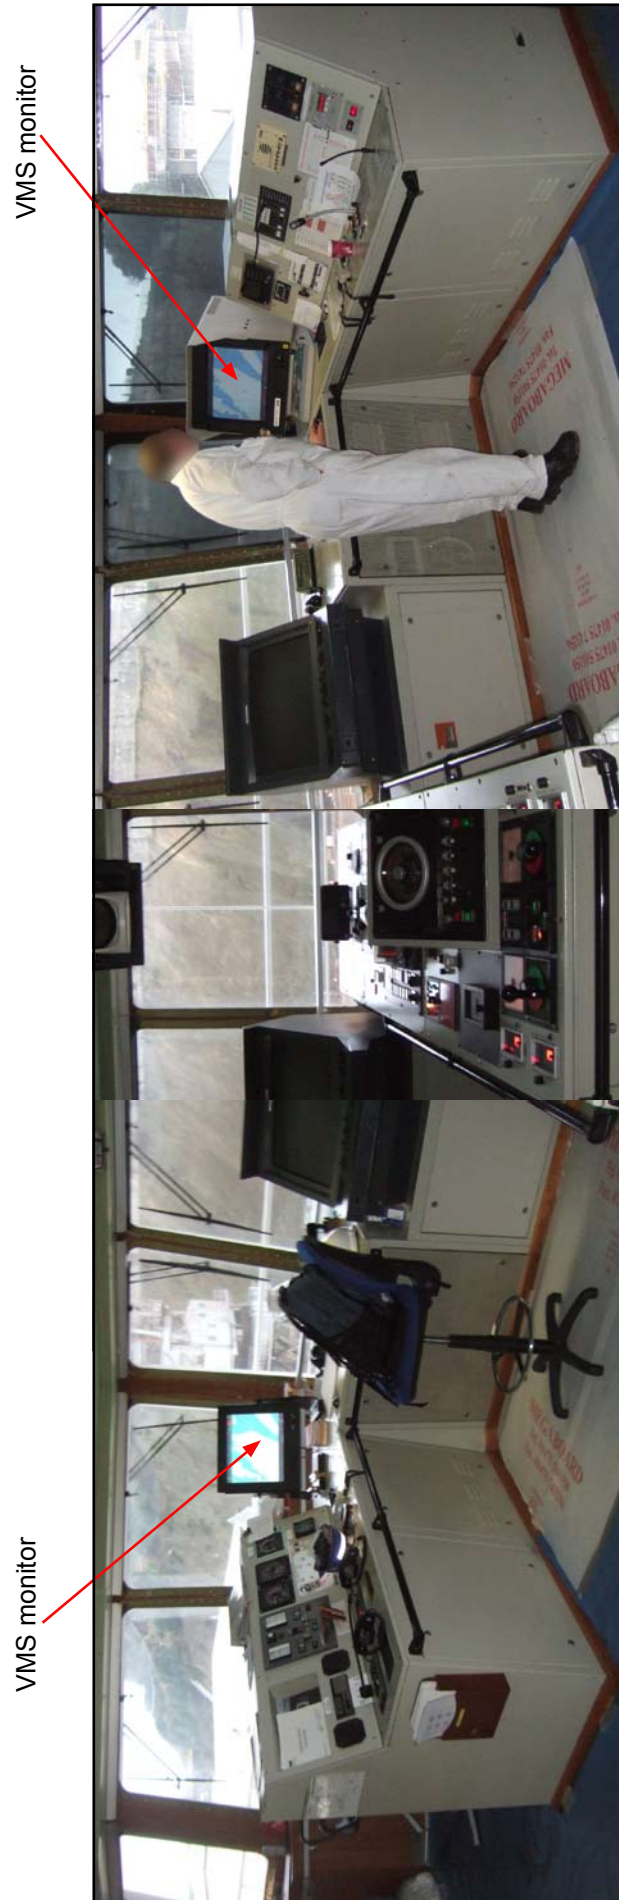
Figure 10

Pride of Canterbury was fitted with a Northrup Grumman Sperry electronic chart system, described in the manufacturer’s user manuals as a Voyage Management System (VMS) – NAVIECDIS (**Annex 2**) and type approved to be a fully functional ECDIS (**Annex 3**). However, in the company’s regulations it was referred to as the Voyage Monitoring System (VMS). The VMS was provided with four display screens located prominently on the bridge (**Figure 10**), connected to a single computer which ran the manufacturer’s software programme.

Bridge Conning Position, indicating 2 of the 4 VMS Monitors
