Report on the investigation of the heavy weather  
damage to the passenger cruise ship

***Pacific Star***

10 July 2007

**Report No 5/2008**  
**February 2008**

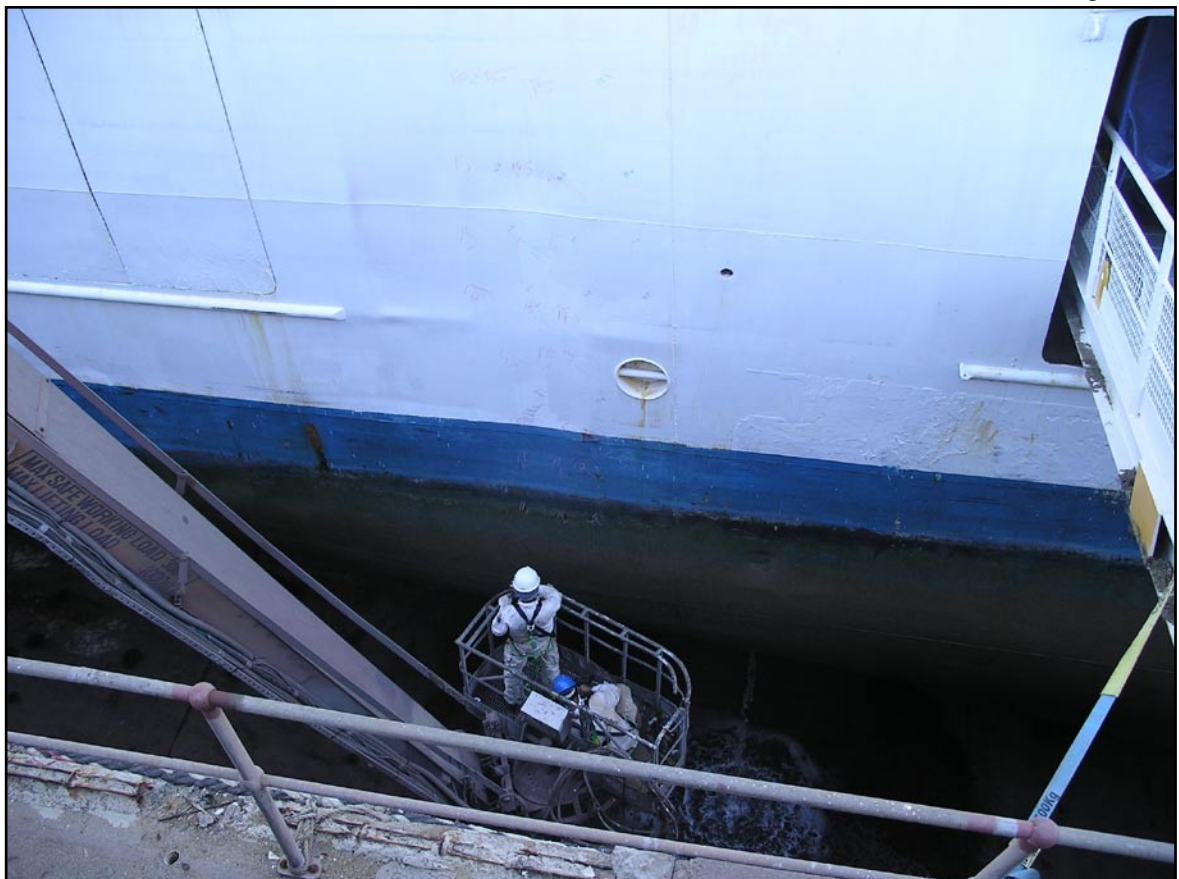
Figure 13

Non-destructive testing (NDT) could be described as *testing that does not destroy the test object*. In the marine environment, NDT is regularly used to provide thickness measurements of component parts of the ship's structure (**Figure 13**). A ship is designed to have certain minimum dimensions (or scantlings) for the material used in its construction, to provide sufficient strength. Classification societies recognise that a ship made of steel will corrode over time, so rules have been established to allow a certain reduction in the scantlings before a part of the ship's structure must be replaced. To assess the thinning of the metal, NDT is used, the most common of which is ultrasound testing.

Non-destructive testing in dry dock, Brisbane
