Part 2 – Fishing Vessels

Watch Where You're Going

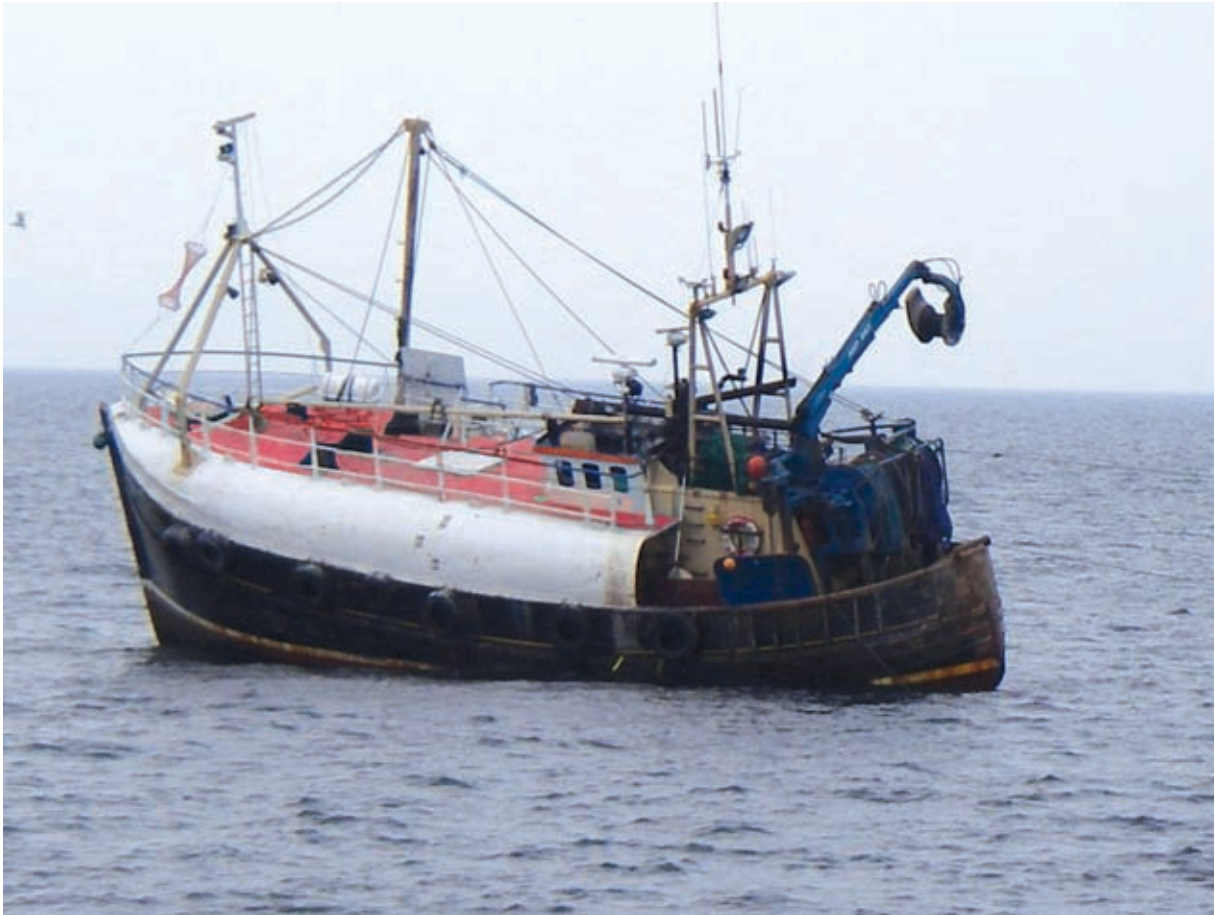
At about 0300, an 18m wooden hulled prawn trawler left her port of landing for her fishing grounds. Once through the breakwaters, the two deckhands, who had helped letting go, turned in, leaving the skipper alone on watch in the wheelhouse. Although the skipper went home at weekends, during the working week he was receiving only about 4 hours sleep a night when the vessel was alongside. He was maximising the time spent fishing for prawns during the long summer daylight hours.

When the vessel cleared the approaches to the harbour, the skipper set a course on the automatic helm to pass on his port side a small island, which lay about 2 miles to the south-west. The tidal stream was flowing north to south.

The skipper was able to obtain the assistance of two passing fishing vessels to tow his vessel off the shoal at the next high water. The trawler then returned to harbour, where it was found that damage was limited to the forefoot and the steel keel band.

1. It is essential that watchkeepers maintain a proper navigational watch at all times and do not undertake any other duties that would interfere with the safe navigation of the vessel. Further advice on best navigational practice can be found in the MCA's MGN 313 (F).

3. In this case, the skipper did not alert the coastguard because he believed that he was in a stable position, and that his vessel would refloat safely at high water. It is always wise to alert the coastguard as soon as possible following an accident or incident, even if assistance is not needed immediately. Do not adopt a false sense of security. Incidents can deteriorate rapidly. Forewarned emergency services can respond more effectively.

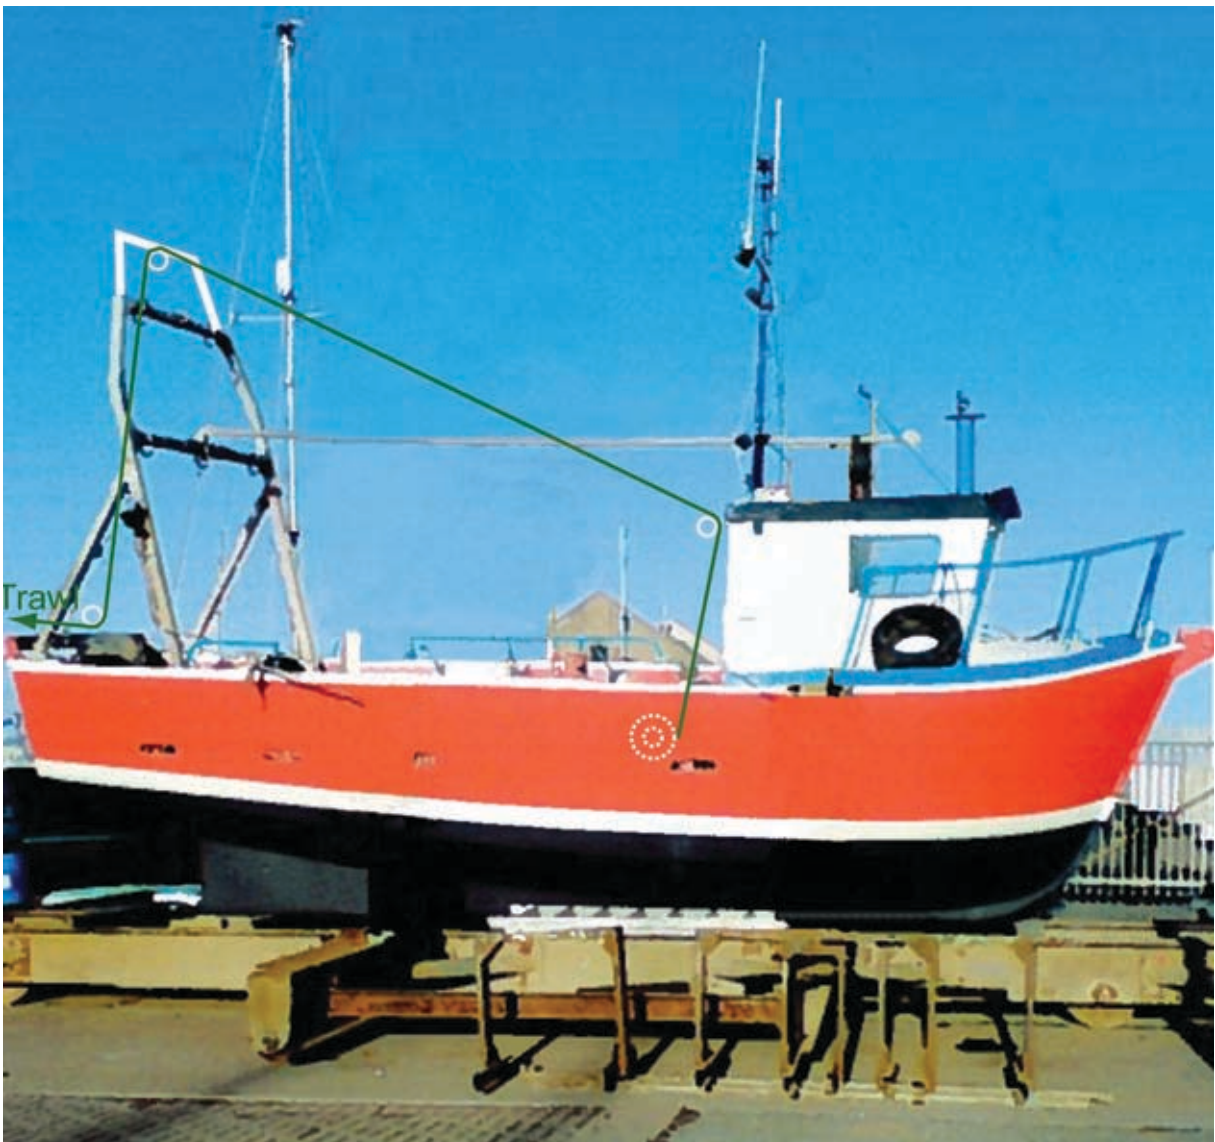
initially heeled over, waves started to come onto her deck, causing her to heel over even further. A short time later she started to capsize, and the crew were pushed back into the wheelhouse by the power of the onrushing water, leaving them no time to send a 'Mayday'.

After the vessel had capsized, the crew found themselves inside the now inverted and flooded wheelhouse. One of them managed to swim clear quite quickly, while the other relied on a pocket of air to survive the initial capsize

until he, too, was able to swim out of the upturned wheelhouse. Although his clothing snagged on the winch, he was able to get himself to the surface and clear of the vessel just before she began to settle by the stern, shortly after which she sank.

2. The crew were fortunate in that they were able to cling to a lifebuoy which had floated free of the sinking vessel. MSN 1813(F) lists the minimum safety equipment requirements for small fishing vessels, and recommends the carriage of a liferaft and EPIRB. In this case neither was carried; had they been, the crew would not have had to place such reliance on good luck and the vigilance of a member of the public to ensure their survival.
