Part 2 – Fishing Vessels

What Did We Hit?

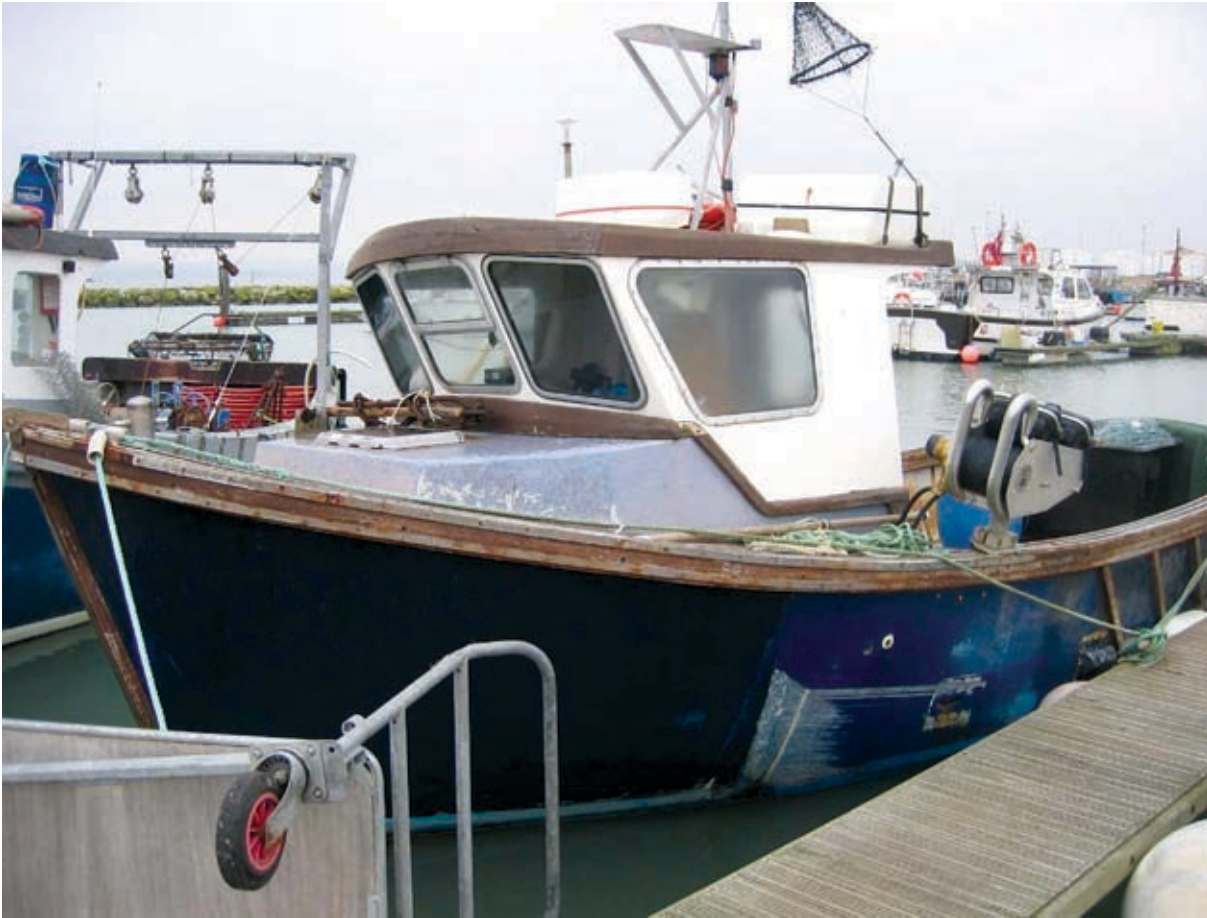
Over and Out

Two fishermen were on the deck of their small fishing boat, attempting to recover an anchor, which they had laid earlier in the season on one of their regular fishing marks, several miles off the south coast.

The fishermen were now in a very serious situation. They had not been wearing lifejackets and, due to the rapid sinking, had not had any time to alert the authorities to their predicament. Although it was daylight and the weather was fair, they were a long way from land and, being in an area of strong tidal flows, realised they would not have the strength to swim to the shore.

Although the boat had carried a liferaft fitted with a hydrostatic release, it was not in date and had not been serviced or checked for some considerable time. Predictably, it failed to inflate, and the two lifebuoys which the boat also carried failed to float free. They did not carry any float free device, such as an EPIRB, which would have alerted the authorities to their distress.
