# Part 3 – Small Craft

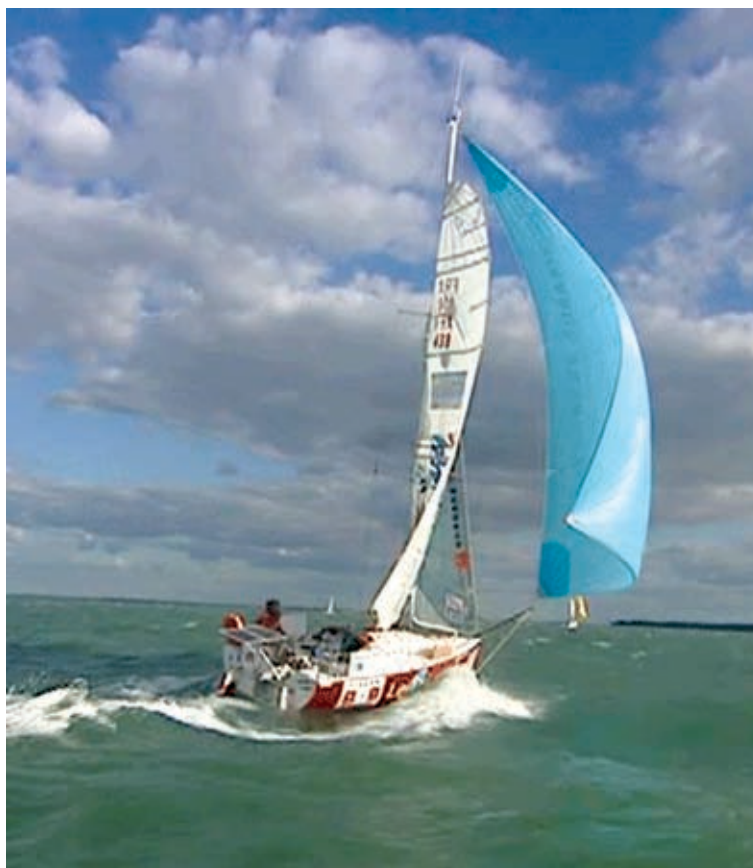
Figure 2: A similar Mini-Transat yacht
