Part 3 – Leisure Craft

They Normally Wore Lifejackets

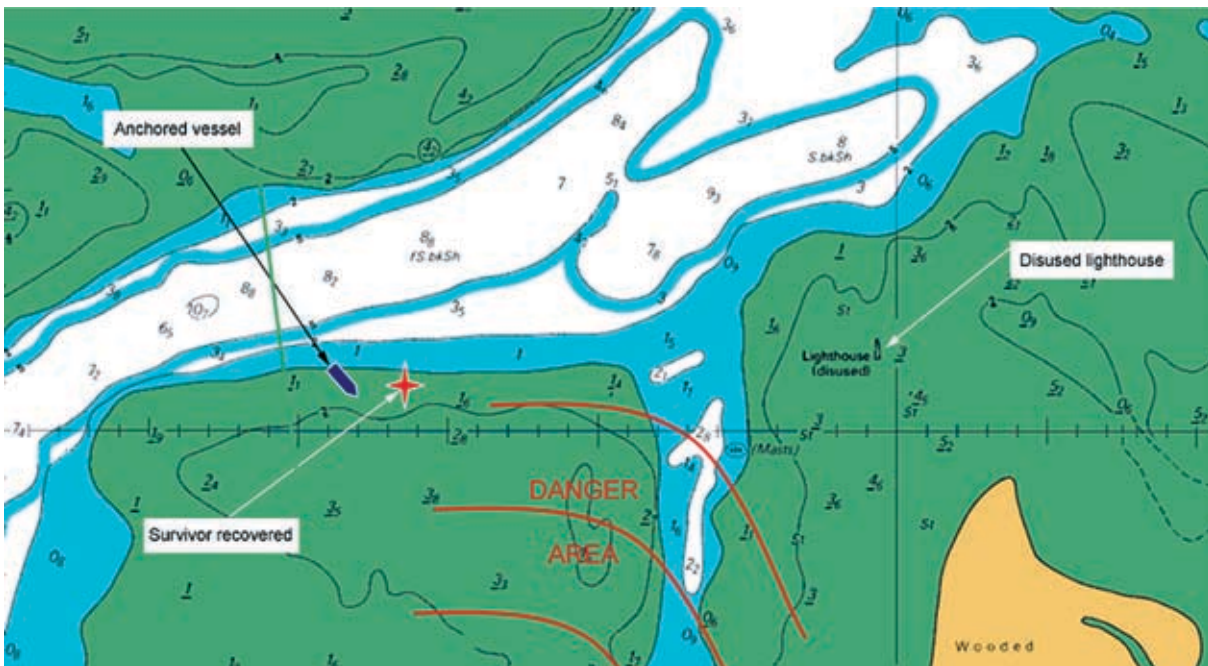
Figure 2: Chartlet of the area

As the boat closed a local disused lighthouse (Figure 2), a large swell wave passed under the vessel from astern. Seconds later, another larger wave broke over the stern. The owner immediately realised he was further south than he thought and was in an area known for large breaking waves at certain stages of the tide. However, it was too late to take any action because the boat was swamped and quickly
