Part 2 – Fishing Vessels

With the Best of Intentions ...

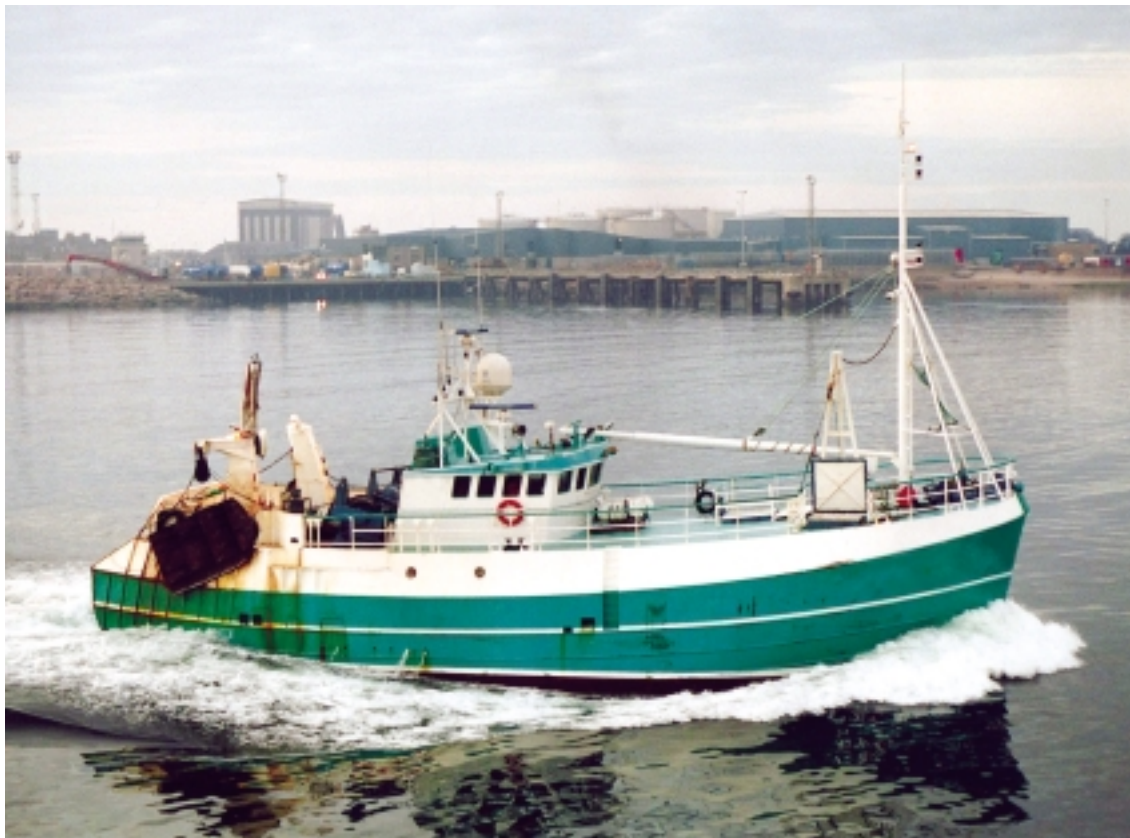
A 16 year old, 24.5m steel trawler was 7 days into her usual 10-day period at sea, when she flooded and sank. She was operating in deep water, and towing for about 6 hours at a time. All had been going well, with the gear shot away at about 1800. The catch was processed by 1930, the skipper took the towing watch and the other three crew members went to bed.
