# Part 3 – Leisure Craft

# Junior Powerboat Racing Accident Raises Safety Concerns

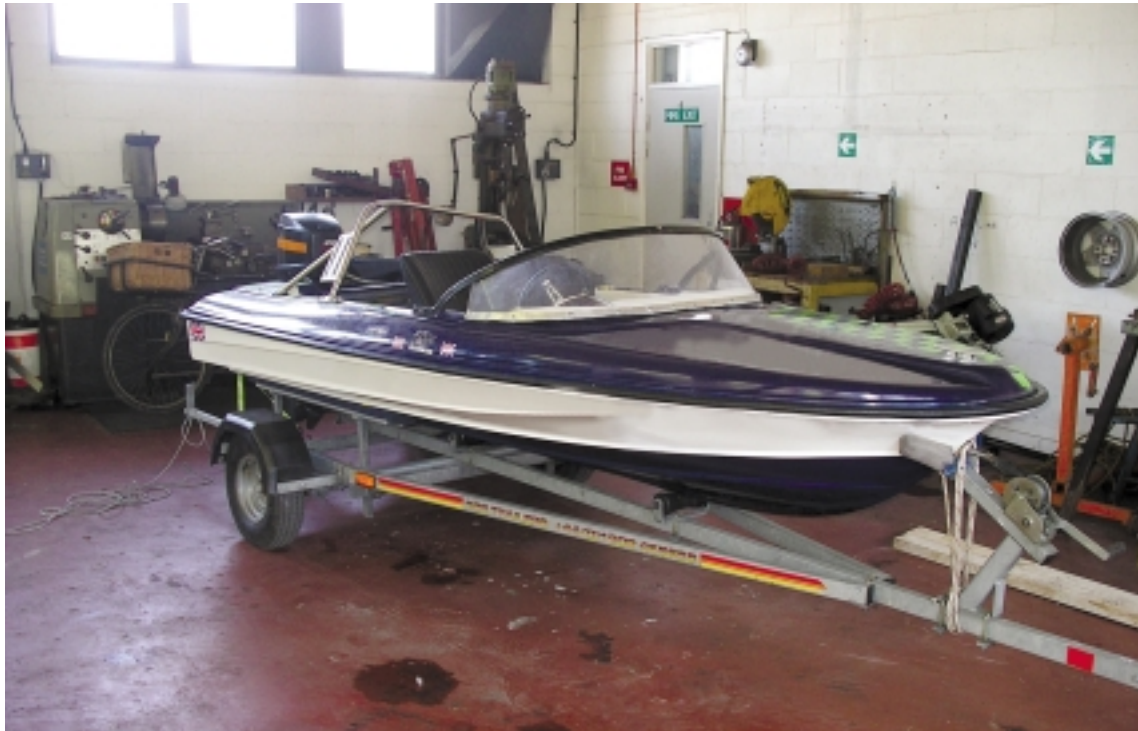
A 13 year old boy suffered a serious head injury during a national junior powerboat racing event. He had been the co-driver of one of 9 boats competing in a race for drivers aged 8 to 12. The field of boats was arriving at the first 90° turn marker, having completed a 400m long straight leg from the start line, when one boat *hooked* and effectively stopped dead in the water broadside on to the following boats. One of the following boats collided with it, and rode up and over the stationary boat, striking the young co-driver on the head and shoulder (Figure 1).

At some stage in the accident, the co-diver's safety helmet came off. It was later found in the water by one of the race safety boats: its chin strap was still done up. A paramedic, who had been stationed afloat on another safety boat, was quickly on scene to give vital first-aid treatment to the boy. The boy was transferred to the shore and then to hospital where he was found to be in a coma.
