Part 3 – Leisure Craft

Secure Anchorage Proves to be Anything But

Divers at Work in Port – Ensure Everyone is Fully Aware Before Signing the Permit

Kill Cords Save Lives, When Used Properly

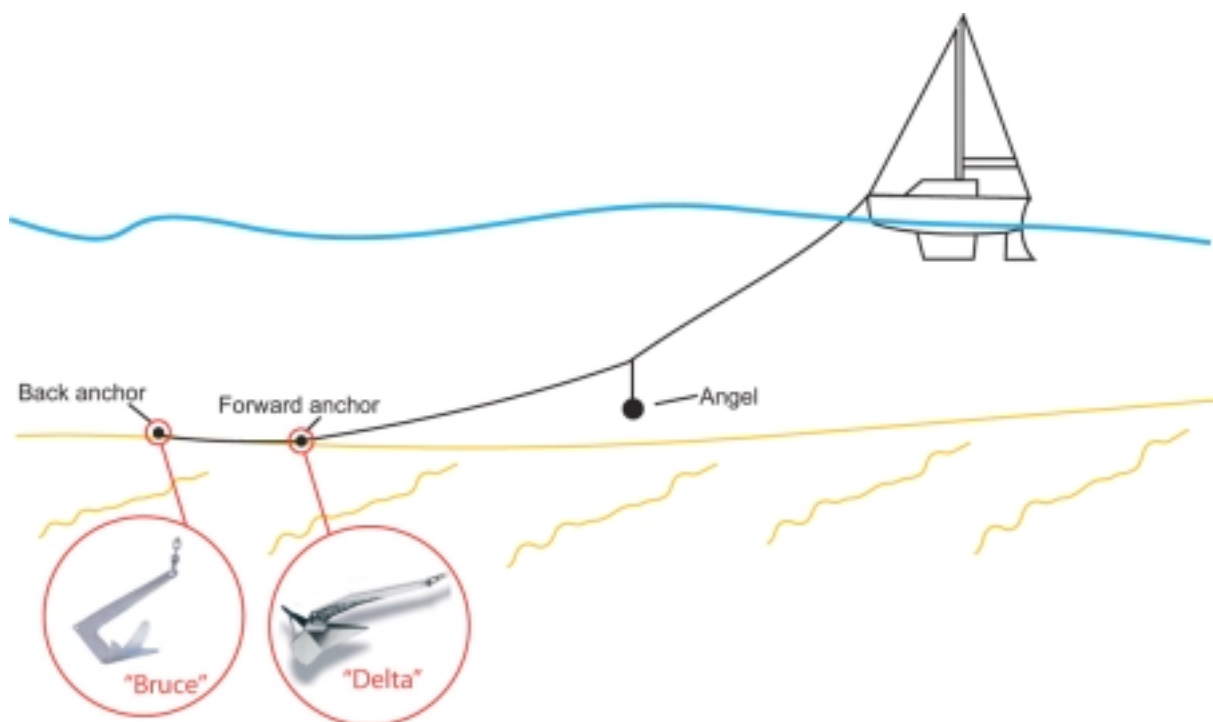
Just before midnight the GPS alarm woke the skipper. He jumped out of his berth and saw that they were 0.04 mile out of position. He started the engine and donned a lifejacket, telling his crew of four to do likewise. By the time he was on deck, the depth sounder was showing minimal depth, and almost immediately the keel touched the bottom. Attempts to motor off failed and the yacht soon listed by 20° to starboard, with the wind and sea on the port bow. A "Pan Pan" was sent and acknowledged by the local coastguard. The local lifeboat was dispatched to the scene but had some distance to travel.

It was soon established that the yacht was on a reef and was being driven on by the weather. The angle of heel increased to 30°. The crew managed to recover the anchors during this time so that they could be deployed again when necessary.
