Part 2 – Fishing Vessels

Delay Structural Repairs at Your Peril

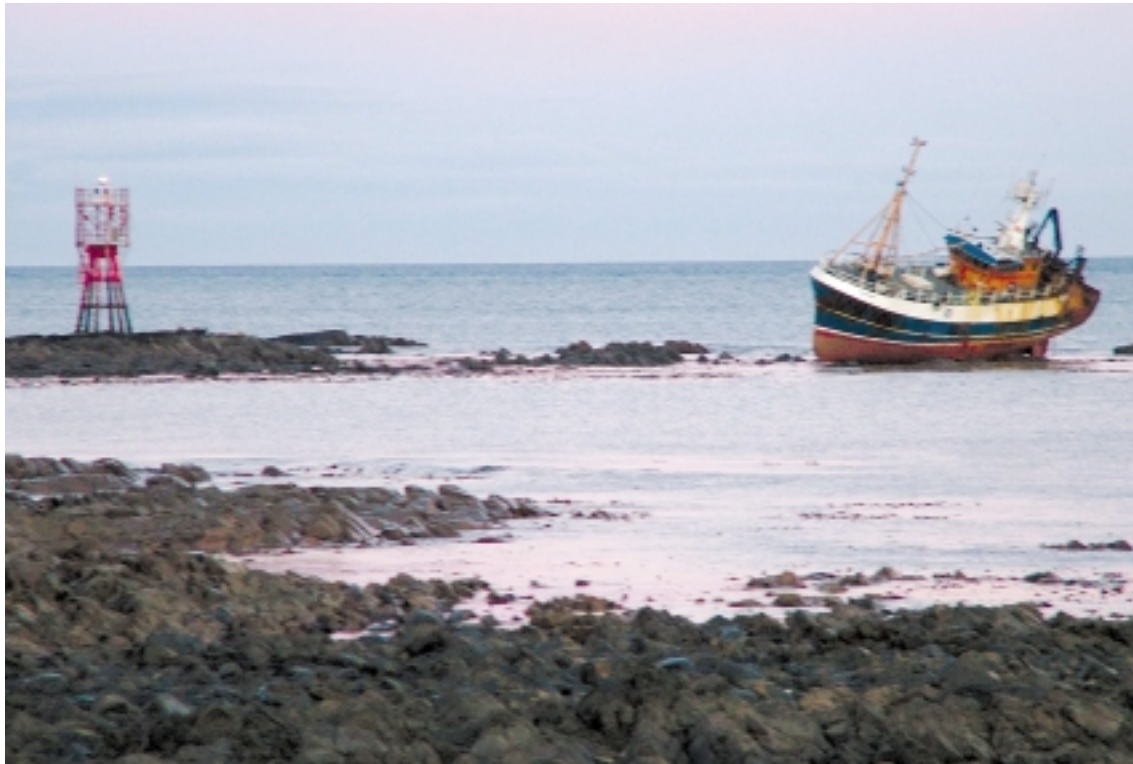
A 23m long fishing vessel grounded at night close to a light beacon. She had been returning to her home port after 18 days on guard duty near a North Sea pipeline. The experienced skipper was on watch when she grounded only a few miles from a harbour entrance.

Two hours into the passage, the ARPA radar also failed. The skipper replaced the fuses but was unable to re-start the radar. He usually relied heavily on the radar for navigational guidance when making a landfall. However, he allowed the vessel to continue on the same heading, expecting to make fine course adjustments when he could see the lights of the port. To aid his night vision, he dimmed all the bridge equipment lights, effectively making them unusable.

2. As well as not using his human resources, the skipper failed to use the available equipment to assist him navigate the vessel safely. He had an electronic chart plotter which was switched on and running but, because it was not supposed to be used for navigation, he left its lights turned down and did not refer to it. In the absence of any radars, it would have been prudent to refer to the chart plotter, at least for warning purposes and general guidance.

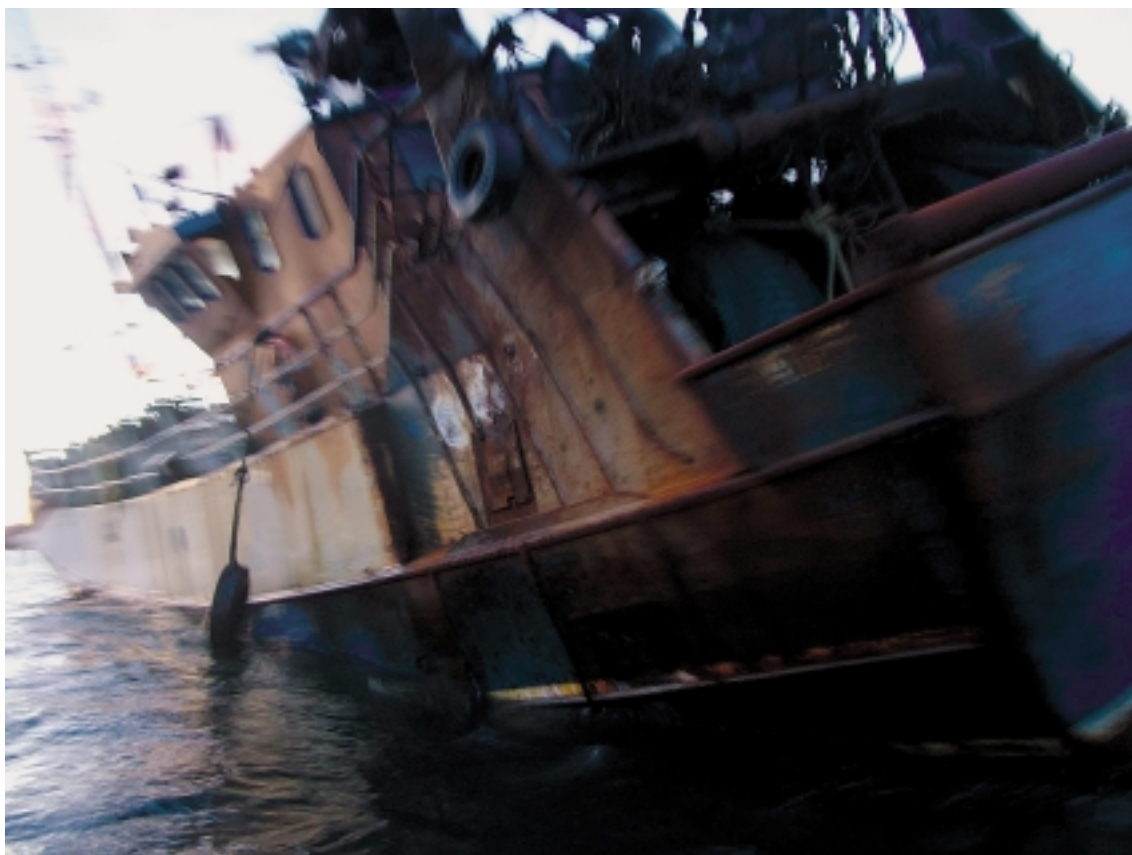
allowed the vessel to continue on the same heading toward a light beacon, which was situated on rocks about 2 cables from the shore and which marked the southern entrance to a wide bay. The skipper intended to pass quite close to the north of the beacon in order to line up for the harbour entrance. The characteristic of the beacon was a white flash once every 10 seconds, and the direction from which the fishing vessel was approaching could be lost easily among the background lights of the port.
