Report on the investigation of
the collision between
mt *Saetta* and mt *Conger*
on completion of a ship to ship transfer
9.5 miles south east of Southwold, UK
on 10 August 2009

Marine Accident Investigation Branch
Mountbatten House
Grosvenor Square
Southampton
United Kingdom
SO15 2JU

Report No 3/2010
March 2010

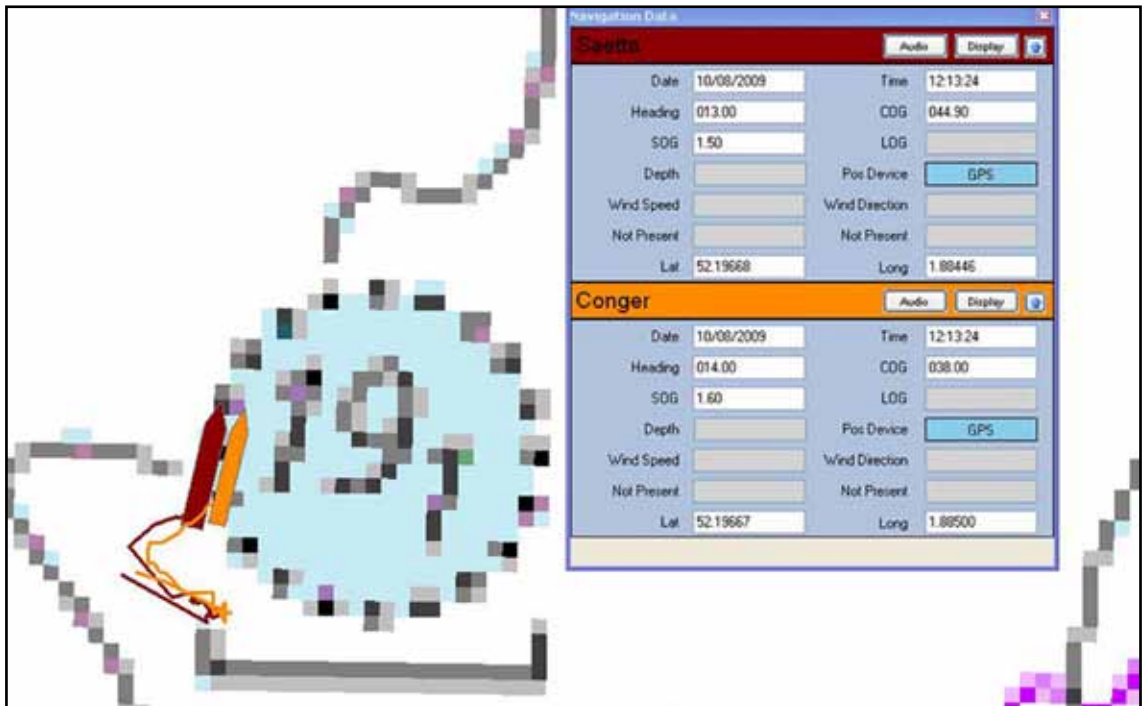
Figure 2

The vessels slowly turned to port, with their headings passing through 012° at 1313 when speed through the water had increased to 2.3 knots (**Figure 2**). The superintendent called *Saetta* and suggested that the time for completing transfer guide checklist 5 '*before unmooring*' be recorded as 1310. This checklist included '*The method of unberthing and of letting go moorings has been agreed with the other ship*'.

AIS tracks of vessels (underway and manoeuvring)

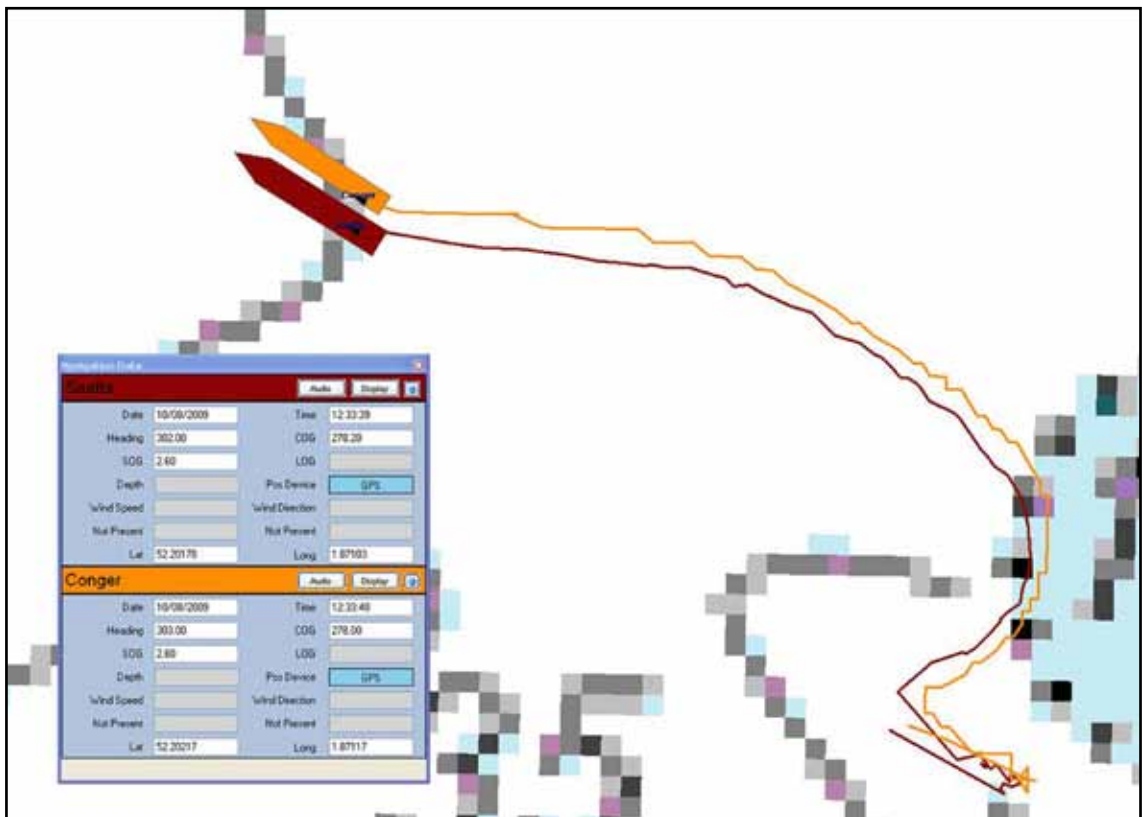
Figure 3

The number of mooring lines had now been reduced to two headlines and two stern lines and, at 1333, the superintendent ordered *Saetta* to 'stop engines' and 'wheel amidships'. Seconds later he ordered all lines fore and aft to be slipped simultaneously; the ships were on a heading of 303° at a speed of 2.4 knots (Figure 3).

AIS tracks of vessels (as moorings slipped)

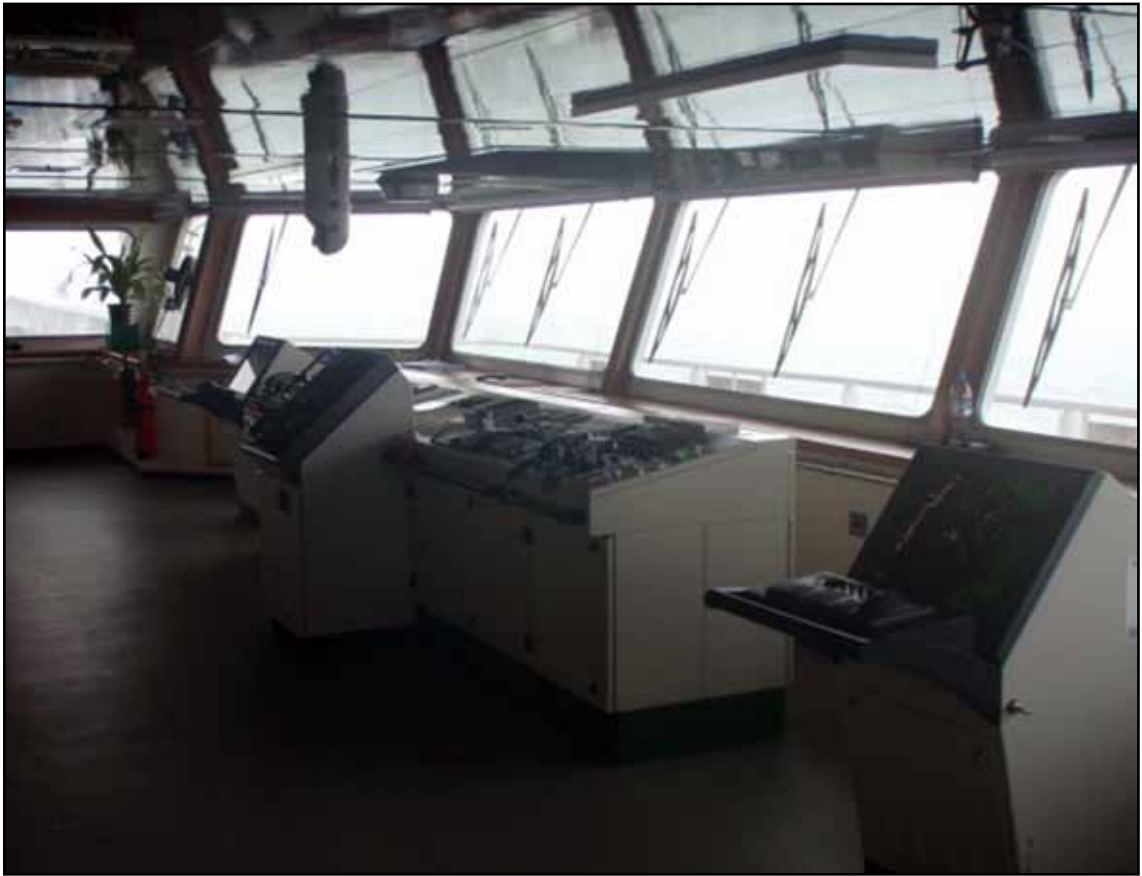
Figure 8

The Filipino OOW had previously participated in STS transfers and was primarily stationed at the port radar display (**Figure 8**) adjacent to a fixed VHF radio. He was responsible for collision avoidance, external VHF communications, and monitoring the application of helm orders. He also operated the engine telegraph when the master was on the bridge wing. The vessel was operating in manual steering, and a Filipino AB was stationed at the helm.

Saetta's bridge

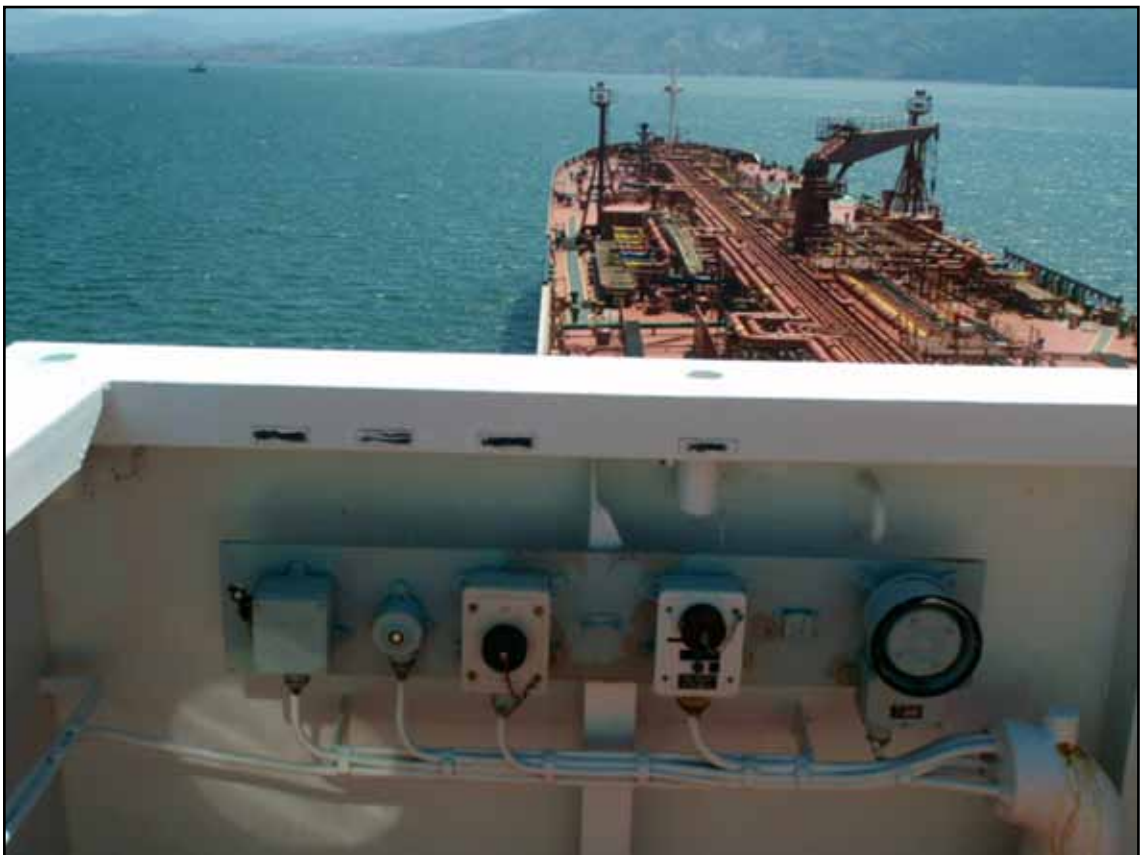
Figure 9

The superintendent had the con and was stationed at the extremity of the port bridge wing (**Figure 9**). He passed engine and helm orders to *Conger's* Ukrainian OOW and helmsman verbally, and to *Saetta* via a hand-held VHF radio. The superintendent communicated to both vessels in English.

View from Conger's port bridge wing

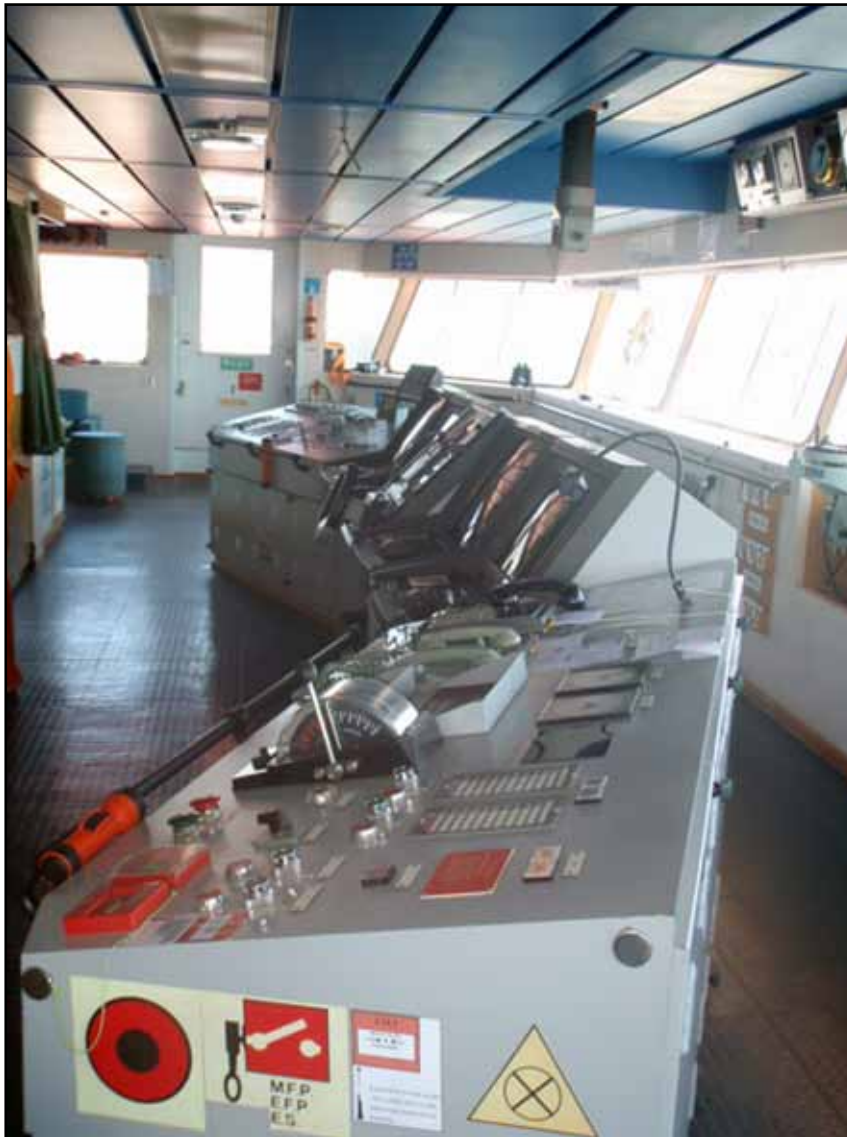
Figure 10

The OOW was positioned on the starboard side of the bridge (**Figure 10**), next to the engine telegraph and close to VHF radios monitoring both the channels in use for internal and external communications. He had previously been involved in a number of STS transfers as an OOW. The vessel was also operating in manual steering, with an AB at the helm.

Conger's bridge
