# Part 3 – Leisure Craft

## Fatal Injuries From Propeller

# A Change of Mind

#### **ACCIDENT WITH THREE FATALITIES 21 AUGUST 2006**

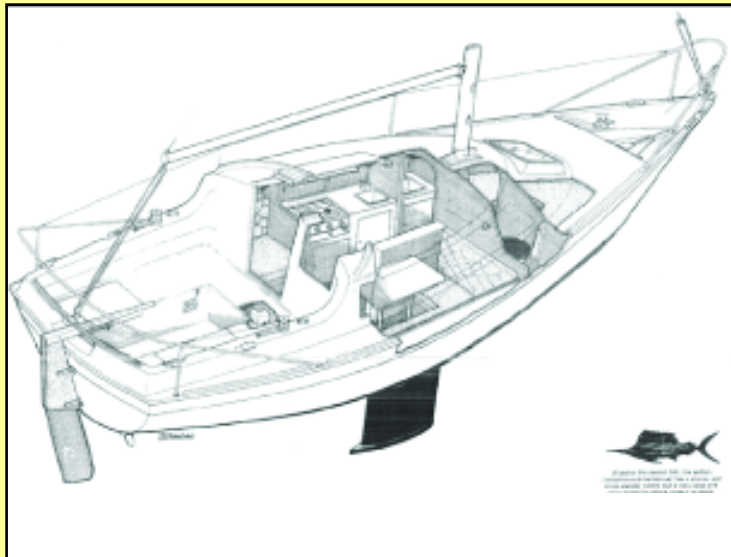
The yacht *Ouzo* sailed from Bembridge, Isle of Wight (IOW), bound for Dartmouth, Devon on the evening of 20 August 2006 with her three regular crew on board. The last record of the yacht was at 2230 when she went out of range of the Southampton/Portsmouth VTS radar system in Sandown Bay. At this time it is believed that the yacht was sailing close hauled in a south-south-westerly direction.

The body of one of the crew members was found in the sea just before midday on 22 August about 10 miles south of the Nab Tower. At about 1900 on

the following day, the bodies of the other two crew were recovered from the sea. They had all been wearing inflated lifejackets and good quality yachting clothing. Despite extensive surface and sub-surface searches no trace of the yacht has been found.

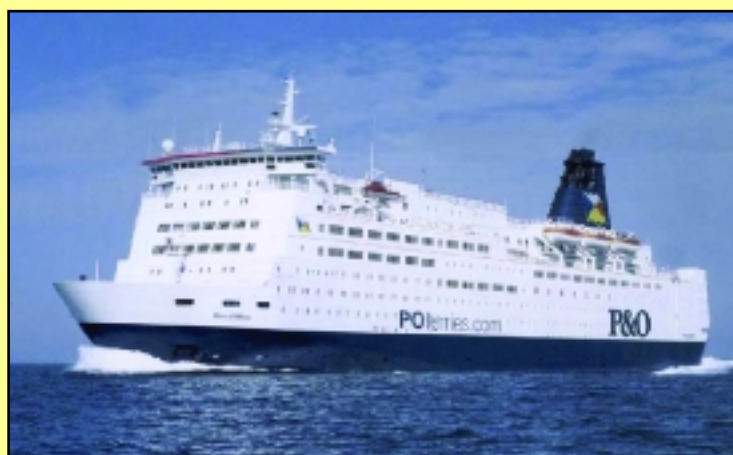
Voyage data recorder (VDR) records from ships that had been in the area during the night of 20/21 August were recovered and analysed by MAIB inspectors and it was discovered that the ferry *Pride of Bilbao* had been involved in an incident with a yacht 6 miles south of the Isle of Wight in the early hours of 21 August. The investigation concluded that she had either collided with, or passed so close to *Ouzo* at that time, and that the yacht had been swamped or capsized by the vessel's wash.

Just before the incident, *Pride of Bilbao* had made an alteration of course for navigational purposes which might have inadvertently served to confuse the yacht's crew about the ferry's intentions. In any case, any attempts the yachtsmen might have made to attract the ferry's attention were ineffective as the ferry's watchkeeping officer and lookout only saw the yacht's lights at the last minute, by which time they were unable to keep well clear. The yacht had not shown up on the ferry's radars despite probably having a radar reflector hoisted.
