Report on the investigation of the death by asphyxiation of

two crewmen on board

***Sava Lake***

**Report No 15/2008  
September 2008**

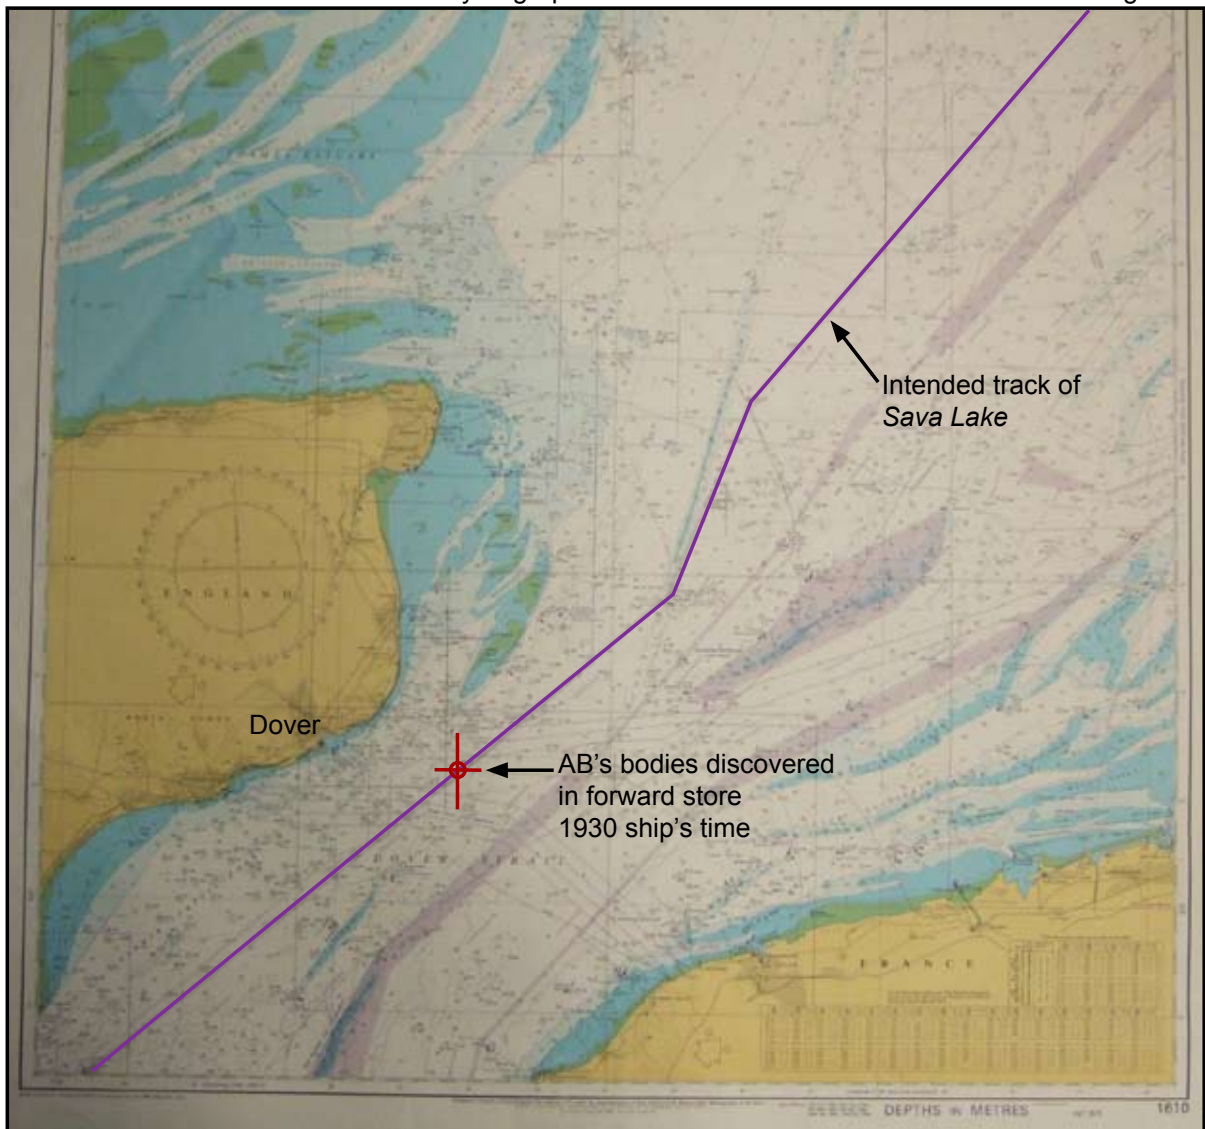
Figure 11

The master decided it was impractical to recover the men to deck as it was clear they were both dead. The master advised the director of Liepajas of the situation, contacted Dover Coastguard, and requested permission to divert *Sava Lake* to Dover for assistance (**Figure 11**).

Chart of the track of *Sava Lake*

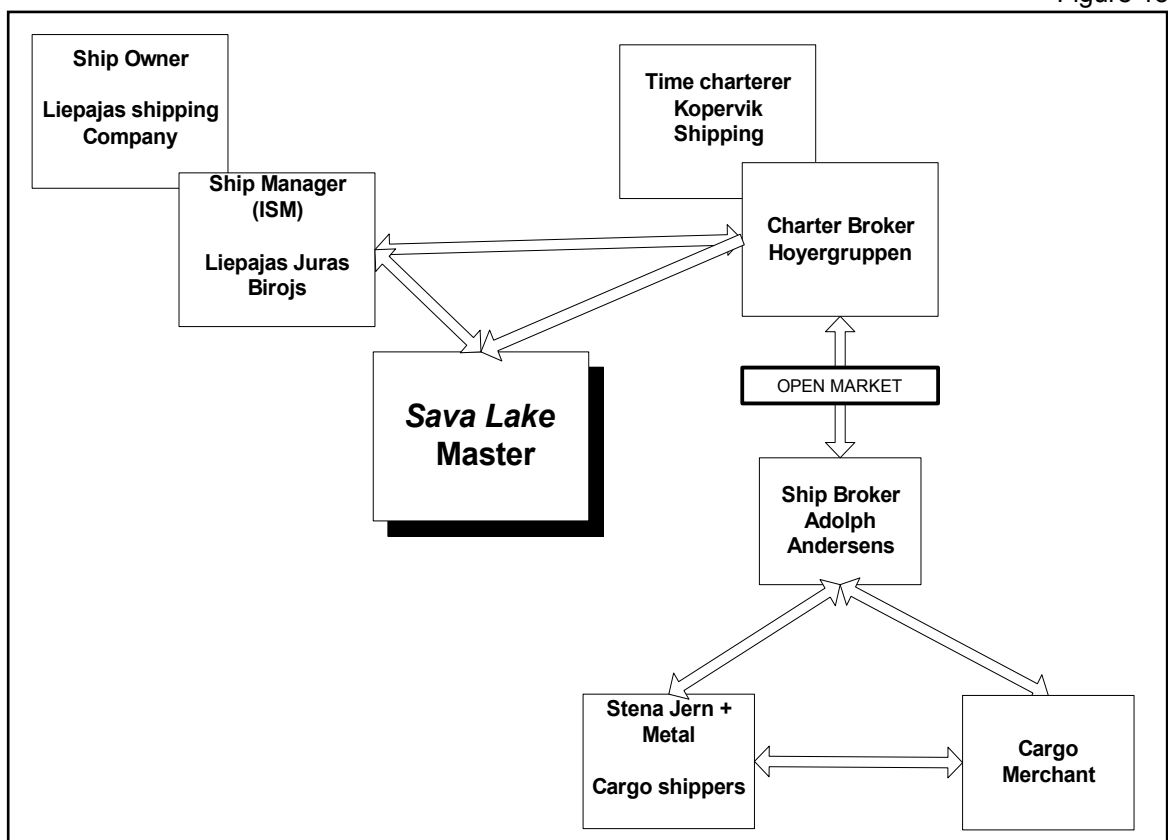
Figure 13

Information flow between parties involved in cargo fixing

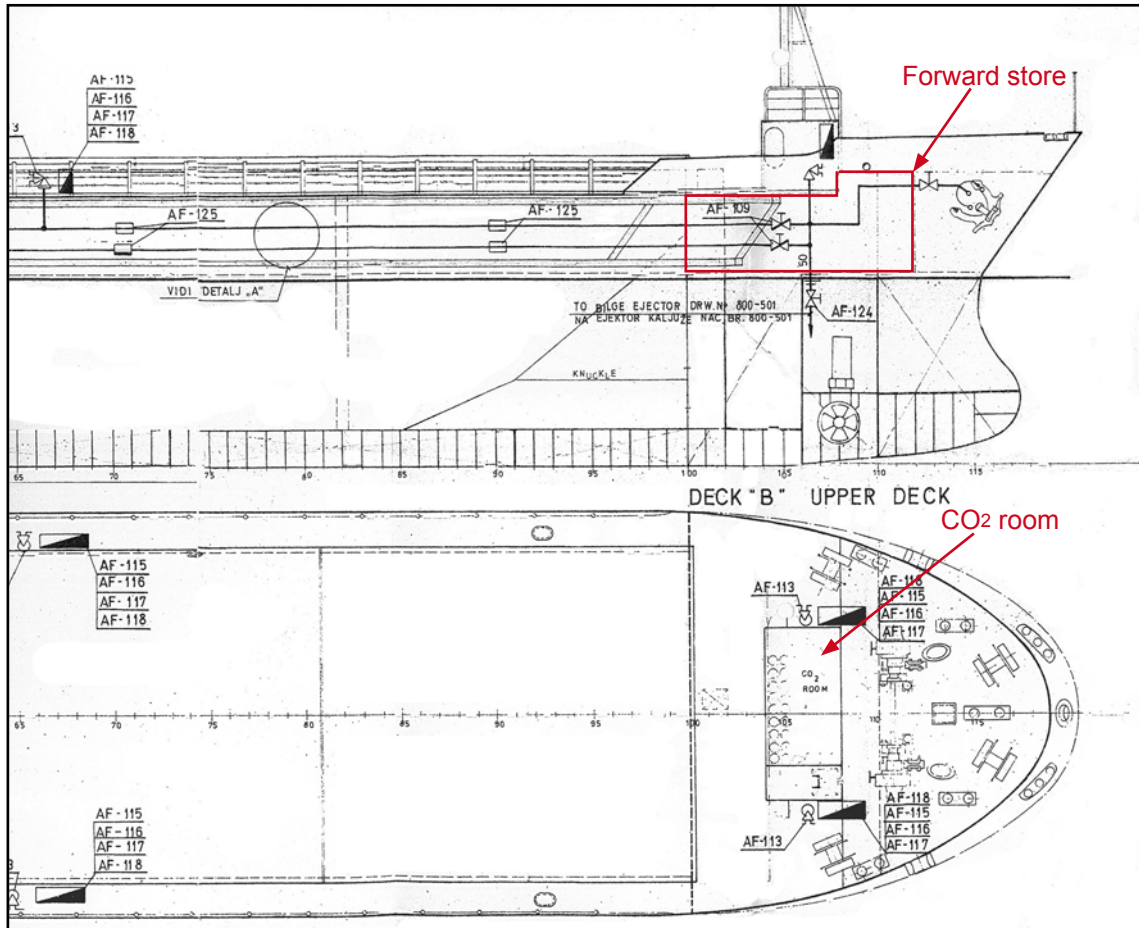
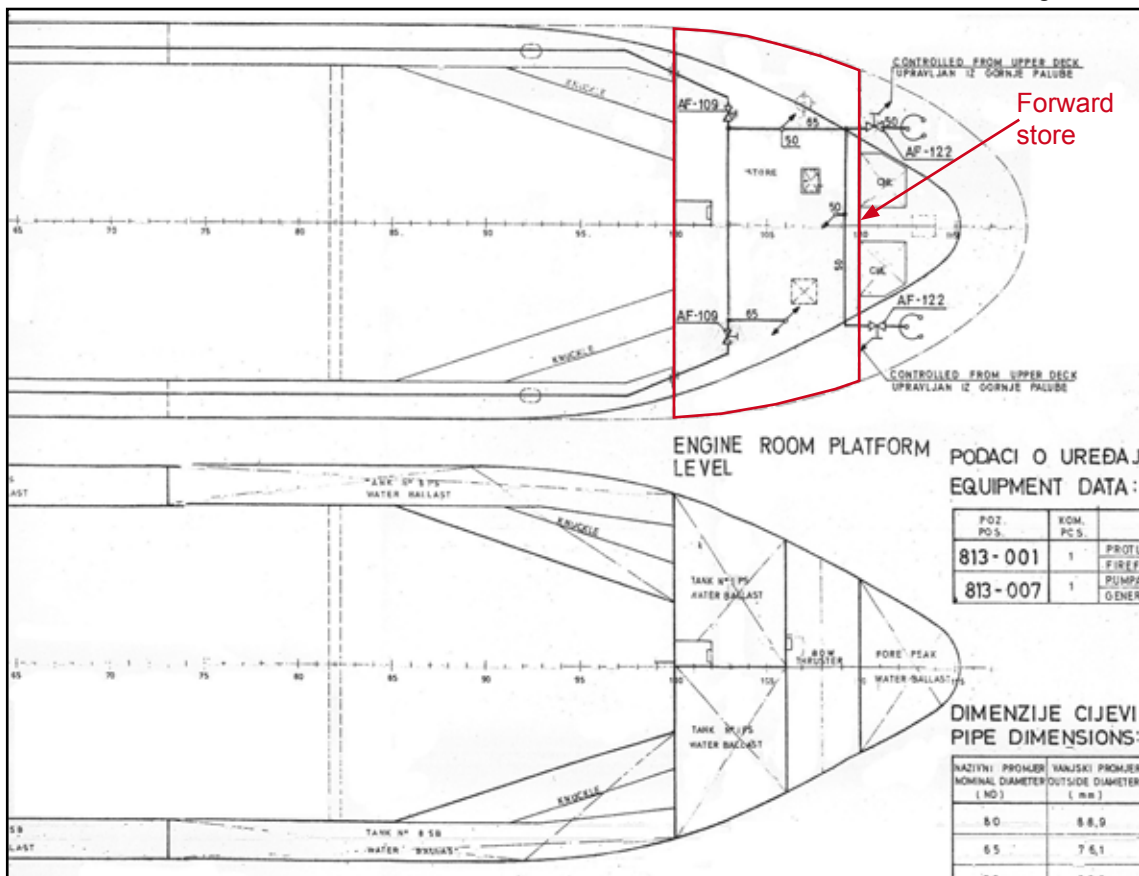
Figure 15a

The forward store was directly forward of the cargo hold and aft of the paint store and chain lockers (**Figures 15 a & b**). The store was under the carbon dioxide (CO<sub>2</sub>) bottle room, located on the open forward deck, and was above the bow thrust space and forward water ballast tanks.

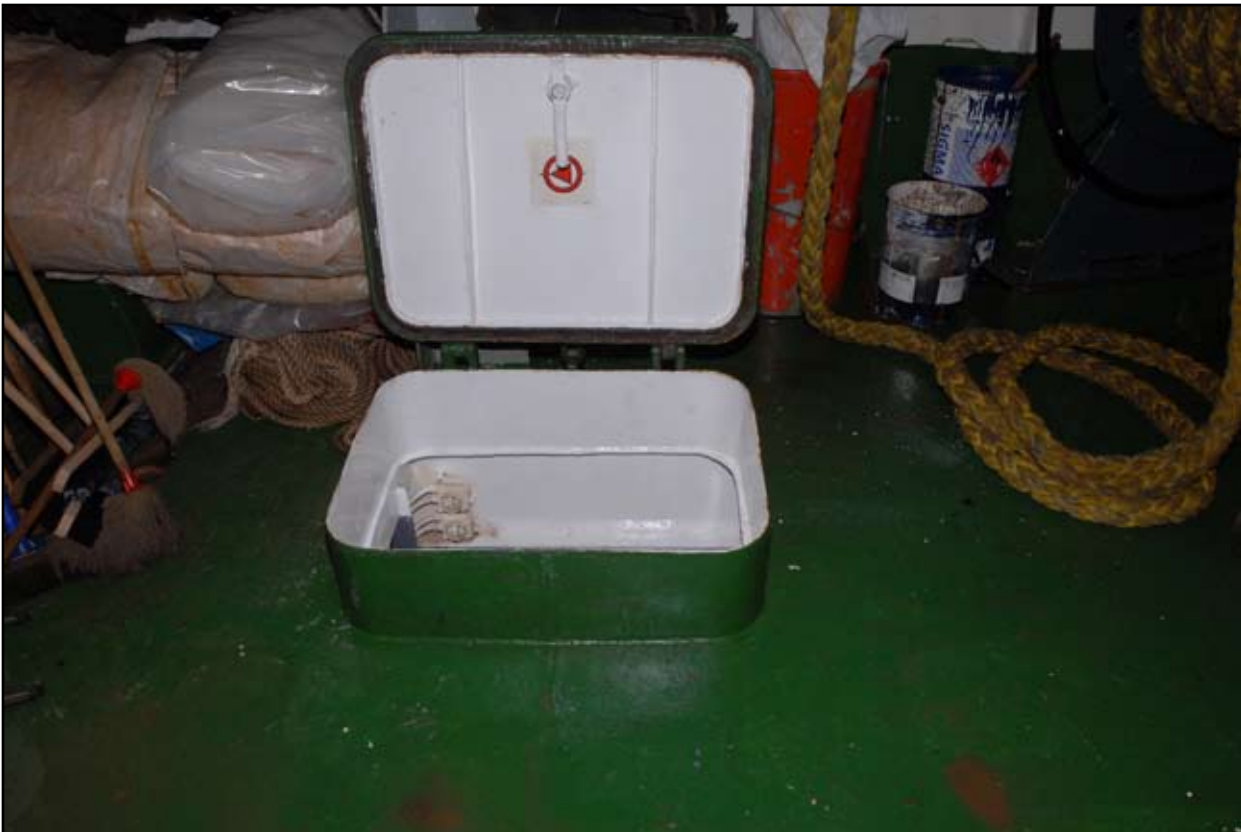
The forward store was accessed through a weather tight door on the starboard side of the deck house and down a single steep ladder. The store contained the vertical access ladder down to the bow thrust room. The two compartments were separated by a hatch (**Figure 16**). The hatch was routinely left open on passage and the two spaces were effectively common.

Hatch from forward store to bow thrust room

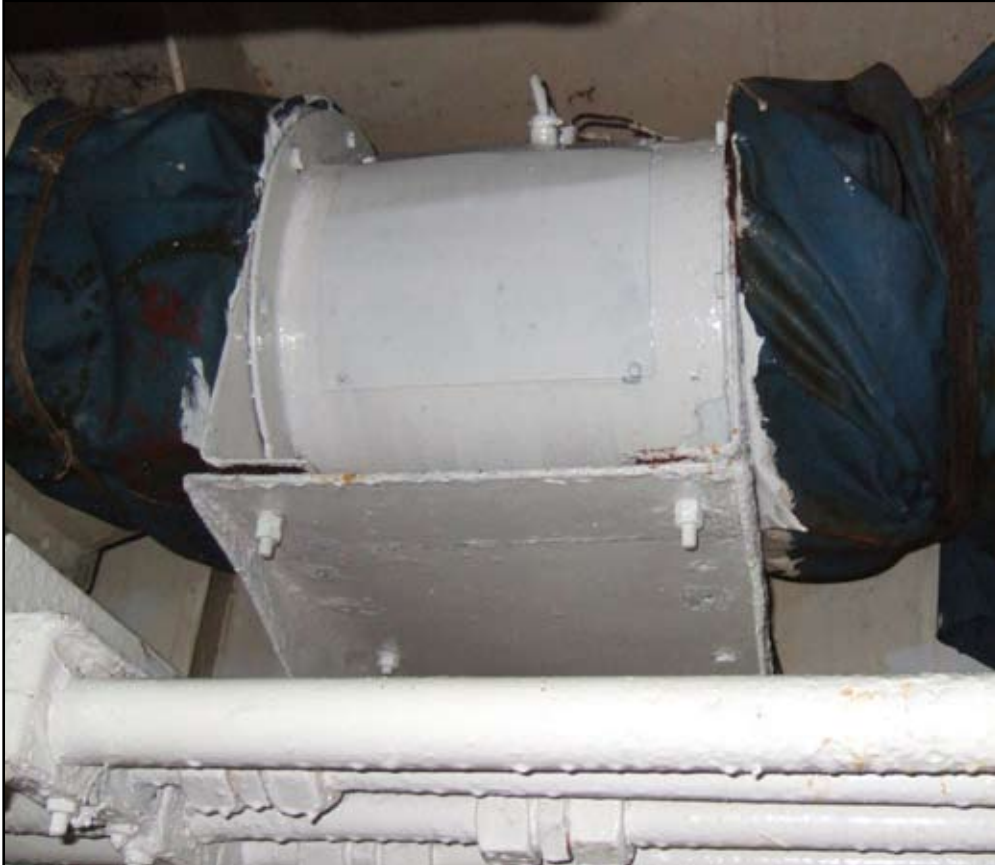
Forward store ventilation fan

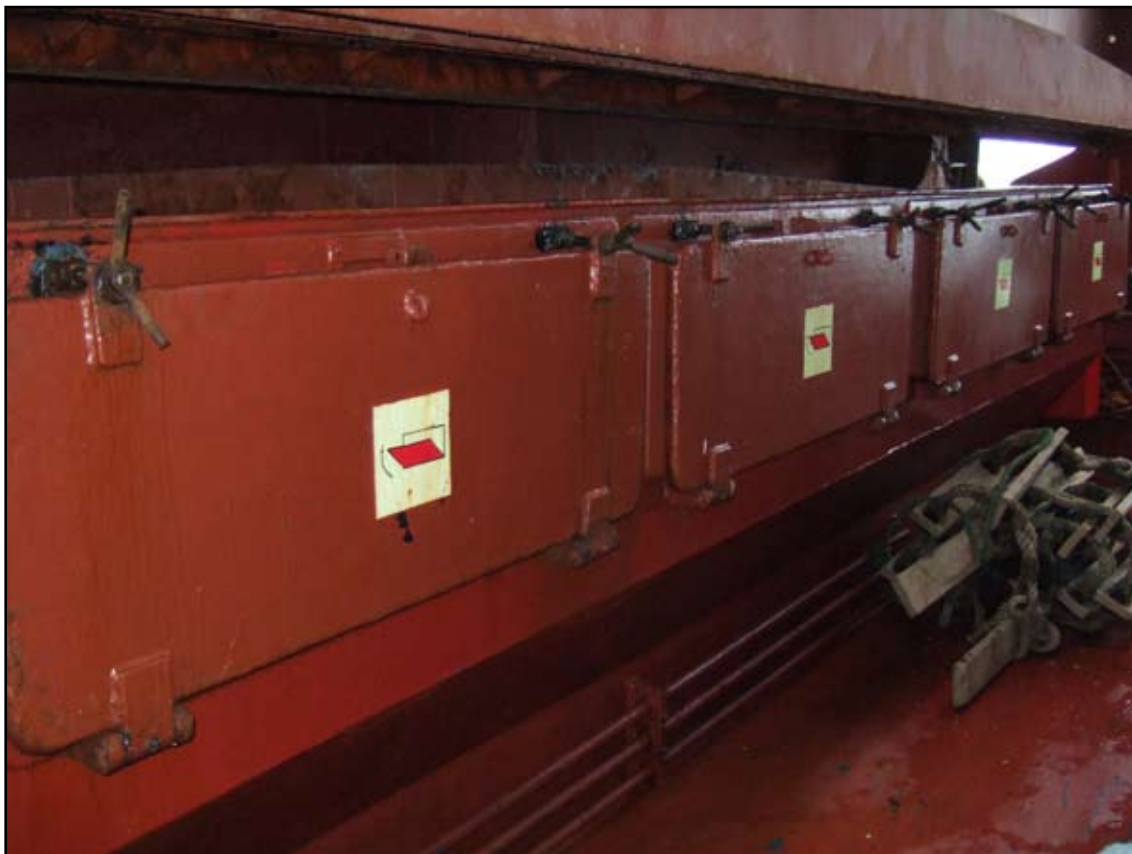
Figure 20

The aft system consisted of natural ventilation only with several securable flaps aft of the cargo hold (**Figure 20**). Within the cargo hold, shutters were fitted over the ducts; the flaps were sealed with various types of expanding foam and sealant (**Figure 21**).

Aft cargo ventilation flaps on deck

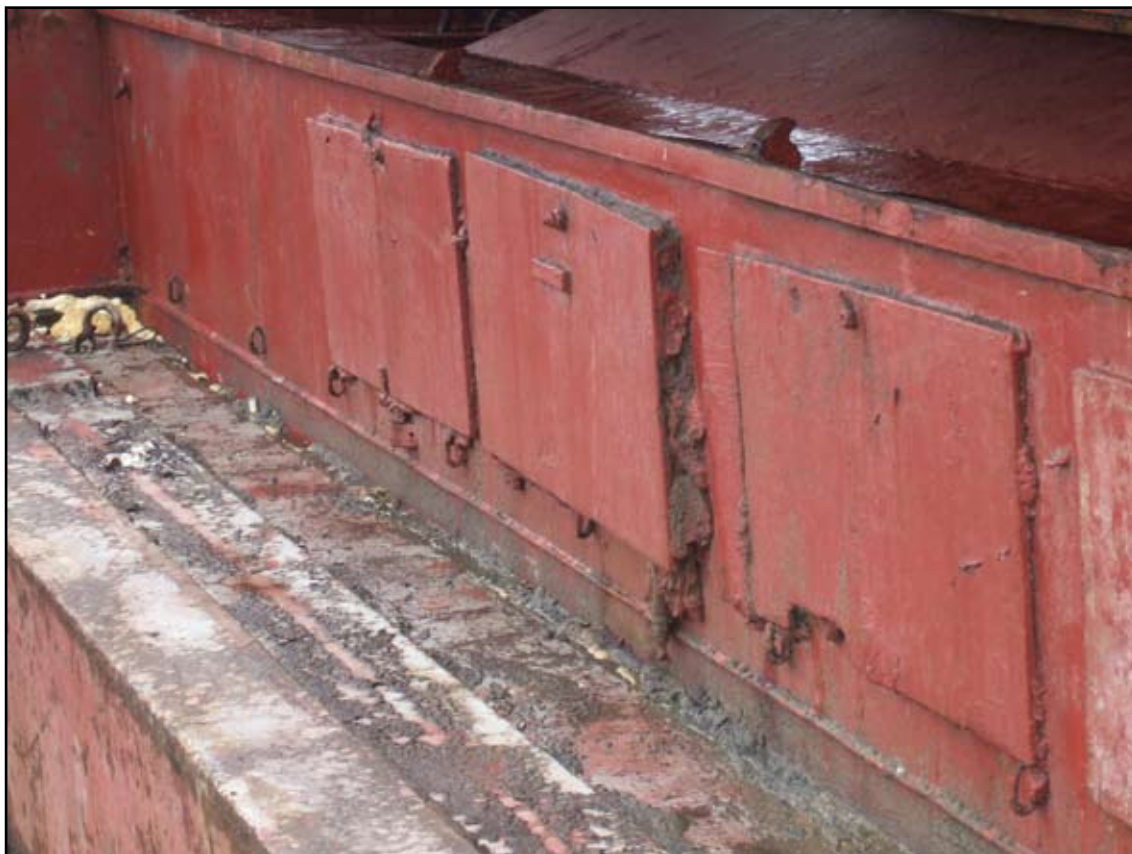
Figure 21

Aft cargo ventilation flaps within hold

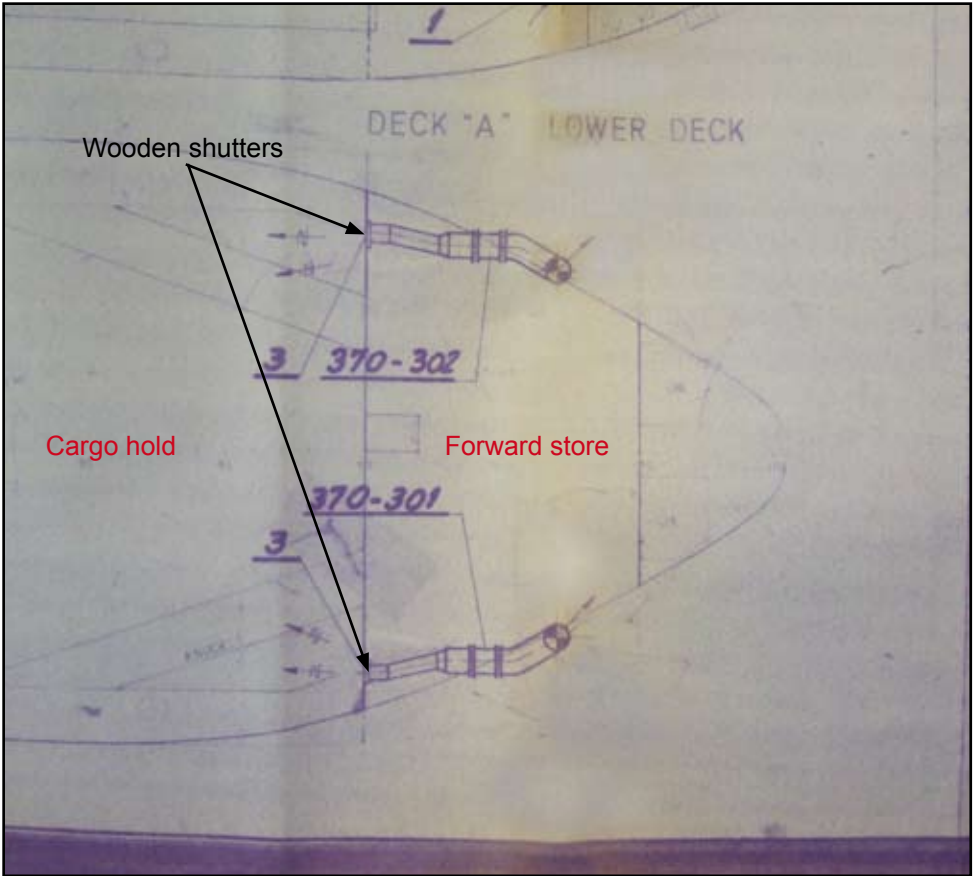
Figure 23a

The system (**Figure 23 a & b**) led immediately into the forward store and consisted of two, symmetrical, independent tubular steel ducts located at the outer extremities of the space.

Plan of forward ventilation system

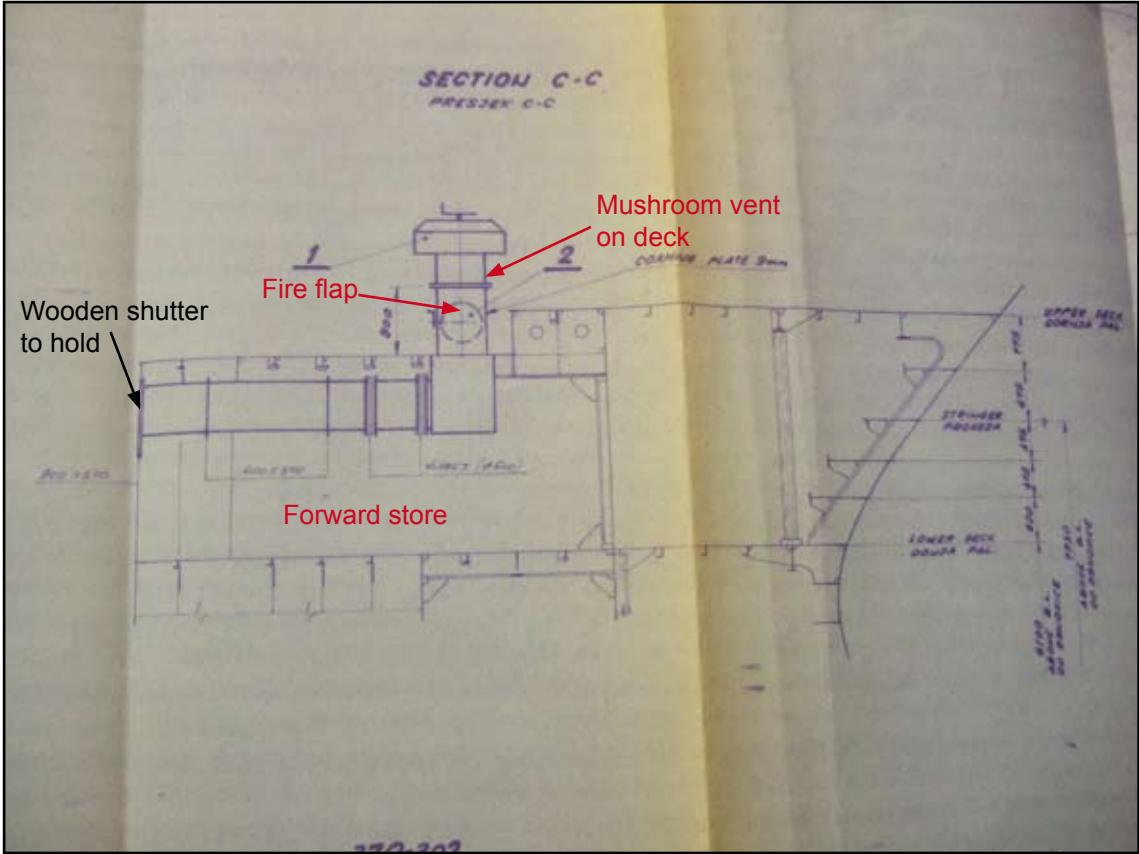
Figure 23b

Plan of forward ventilation system

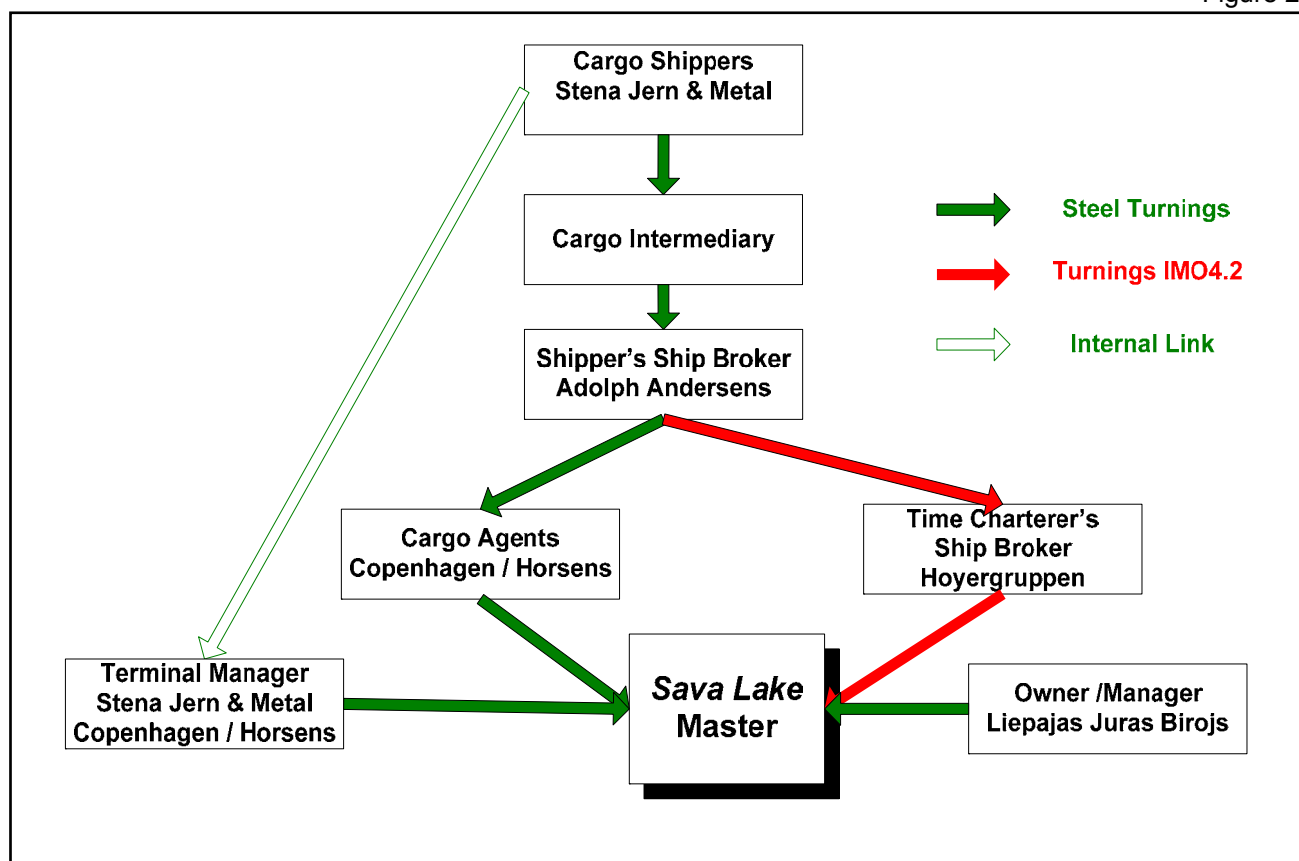
The master was advised by the ship broker, Hoyergruppen AS, by telex that the cargo was *turnings IMO 4.2*. As this was not supported by the additional BIMCO clause information supplied by Adolph Andersens Succr., this was the only advice the master had that stated this was a dangerous cargo, albeit the correct BCSN was not included in the information.

Information flow to the Master
