Report on the investigation of

the collision between

Scot Isles

Wadi Halfa

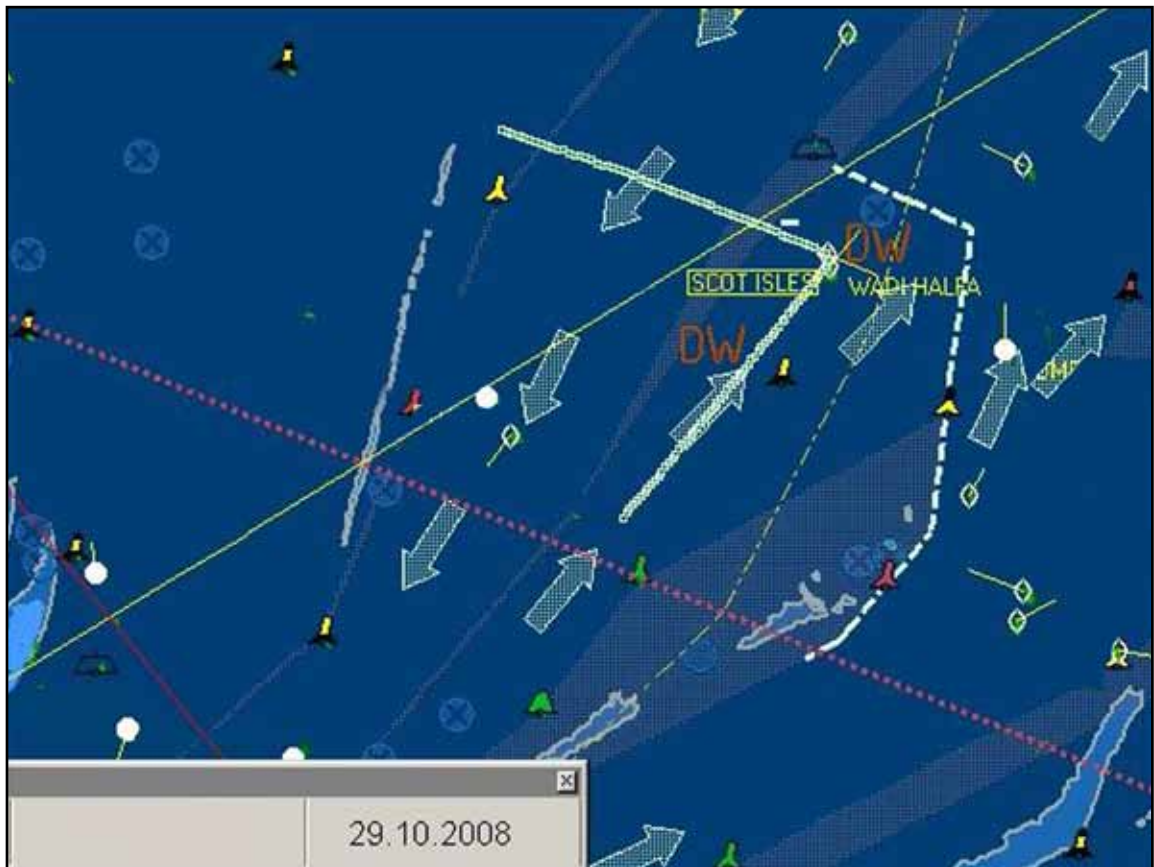
Figure 2

At 0410, *Scot Isles* altered course to 109°(T), and at 0421 she began to cross the SW traffic lane of the TSS. The vessel's position was not plotted on the chart after 0400, so this reconstruction is based on radar replay information obtained from the Channel Navigation Information Service (CNIS) at Dover following the accident (**Figure 2**).

Radar replay screen shot from CNIS, 0449 29 October 2008

The tracks of both vessels were recorded on radar by CNIS at Dover and the radar plot for 0449, 29 October (**Figure 2**) shows their historic tracks at the time of the collision.

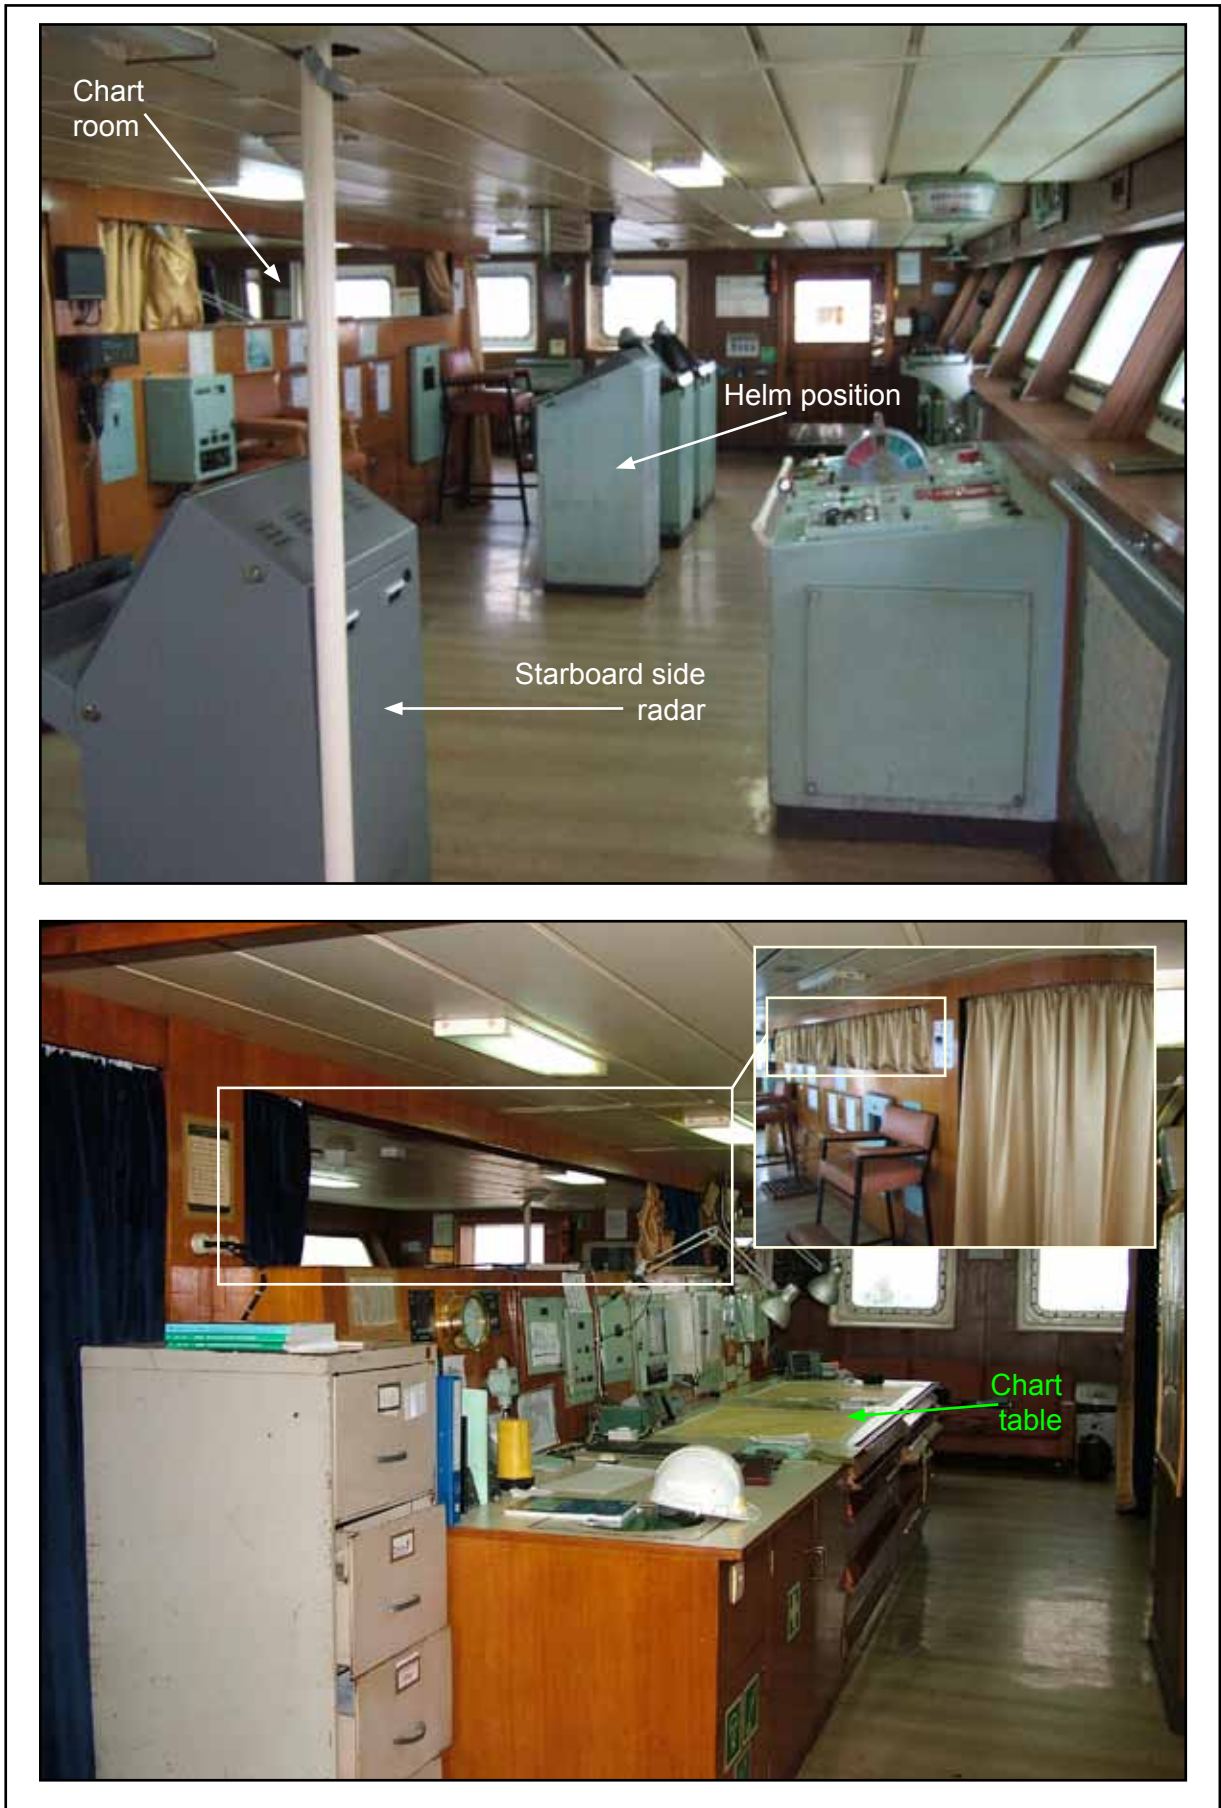
Wadi Hafa - interior of wheelhouse

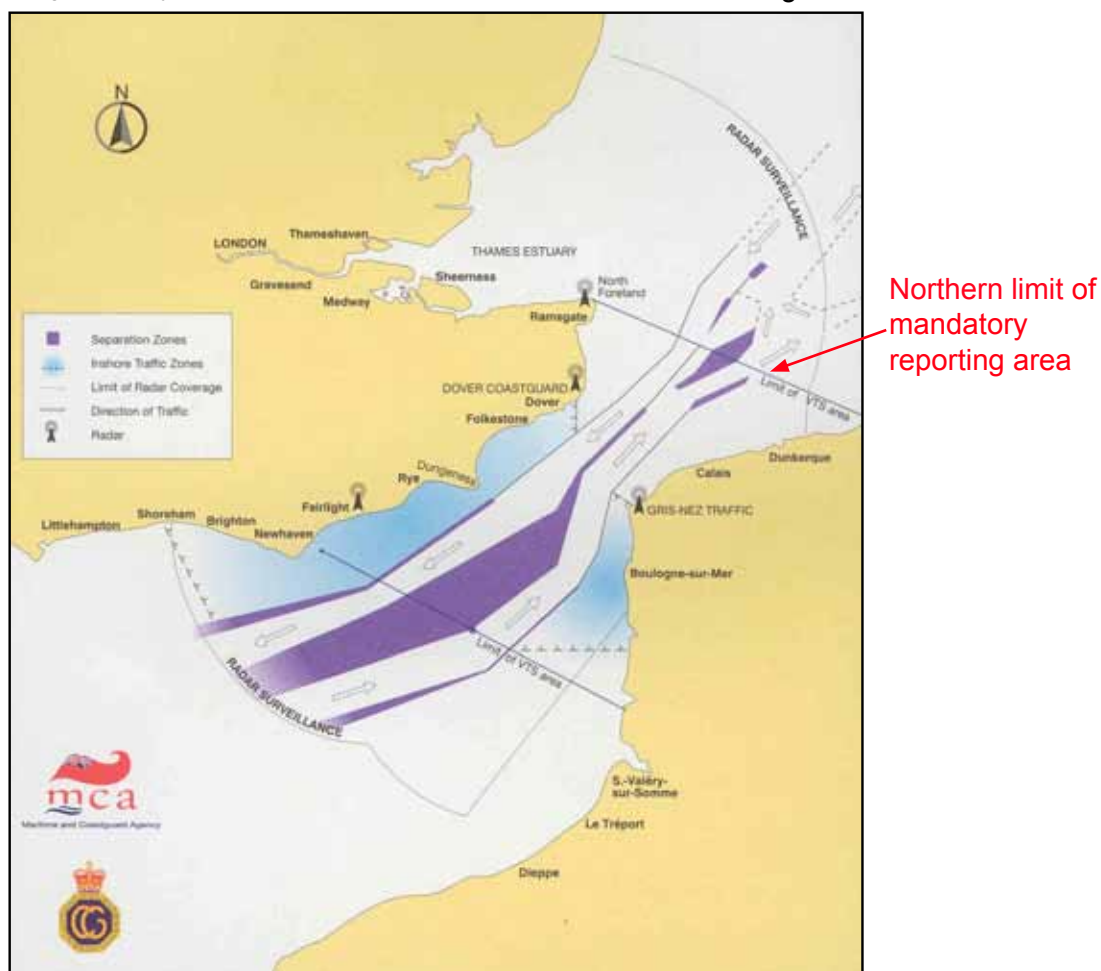
Wadi Halfa reported to Cap Gris Nez when she entered the NE bound traffic lane, while *Scot Isles* was not required to make a report as her passage was conducted outside of the mandatory reporting area (**Figure 9**).

Dover Strait TSS - mandatory reporting area

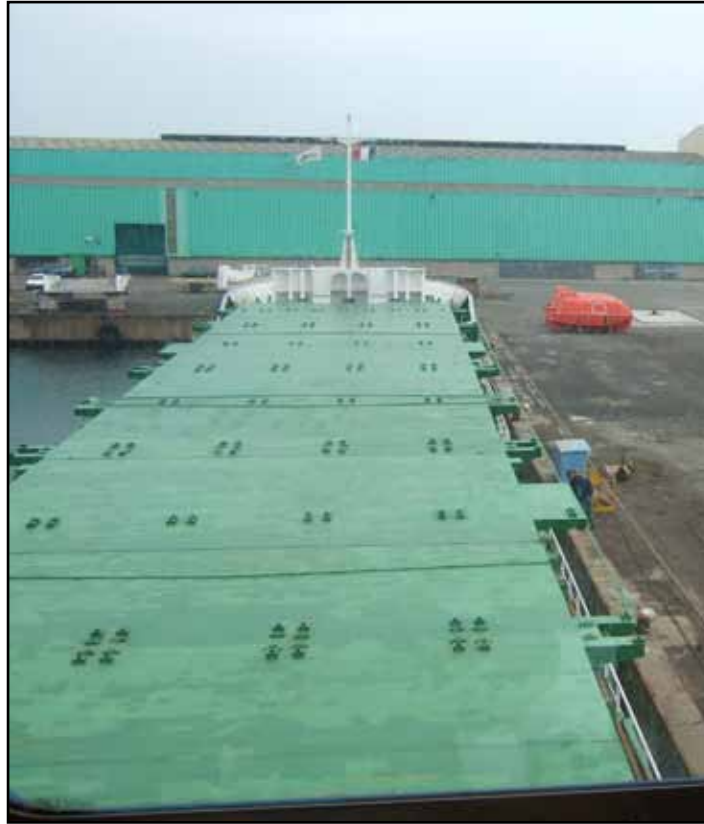
Figure 11

In assuming that only *Scot Isles'* starboard bridgework had been damaged during the collision, the master relied on information provided to him by the chief officer, who was in a state of shock, and on what could be seen from the wheelhouse (**Figure 11**). A thorough inspection of the entire vessel, which should have included sounding all tanks and spaces, should have been undertaken following the collision.

Scot Isles - view looking forward from wheelhouse
