Report on the investigation of the
grounding of the cargo vessel

Sea Mithril

on the River Trent

Report No 16/2008
September 2008

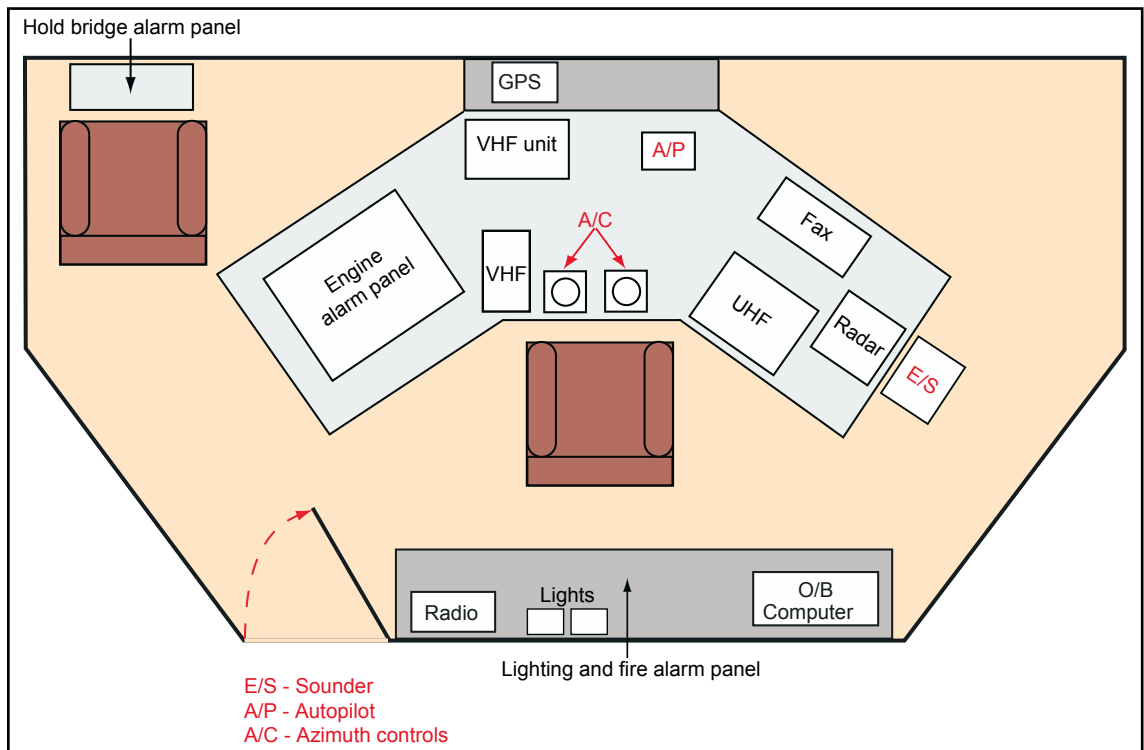
Figure 2

At about 0215, as *Sea Mithril* approached the Humber suspension bridge, the visibility suddenly reduced to about 50 metres. The chief officer immediately called the master; he also called the vessel's engineer and an AB. When the master arrived on the bridge, he sat in the centre chair (**Figures 2 and 3**), from where he started to steer the vessel manually. The pilot stood by the radar display which was sited on the starboard side of the bridge. The chief officer also remained on the bridge, while the engineer went to the engine room and the AB went to the focsle head to act as lookout. The lookout was able to communicate with the master via a hand-held radio.

Diagram of the bridge layout

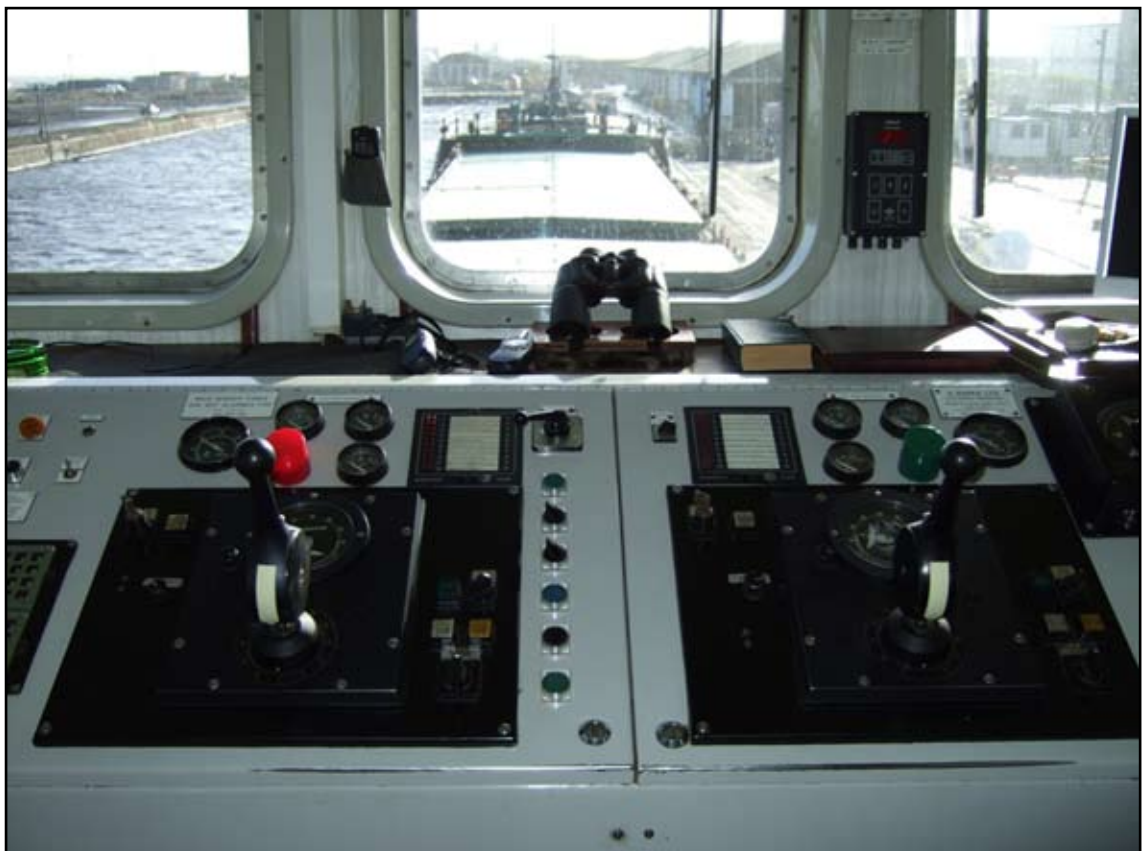
Figure 12

Sea Mithril is powered by two engines driving a series of shafts connected to two azimuth pods (**Figure 11**). The speed of the propellers and the azimuth of the pods are controlled by single levers sited on the bridge (**Figure 12**). The ship is steered by changing the direction of the pods via the levers.

Sea Mithril's wheelhouse azimuth pod controls
