Report on the investigation of
Sichem Melbourne
making heavy contact with mooring structures
at Coryton Oil Refinery Terminal
on 25 February 2008

Report No 18/2008
October 2008

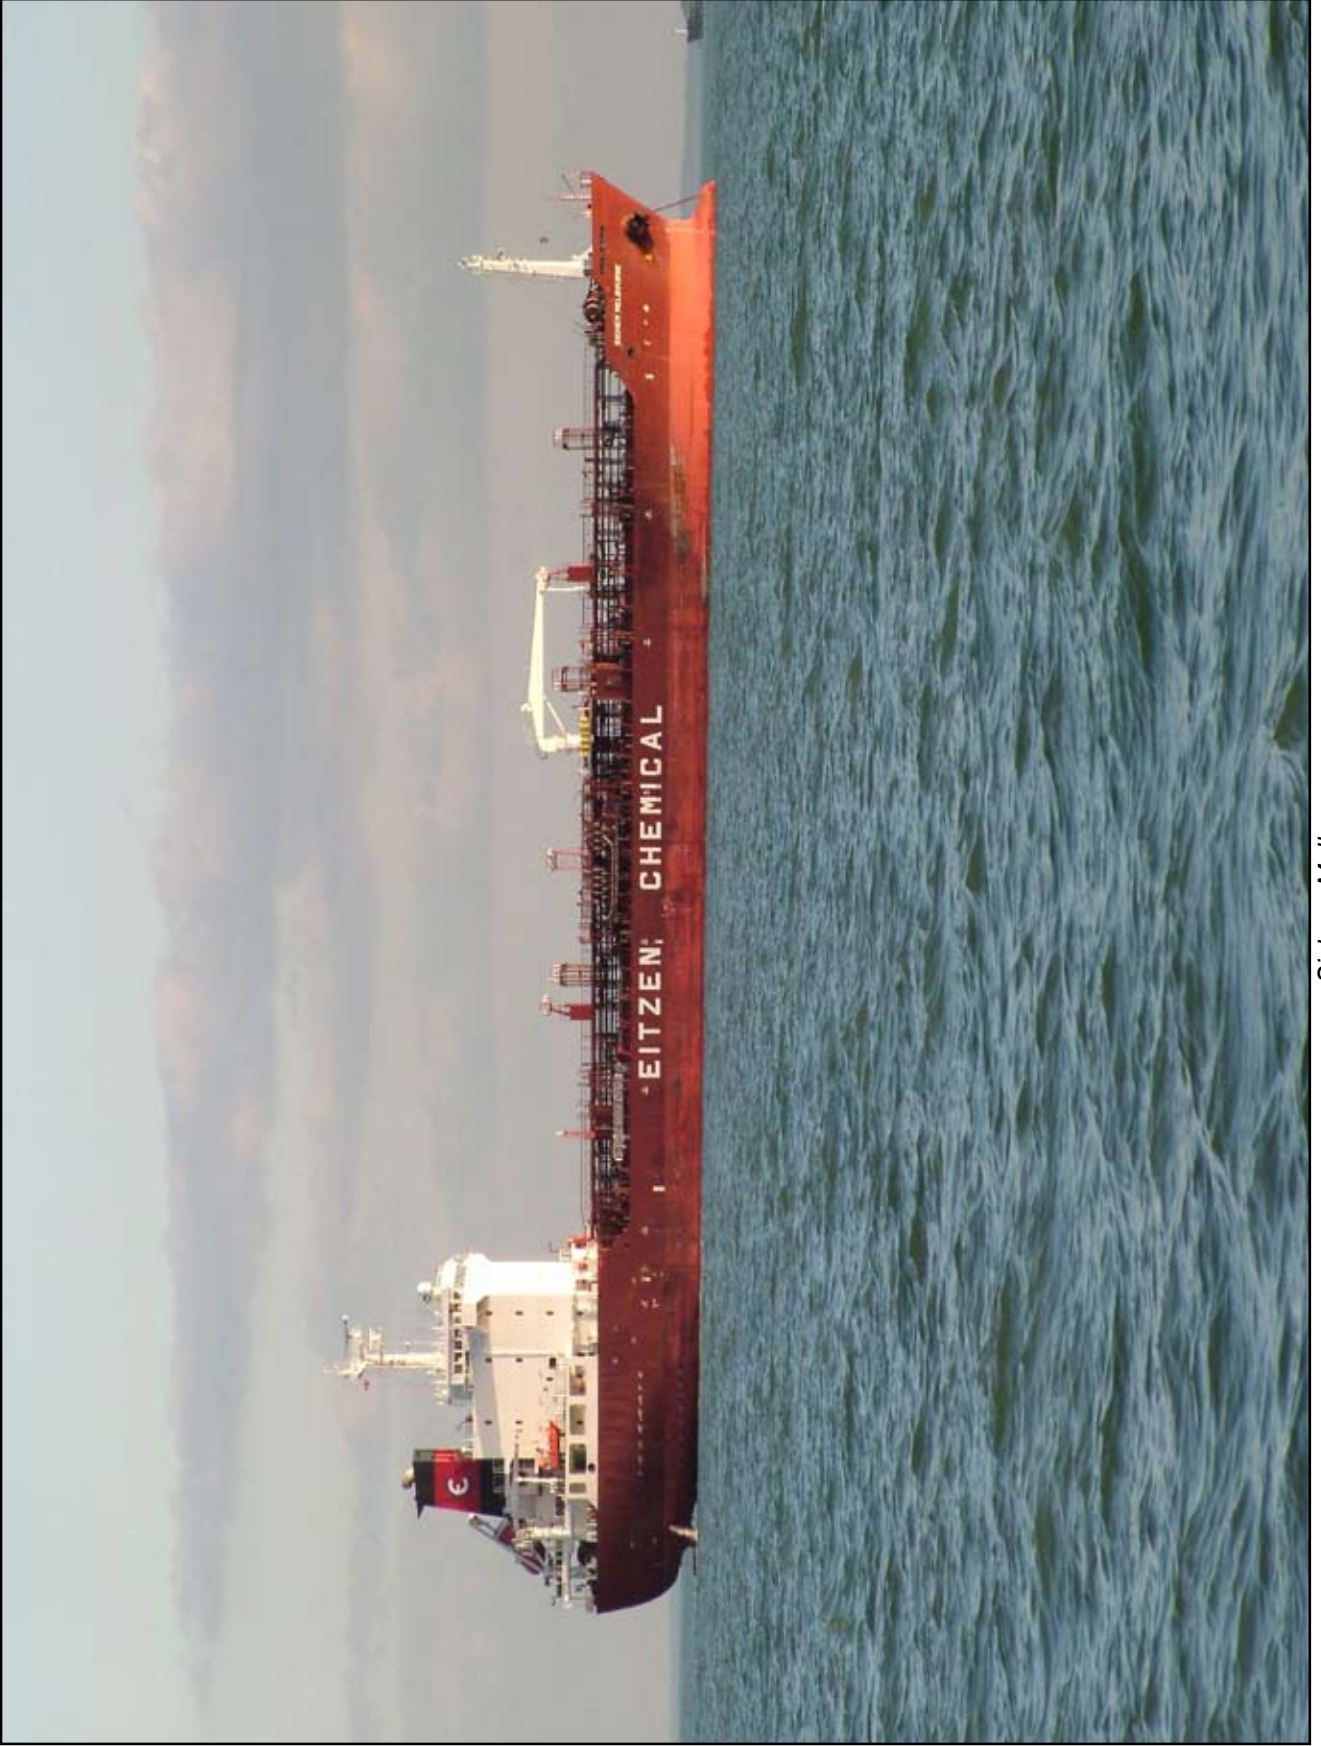
Figure 1

Sichem Melbourne

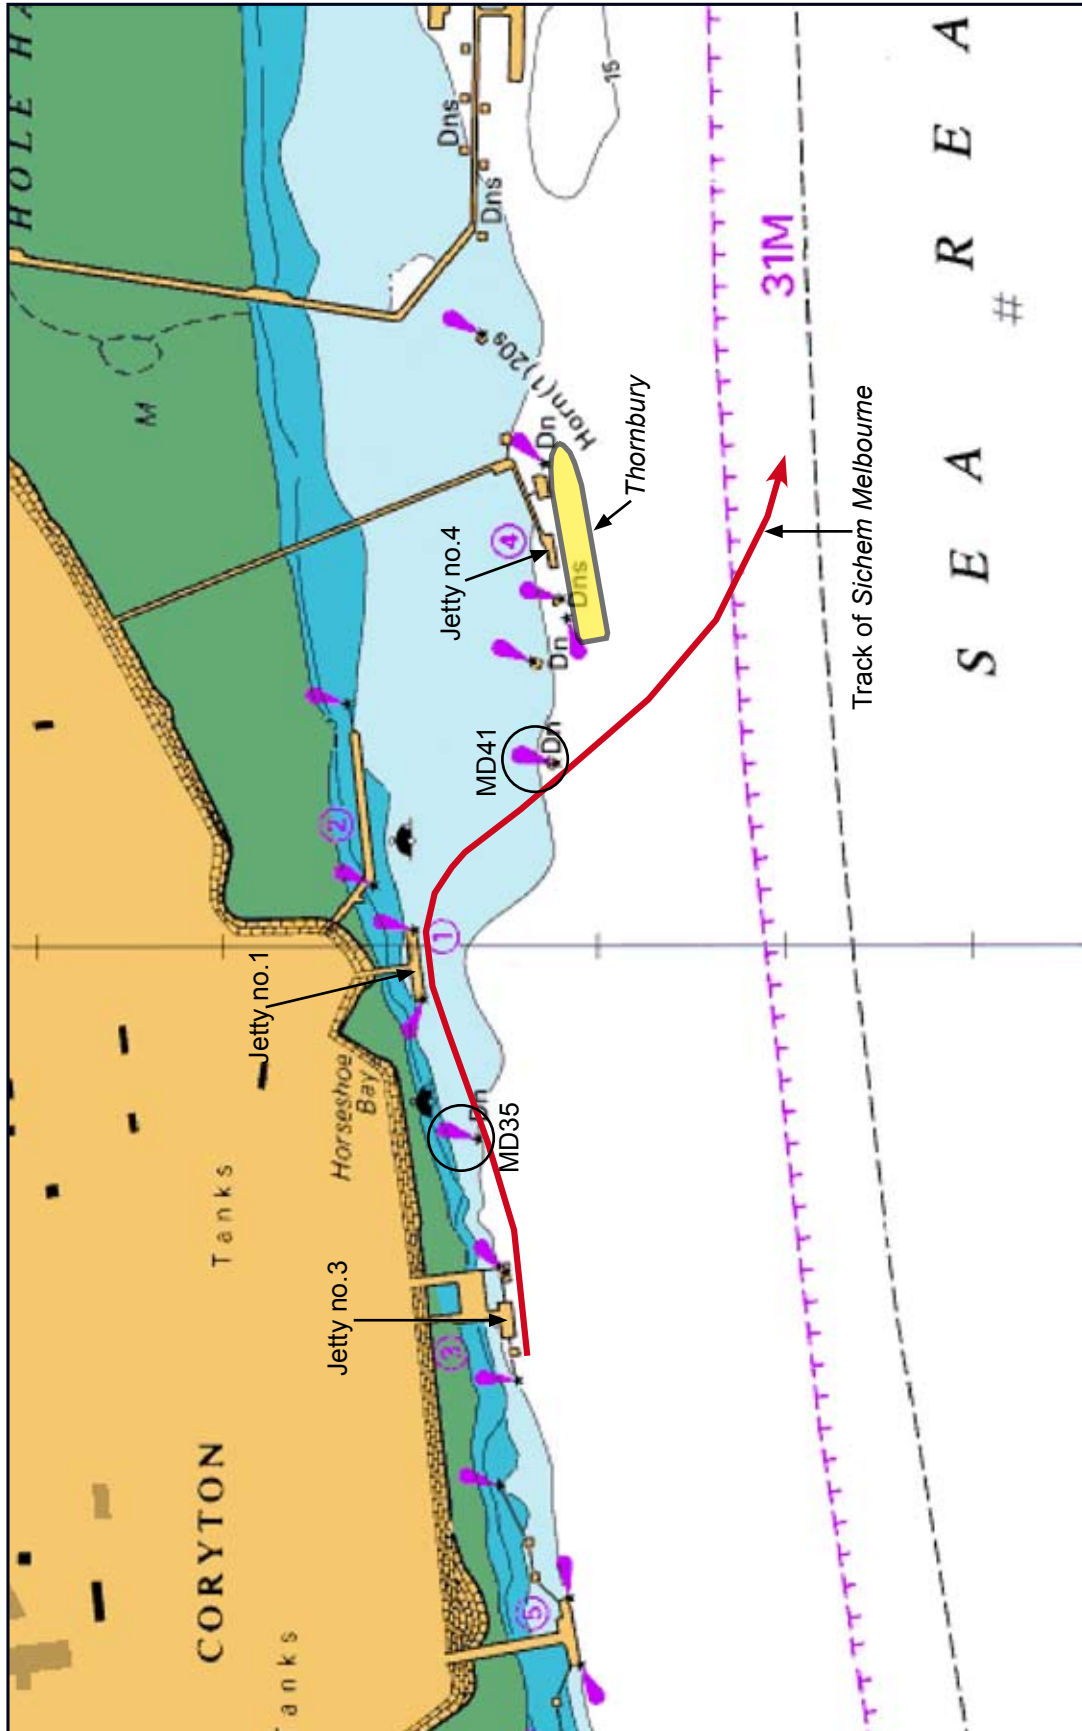
Figure 2

The pilot made an attempt to stop the ship's forward movement by giving instructions to come astern, however this resulted in transverse thrust from the right handed propeller setting the ship towards the shore and mooring dolphin MD35 (**Figure 2**). On seeing this, the pilot requested that the engines were put half ahead, and the helm hard a port in a further attempt to pivot *Sichem Melbourne* clear of the dolphin and move her stern towards the channel; this was thwarted by the master once more applying starboard bow thrust without the pilot's knowledge. Consequently the ship made contact with the dolphin MD35.

Modified chart showing berths at Coryton Refinery

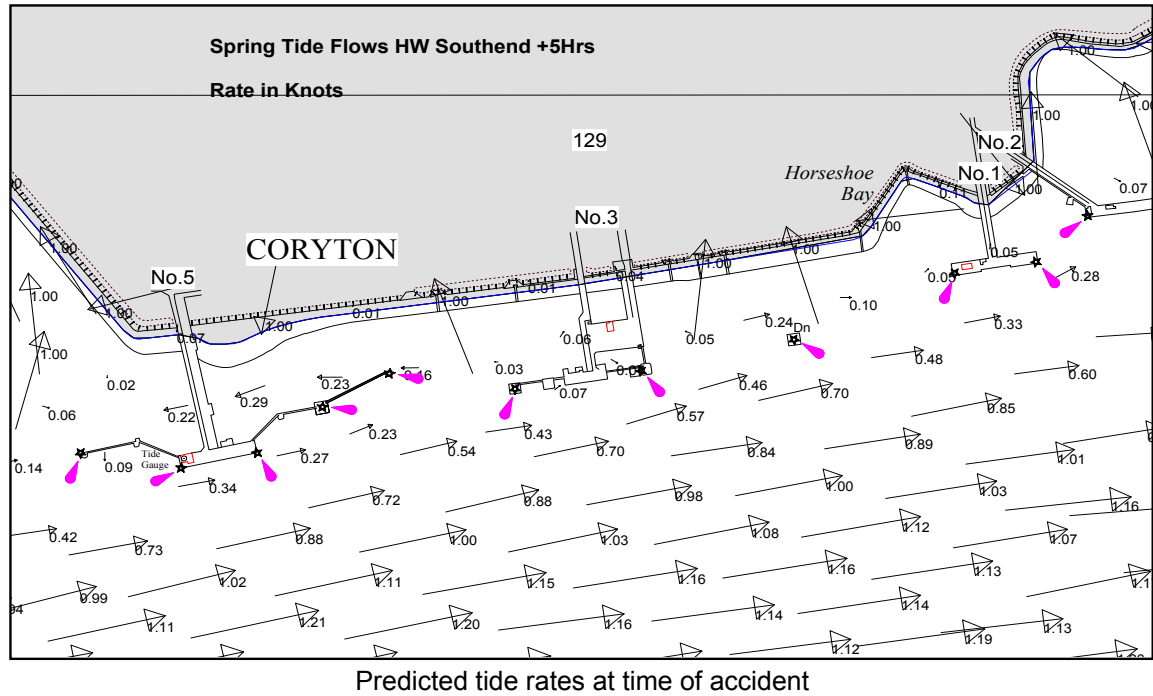
Figure 6

PLA owns, in conjunction with HR Wallingford¹, a sophisticated two dimensional tidal model, which gives detailed tidal predictions at various points on the River Thames; the predictions for Coryton at the time of the accident are shown in **Figure 6**. Observed tidal values and surge differences from the predicted datum are monitored at various points throughout the river; **Figure 7** gives this information for Coryton, 2 hours before and after the incident. This indicates that the heights of tide, and therefore stream velocity at the time of the accident, to be very close to the predicted values.
