Report on the investigation of the collision between

Skagern and Samskip Courier

in the Humber Estuary

Report No 6/2007
April 2007

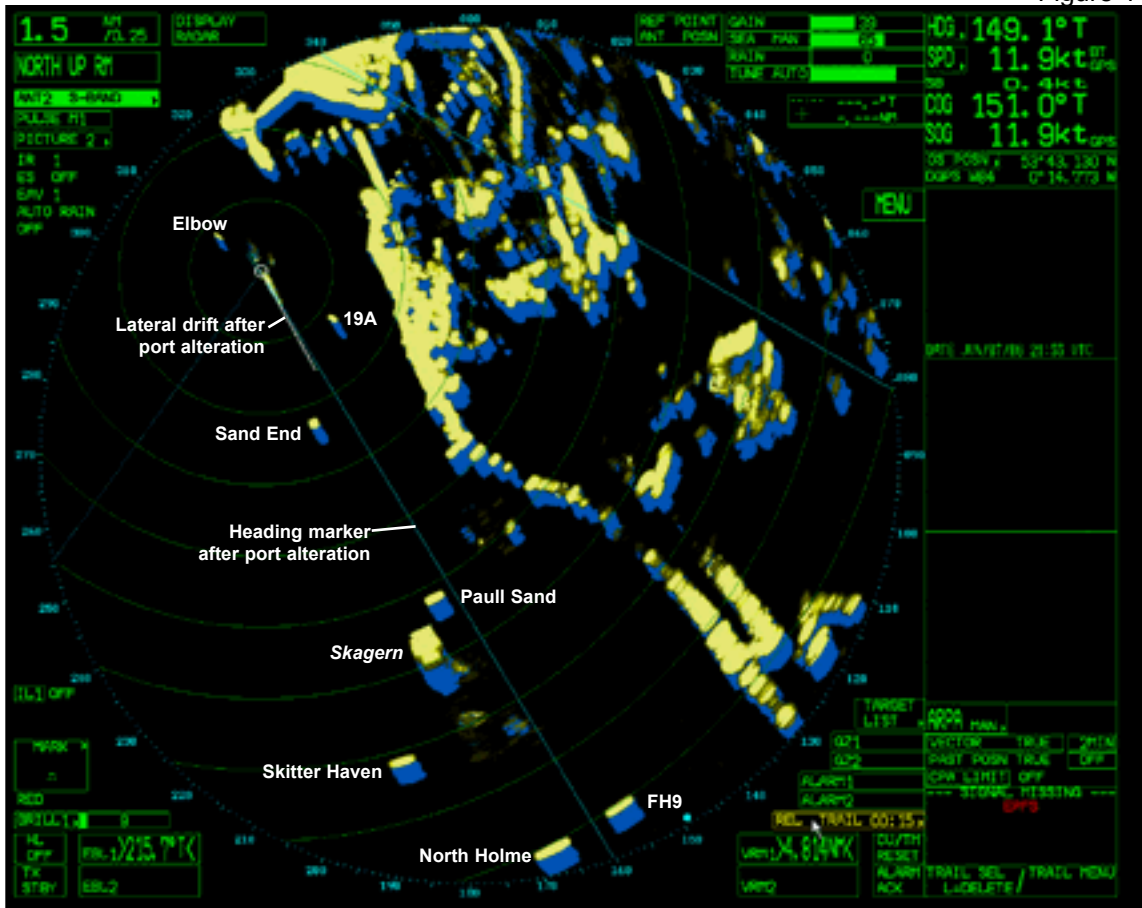
Figure 14

- At 22:54:44 *Samskip Courier*'s pilot counteracted the starboard swing by giving port helm which was held for 26 seconds (**Figure 14**).
- At 22:55:30 both ships were appraised on VHF channel 12 of their respective positions by VTS, approximately 3 minutes before collision (**Figure 15**). Closing speed was 23.5kts. Visibility less than 1 cable.

Samskip Courier given port helm to counteract starboard swing

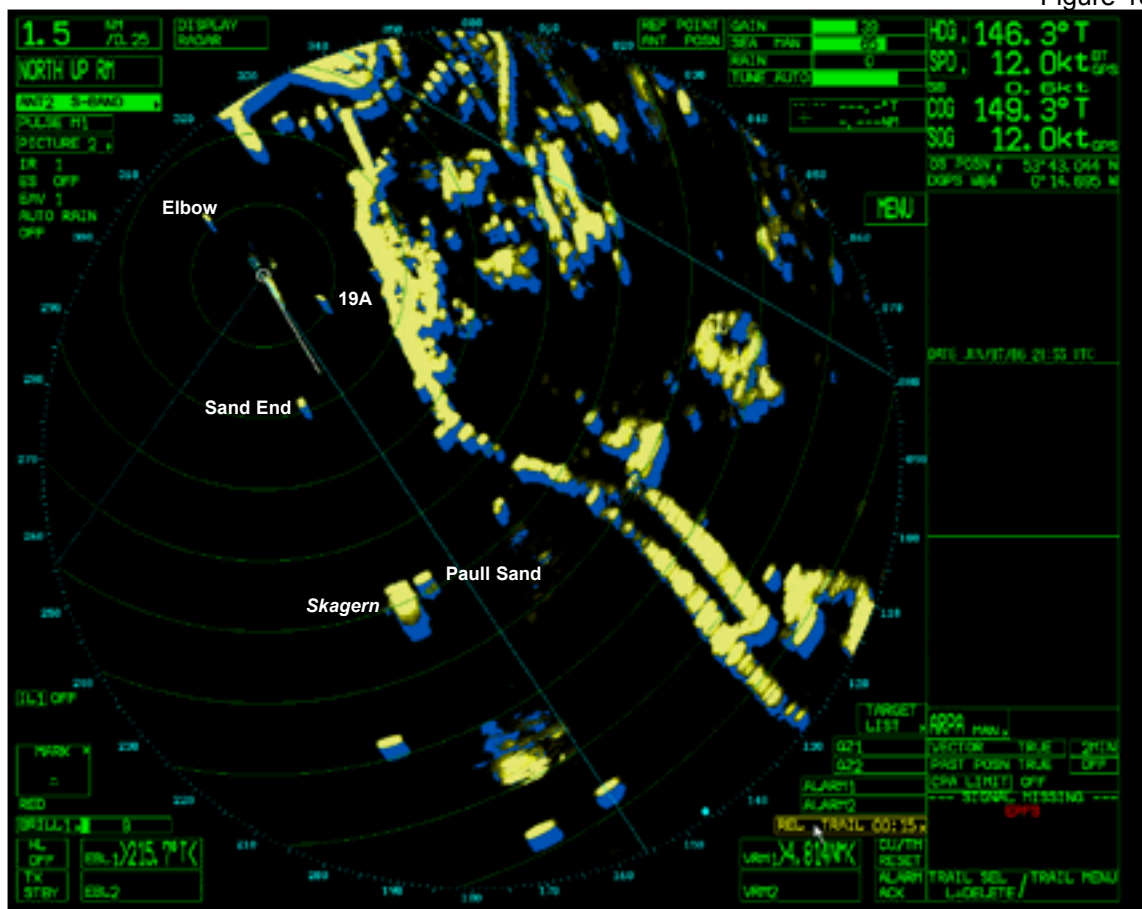
Figure 15

Position of ships when appraised by VTS

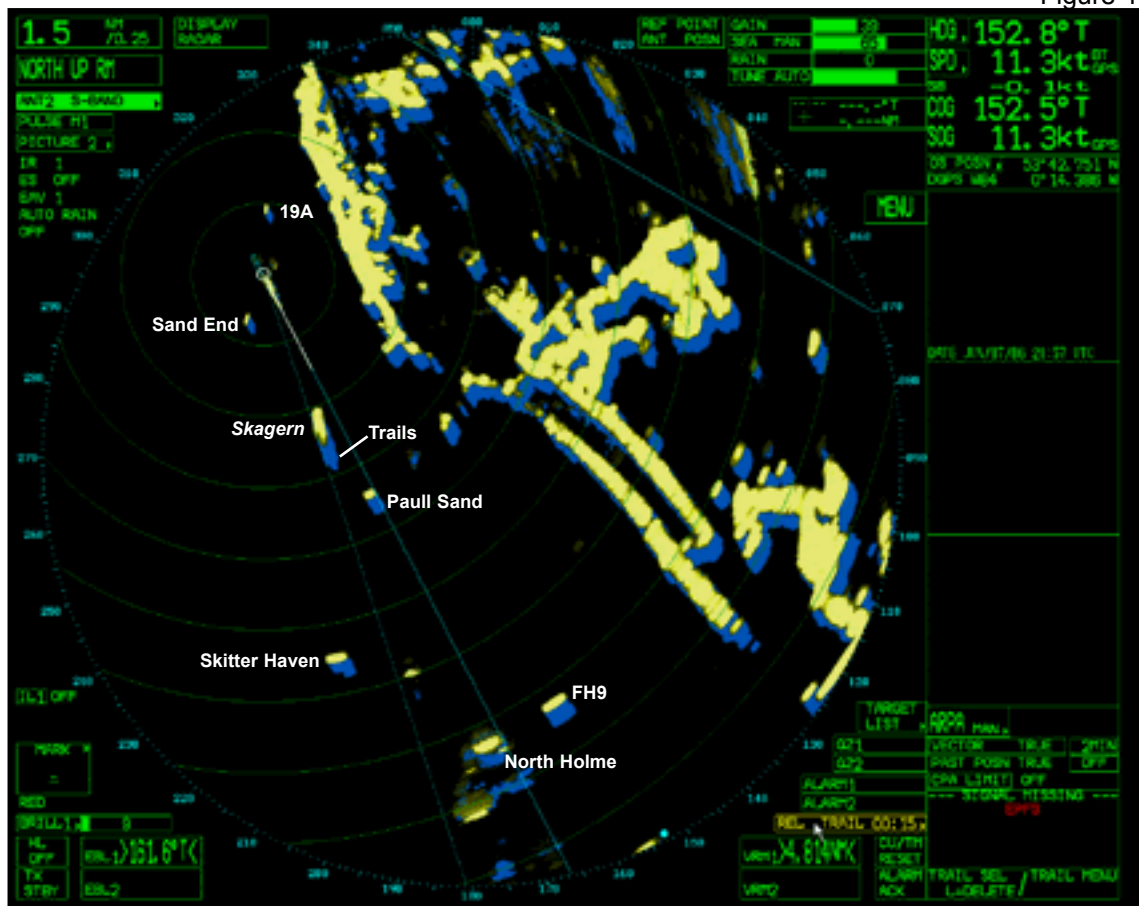
Figure 17

- The first radio contact between the pilots took place at 21:57:34, 60 seconds before collision (**Figure 17**). *Skagern*'s pilot requested *Samskip Courier*'s pilot to change radio channels and requested a reduction in his own ship's speed. *Skagern*'s master went out onto the port bridge wing to try and get a visual sighting of *Samskip Courier*. Closing speed was 22.1kts.

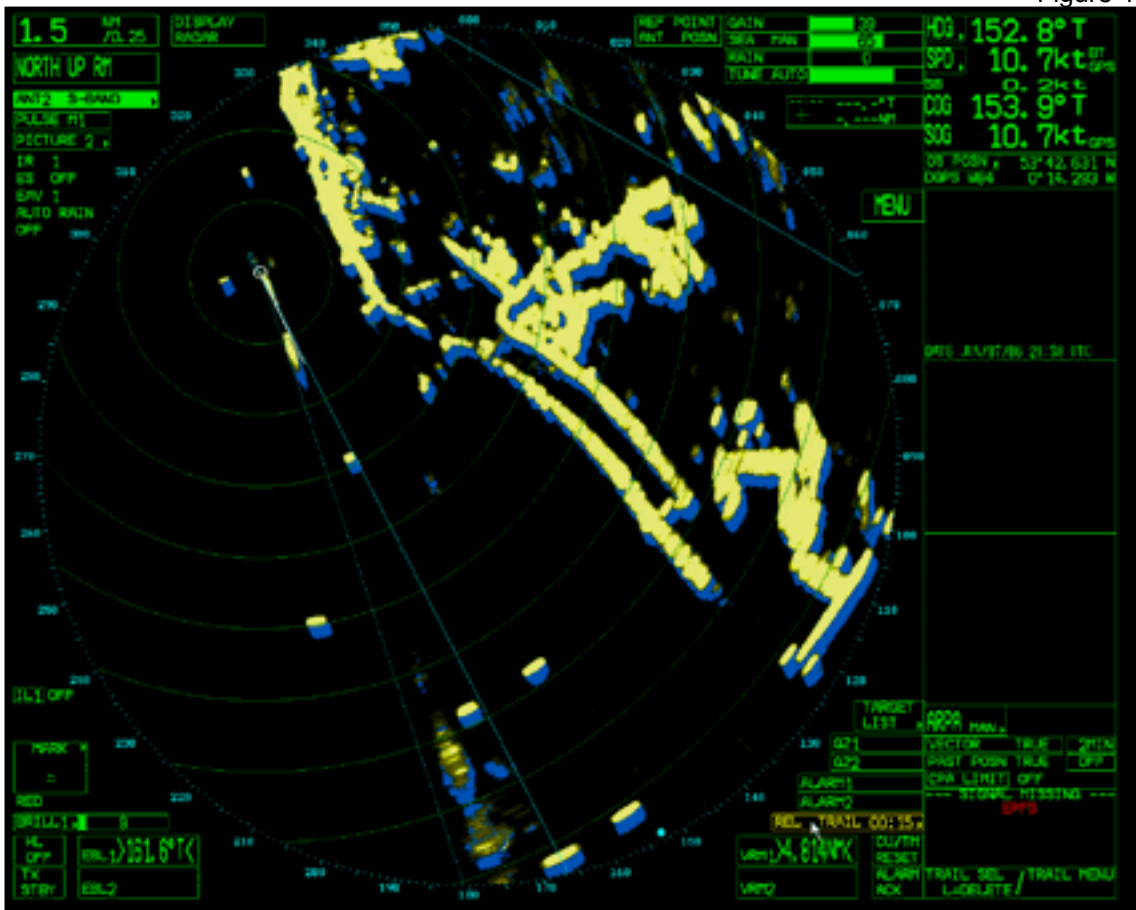
Figure 18

- A period of about 20 seconds was spent by *Samskip Courier*'s pilot trying to select channel 10 on the radio (**Figure 18**). Closing speed 21.0kts.
- At 22:58:31 an evasive manoeuvre of hard starboard and full astern was attempted by *Skagern*'s master; an evasive manoeuvre to hard aport was initiated by *Samskip Courier*'s pilot.

Ships closing as communications are trying to be re-established

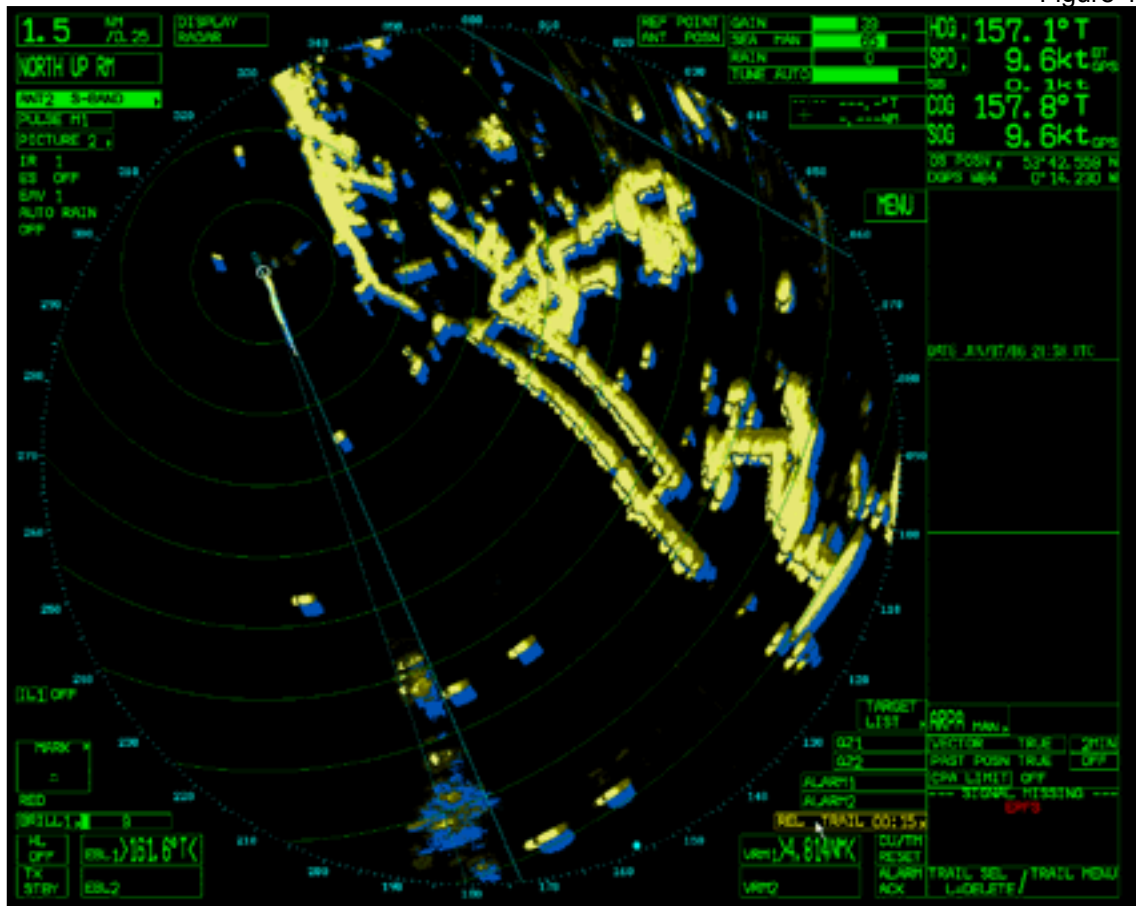
Figure 19

- 22:58:34 collision (**Figure 19**).

Collision
