Report on the investigation
of the failure of a mooring bollard from the
Class V passenger vessel
Star Clipper
resulting in a fatal accident at
St Katharine's Pier, River Thames, London
on
2 May 2004

Marine Accident Investigation Branch
Carlton House
Carlton Place
Southampton
United Kingdom
SO15 2DZ

Report No 3/2005
February 2005

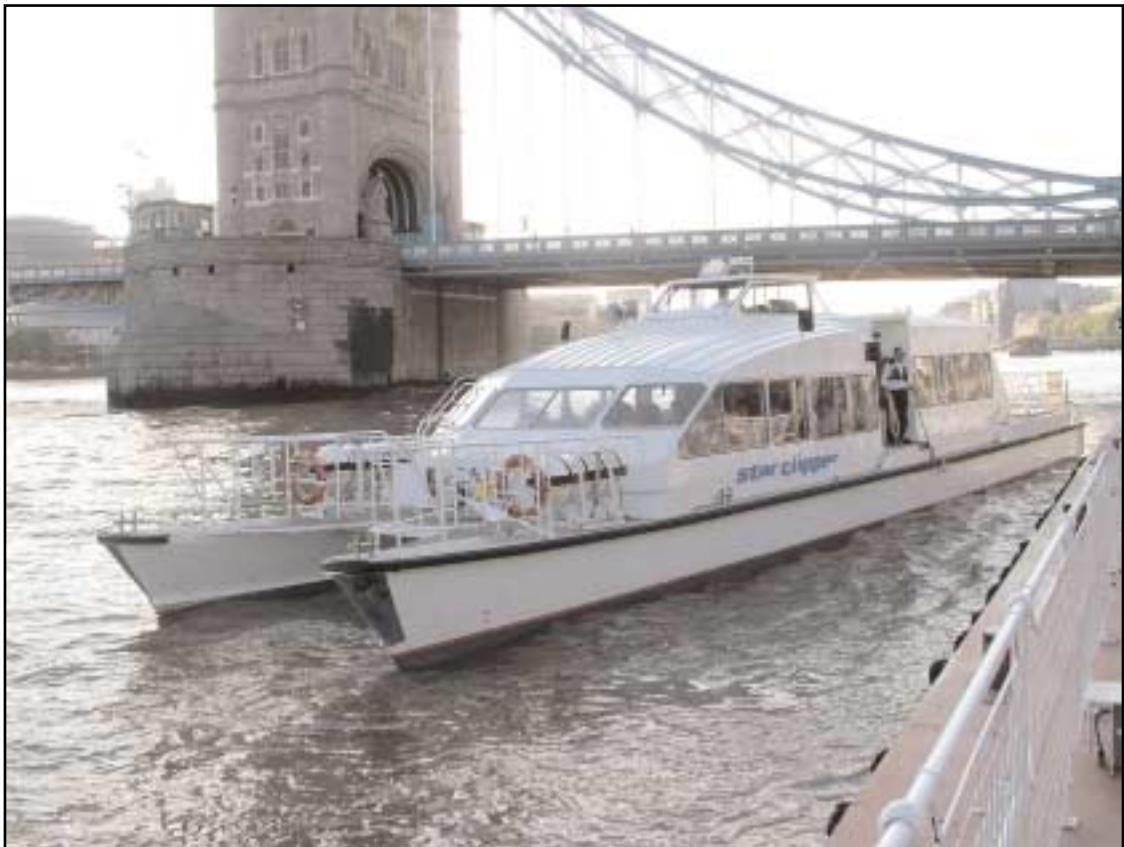
Figure 2

At 1259, having overtaken *Sarpedon*, *Star Clipper* made the final approach to St Katharine's Pier. Her mate was standing in the port passenger access with the mooring rope in his hand (**Figure 2**). The stewardess was inside the passenger cabin. Both port and starboard cabin doors, which gave access to the passenger embarkation platforms, were closed.

Port passenger access - mate's position for coming alongside

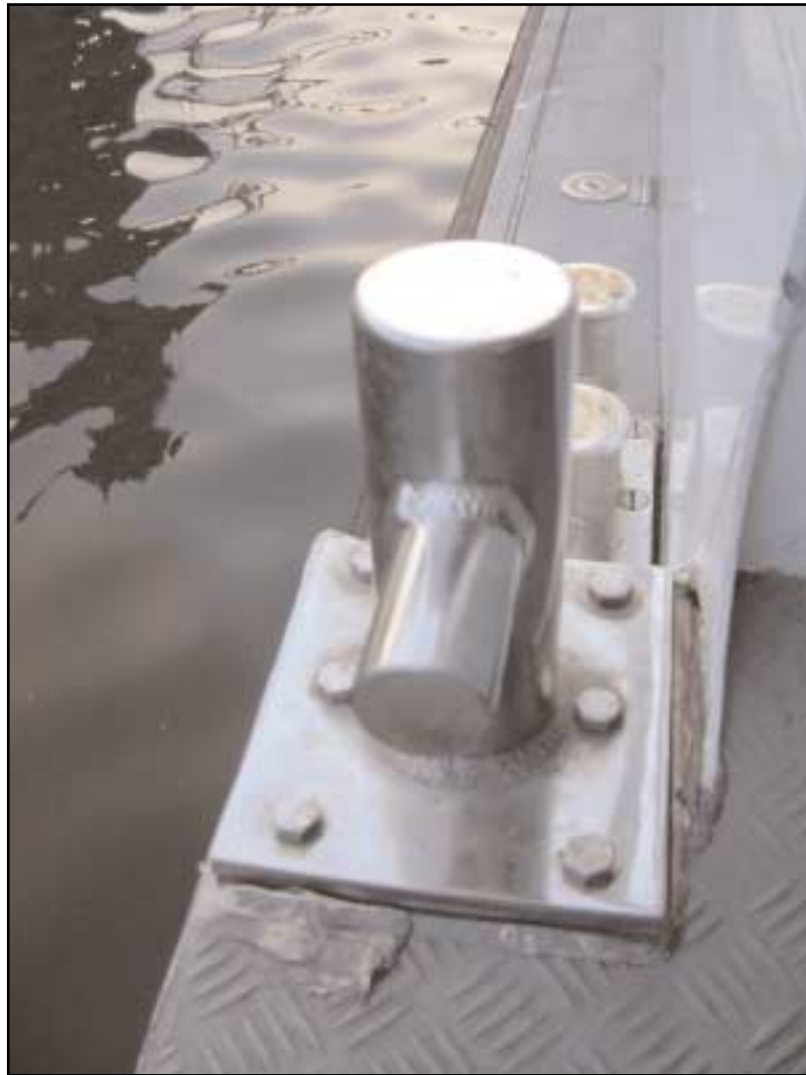
Figure 3

Passenger access - stainless steel MkIII bollard

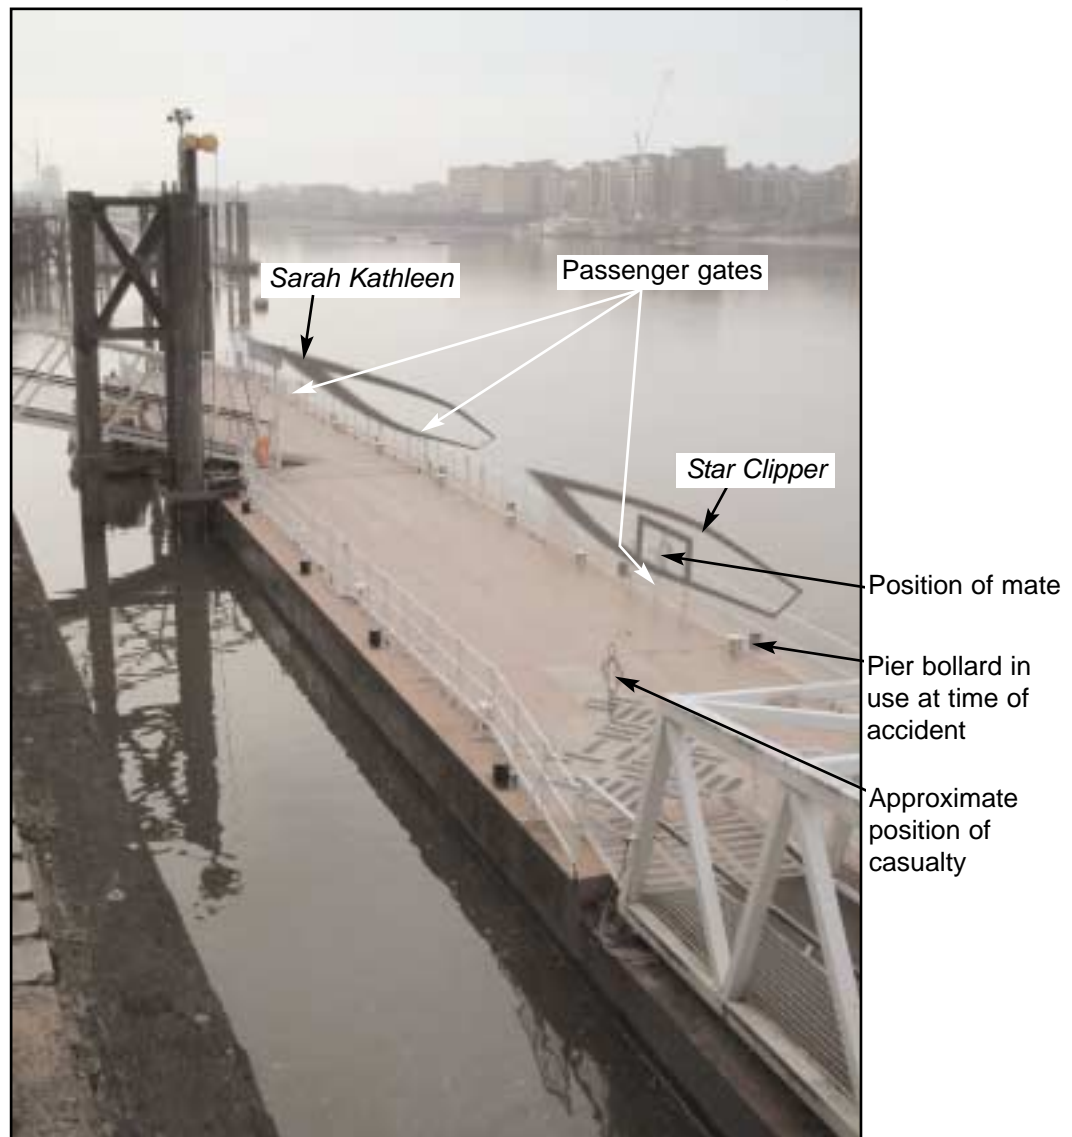
Figure 4

When the rope was over the pier bollard, *Star Clipper's* captain, mindful that *Sarpedon* wanted to come alongside the pier, told the mate that they should go to the next pier passenger gate to give *Sarpedon* enough space to berth. However, the mate reported on the talk-back voice communications unit, that he already had a rope on the pier bollard. The captain confirmed this using his bridge wing mirrors, which provided a clear line of sight to the passenger access platforms. He therefore decided not to move the vessel further forward as originally planned. Positions of vessels and pier gates are shown in **Figure 4**.

Diagrammatic representation of the relative positions of vessels and casualty at the time of the accident (Not to scale)

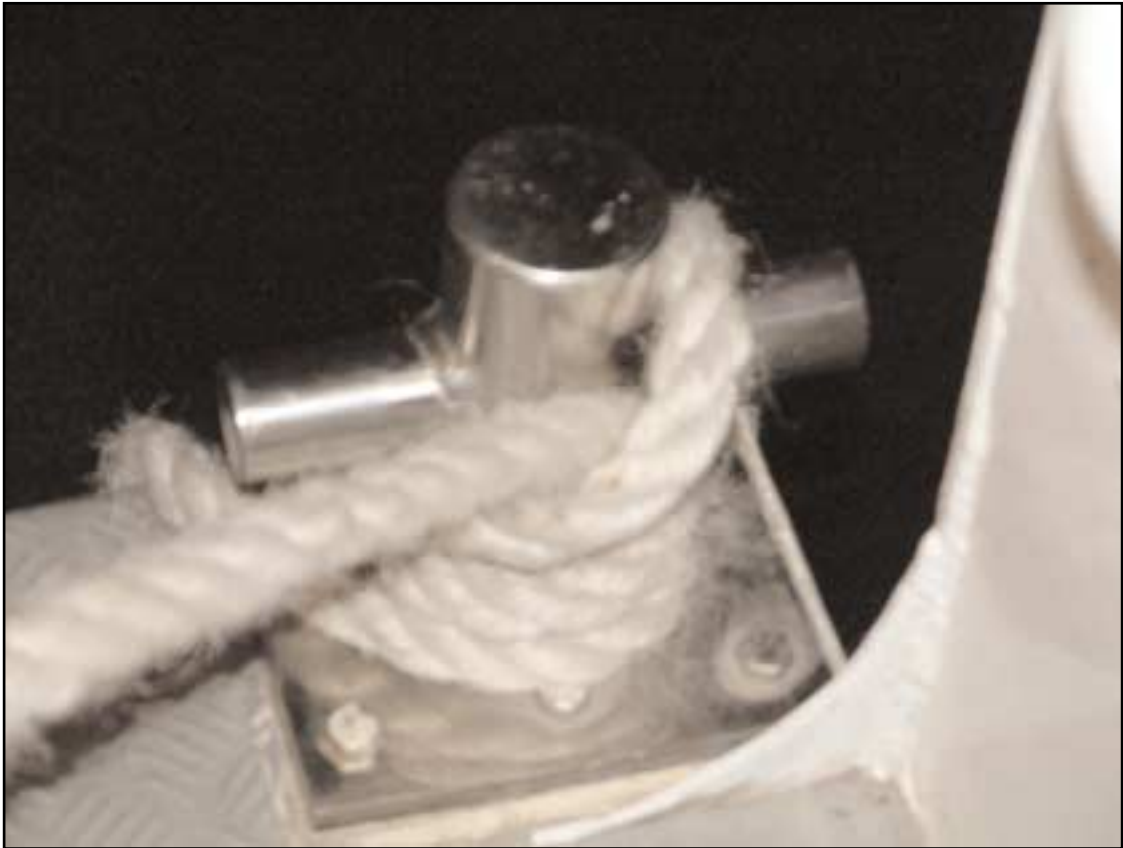
When *Star Clipper* was about 1.5m from the pier, the mate judged that about 2.6m of slack rope was required to allow her to align with the pier passenger gate. He secured the rope onto the vessel's bollard with a "pin hitch" (**Figure 5**). This action is known as the "fetch up".

Mooring rope 'pin hitch' arrangement

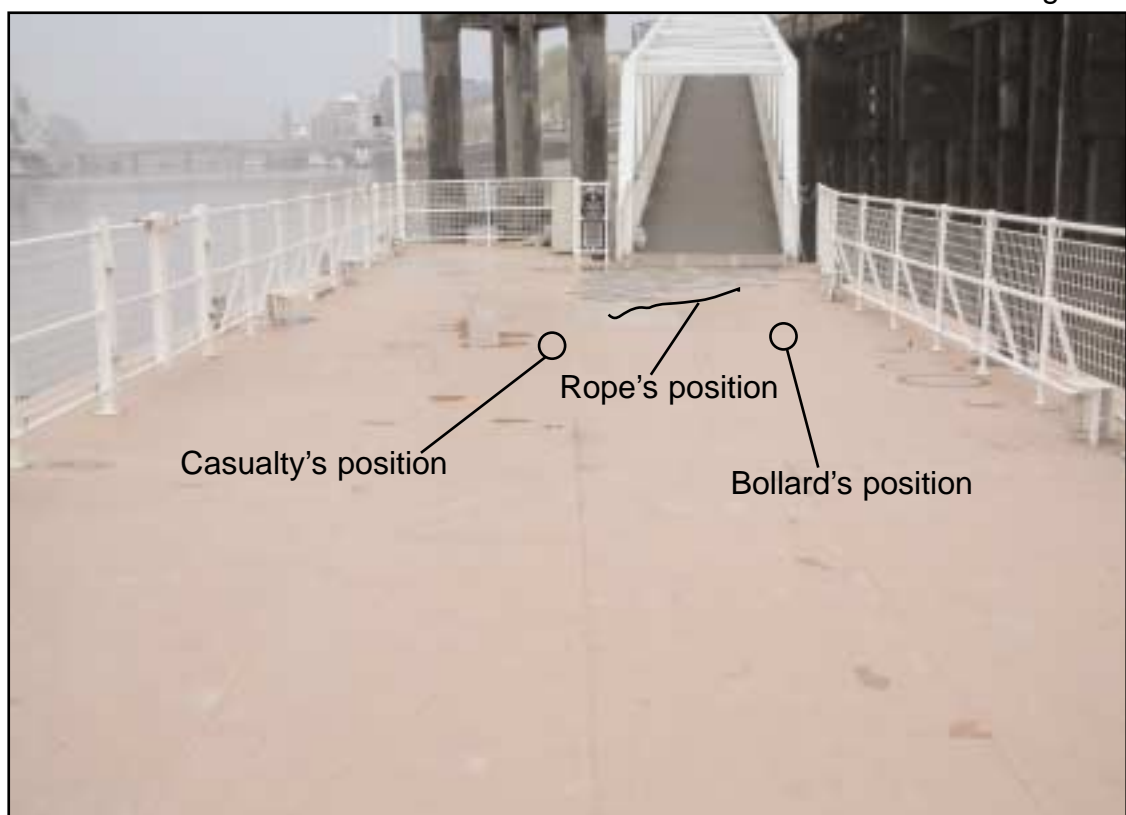
Figure 8

Westbourne’s crew, now aware of the accident, attended to the casualty with two off-duty trauma nurses who were also on the pier. The coxswain noted that *Star Clipper*’s bollard and mooring rope were laying close by the casualty (**Figure 8**).

Approximate position of casualty, bollard, and rope

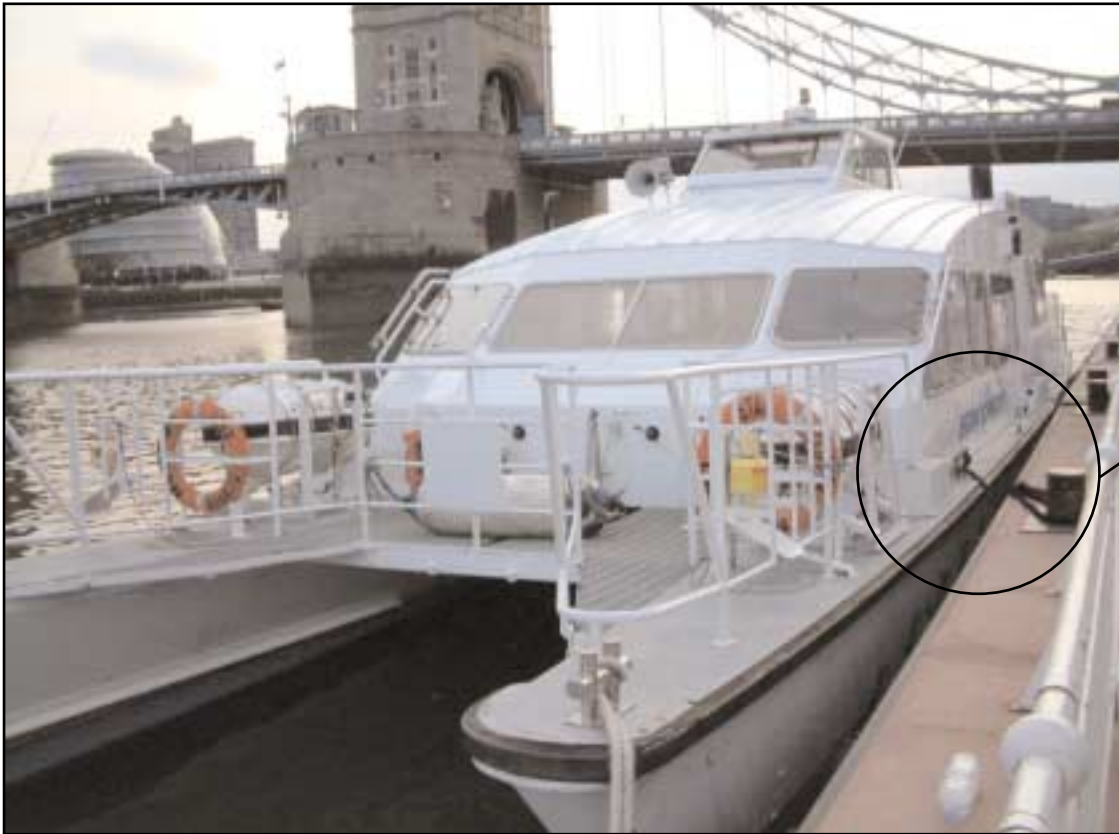
Figure 15

While under Serco Denholm Ltd charter (paragraph 1.7.3), the crews found access from the passenger platform of the three *Clipper* vessels to the forward bollards extremely difficult, particularly during inclement weather (**Figure 15**). To overcome this, four **Mk I** bollards were fitted in the passenger access areas (**Figure 16**). No changes were made to the 3mm aluminium supporting structure. During this time, the bollards were only used during passenger movements. The original fit bollards continued to be used for overnight mooring.

Showing the difficult access to forward bollards

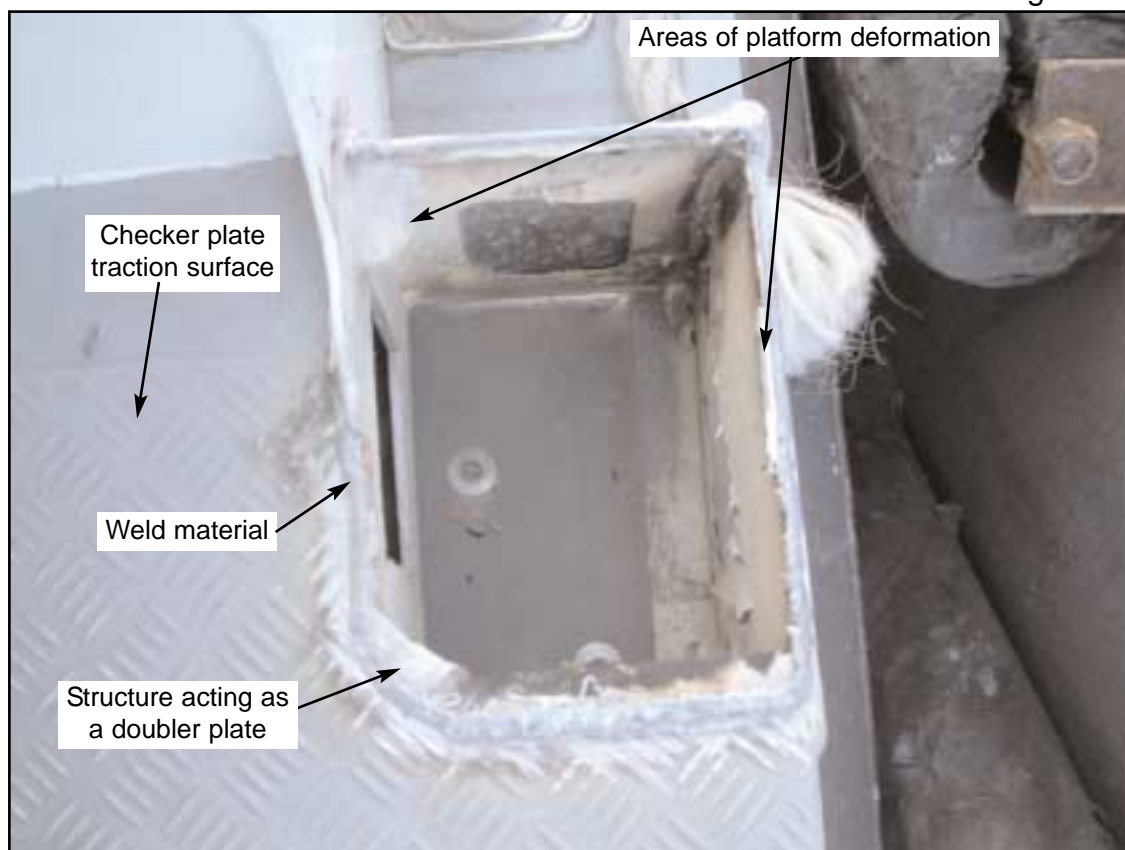
Both port and starboard passenger access platforms are manufactured from 3mm aluminium plate, type 5083, to BS 1470,1987 grade. The passenger platform arrangement is at **(Figure 20)**.

The platforms are constructed in a traditional "box" configuration made up of transverse and longitudinal flat aluminium plates. The construction is finished with a 3mm aluminium checker top plate, providing a traction surface for passengers and crew. The platforms were not designed or constructed to support mooring bollards, and were not designed to withstand the stresses imposed by routine use of the bollards.

Passenger access platform - structural arrangement

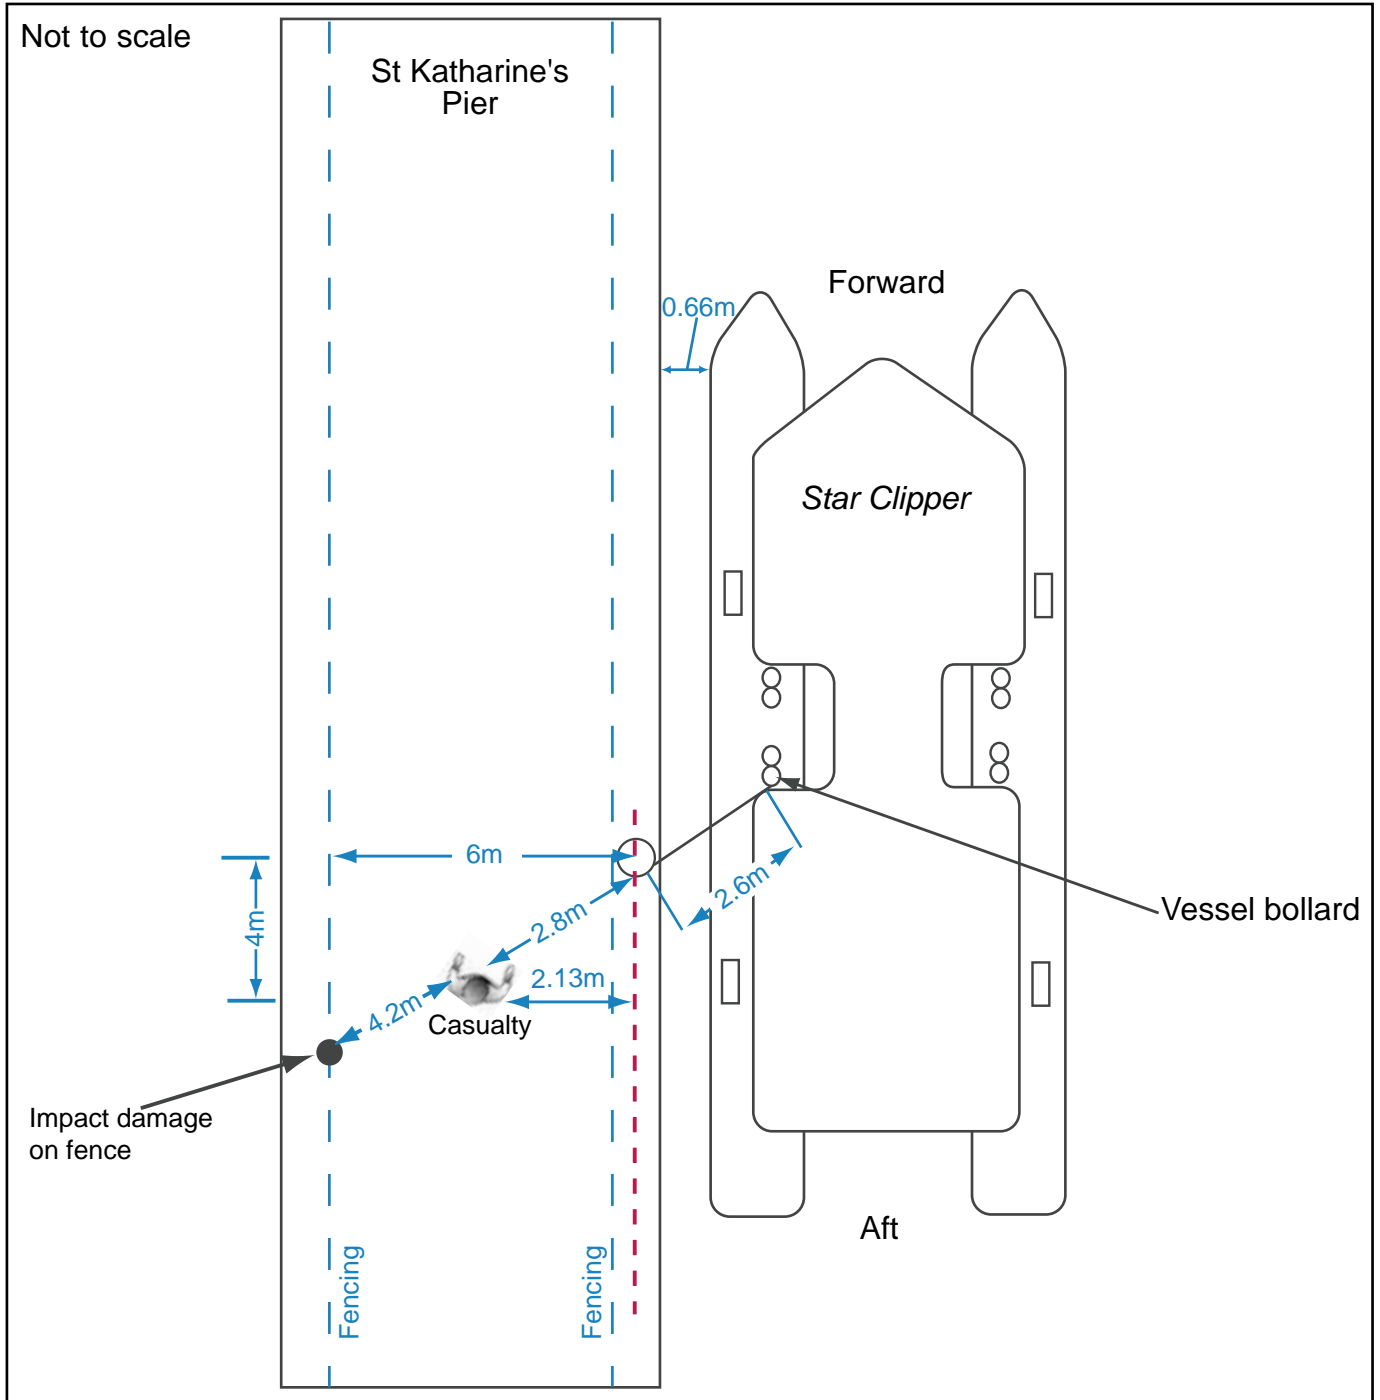
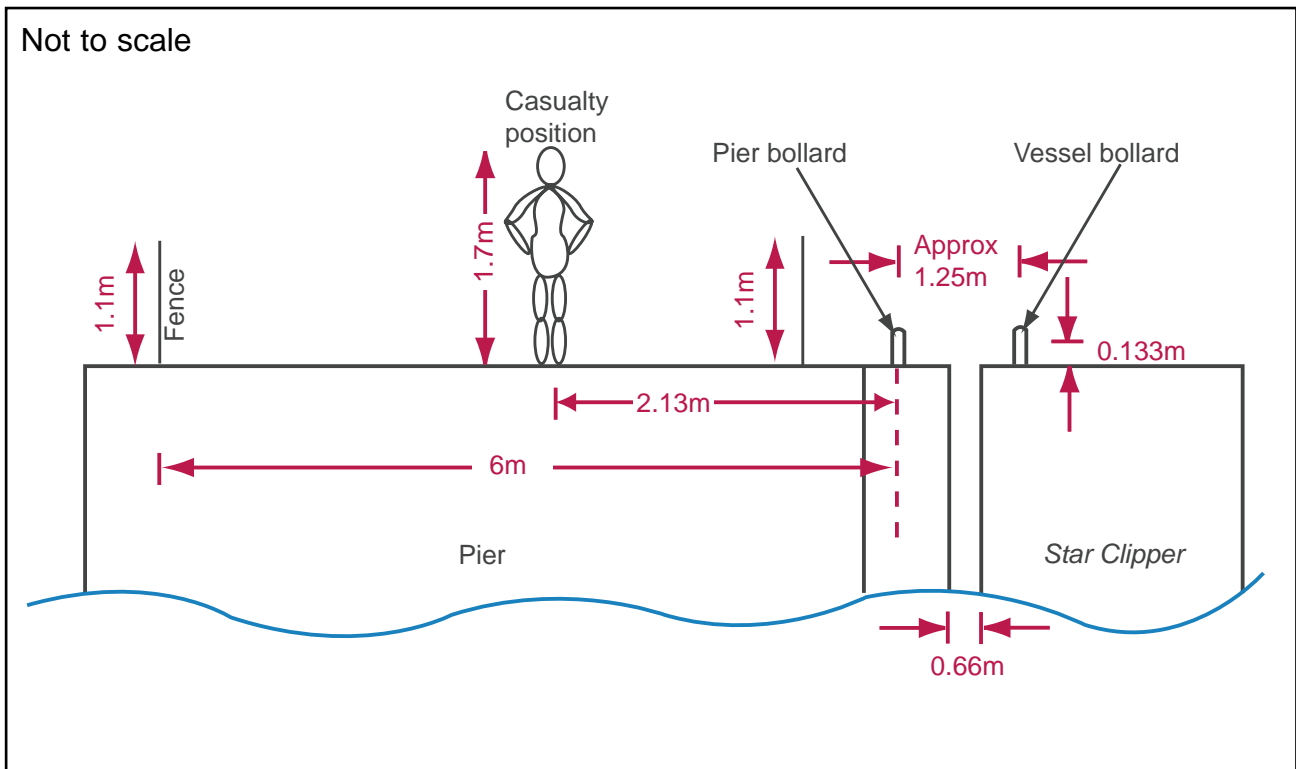
Figure 21

As a result of the re-enactment, it was possible to accurately ascertain the position of the casualty relative to the pier and vessel's bollards (**Figures 21 and 22**).

Casualty's position immediately prior to accident
