Marine
Accident
Report

the fire onboard

Star Princess

**Report No 28/2006
October 2006**

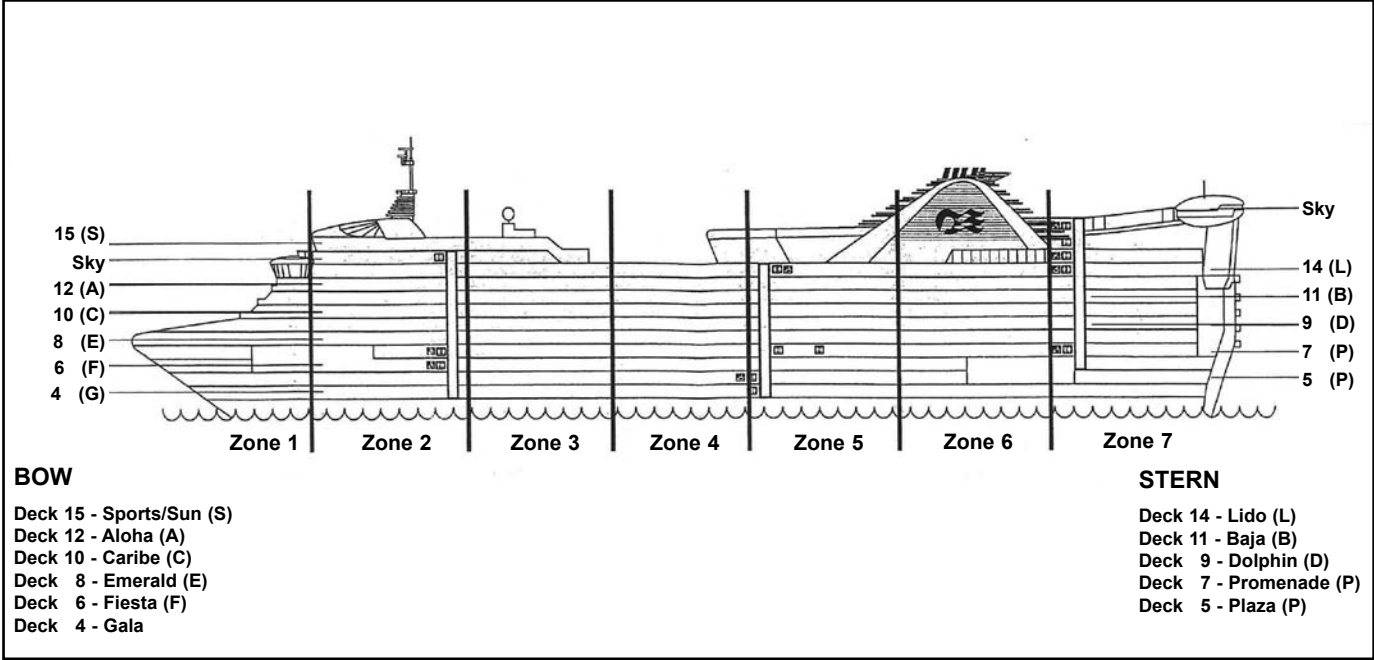
Figure 1

¹ Each deck on board *Star Princess* was given a name as well as a number, and all staterooms were prefixed by the first letter of the name of the deck on which they were located. The names of each deck are shown at **Figure 1**. The first digit of each stateroom number corresponds with the numerical zone within the ship in which the stateroom is located. Staterooms with even numbers were located on the port side of the ship.

Drawing showing deck and zone layout

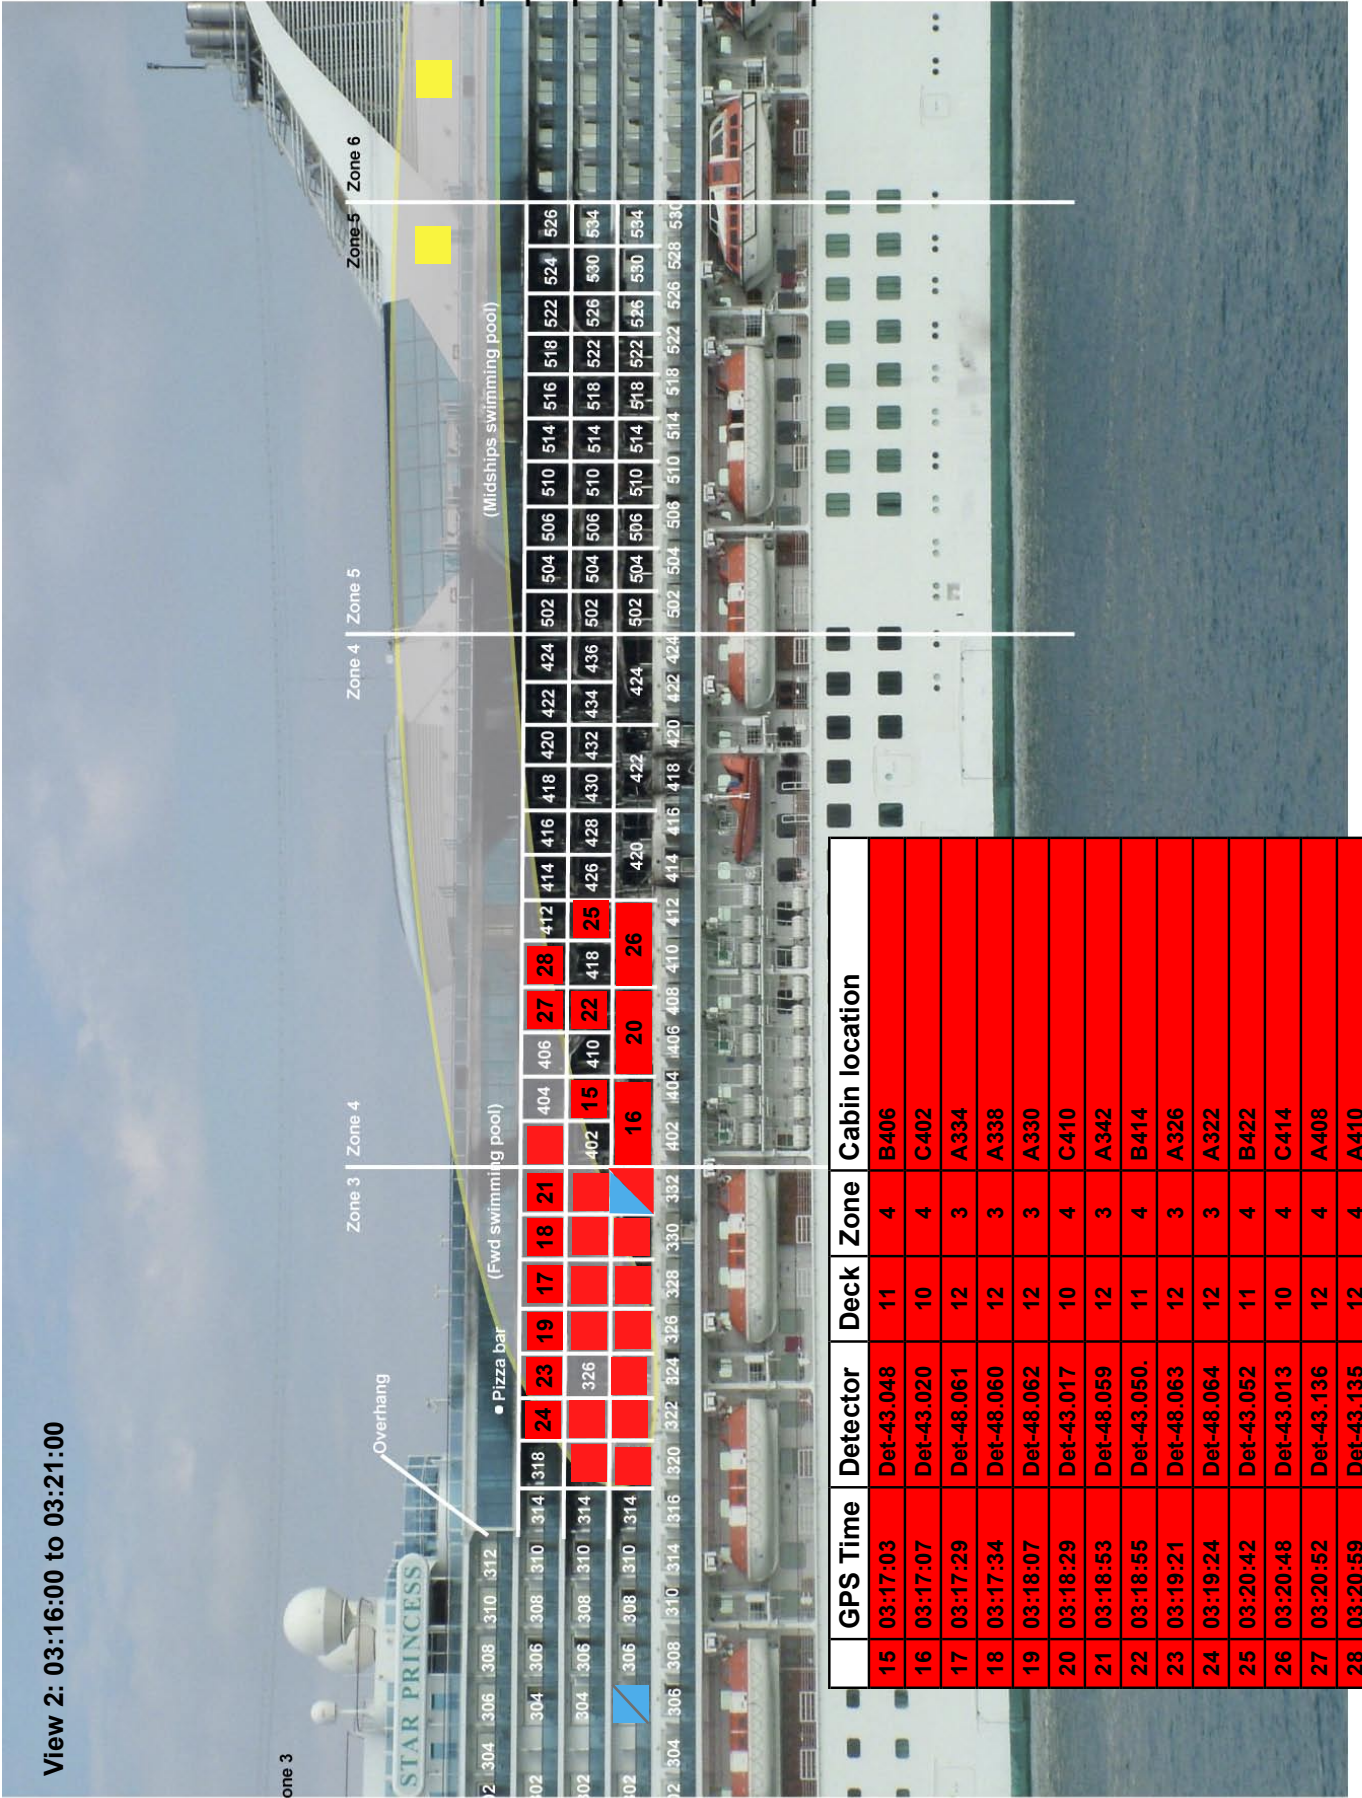
Table 1 - Chronology of significant events

View 2: 03:16:00 to 03:21:00

GPS Time	Detector	Deck	Zone	Cabin location
15 03:17:03	Det-43.048	11	4	B406
16 03:17:07	Det-43.020	10	4	C402
17 03:17:29	Det-48.061	12	3	A334
18 03:17:34	Det-48.060	12	3	A338
19 03:18:07	Det-48.062	12	3	A330
20 03:18:29	Det-43.017	10	4	C410
21 03:18:53	Det-48.059	12	3	A342
22 03:18:55	Det-43.050.	11	4	B414
23 03:19:21	Det-48.063	12	3	A326
24 03:19:24	Det-48.064	12	3	A322
25 03:20:42	Det-43.052	11	4	B422
26 03:20:48	Det-43.013	10	4	C414
27 03:20:52	Det-43.136	12	4	A408
28 03:20:59	Det-43.135	12	4	A410

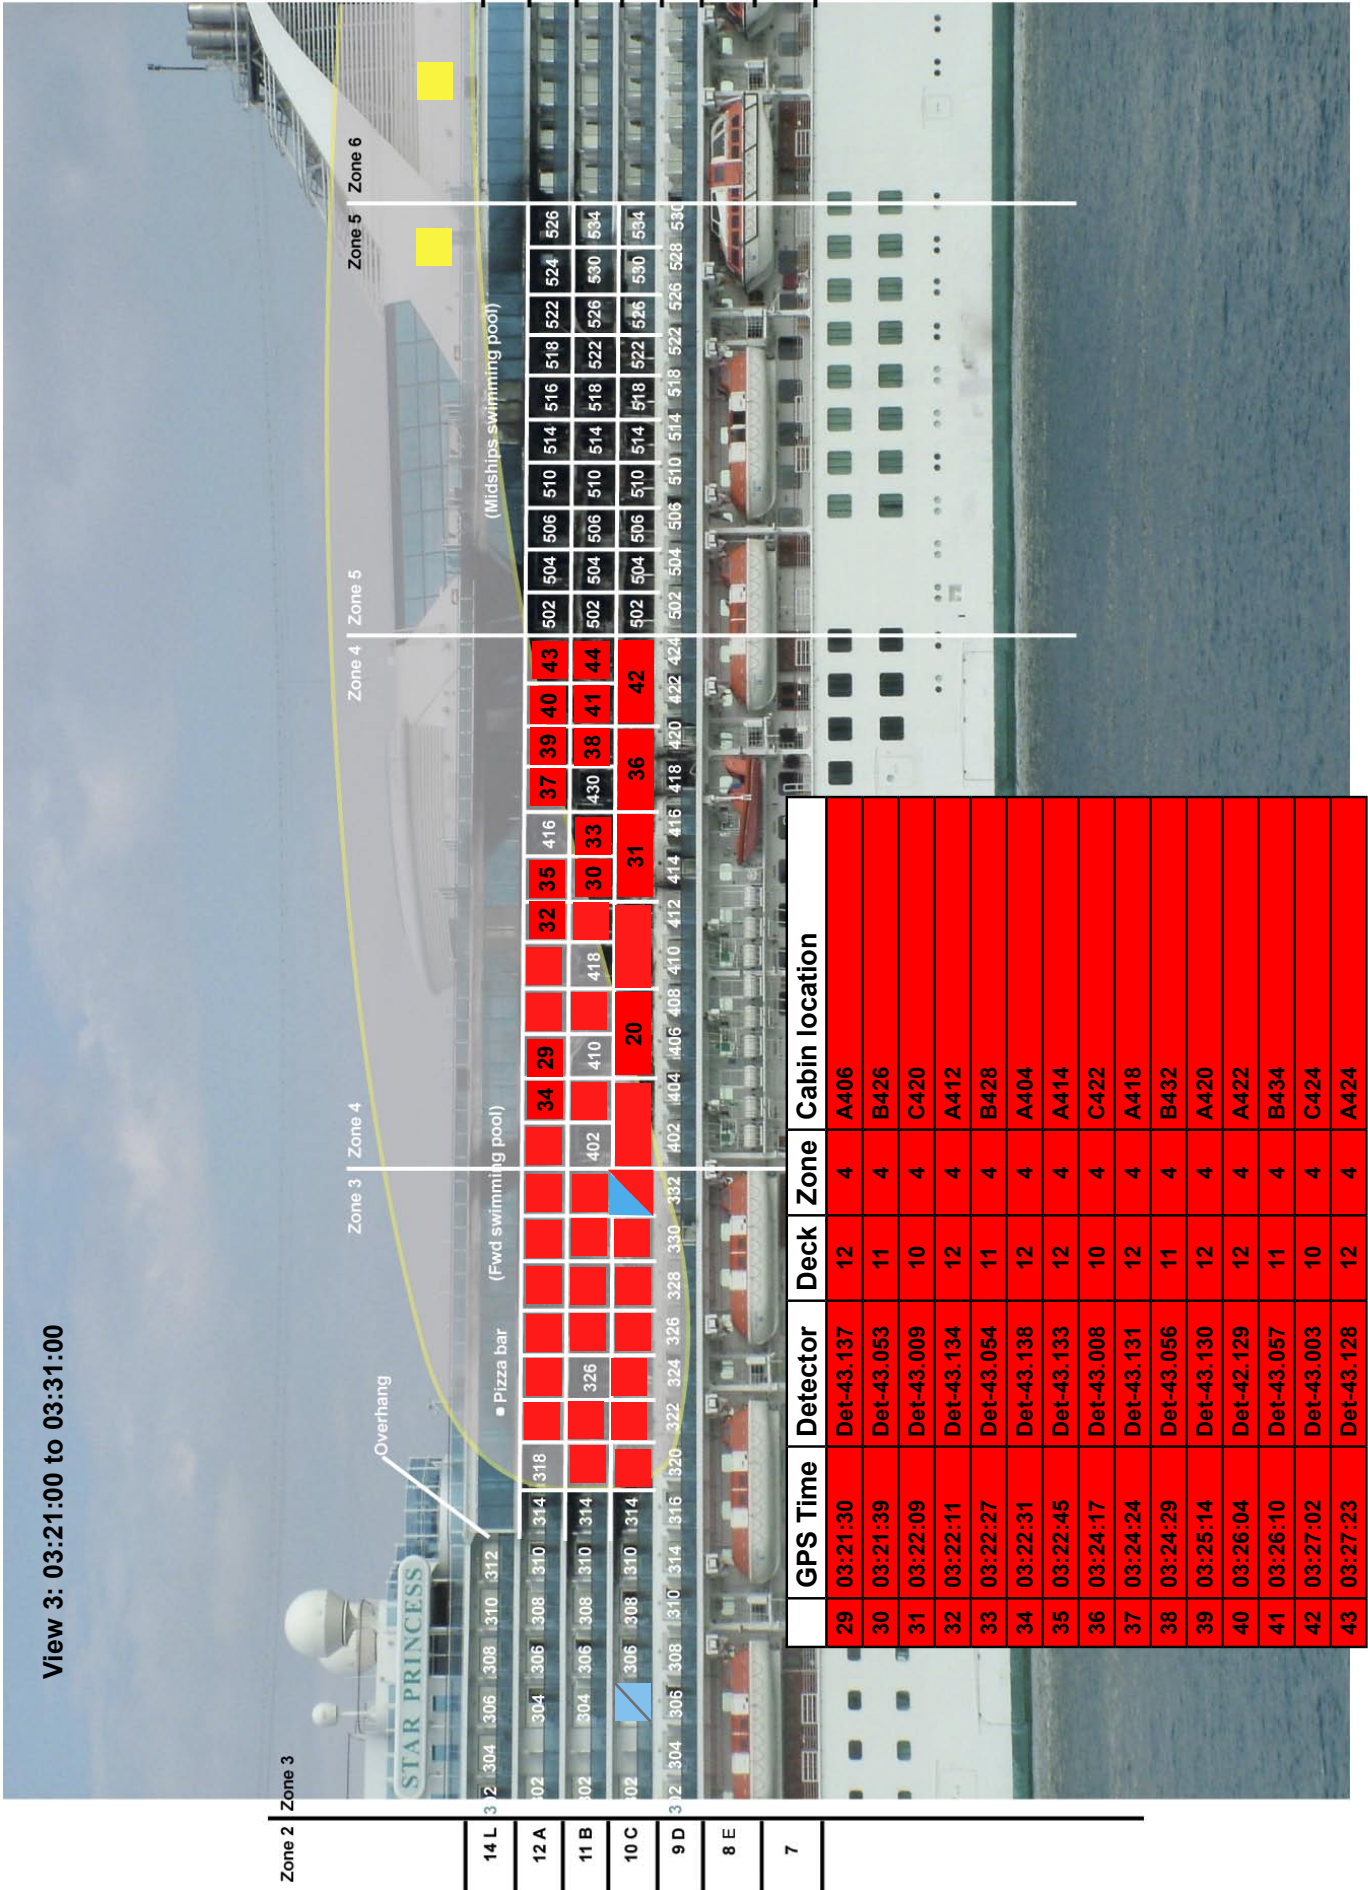
Figure 4

View 3: 03:21:00 to 03:31:00

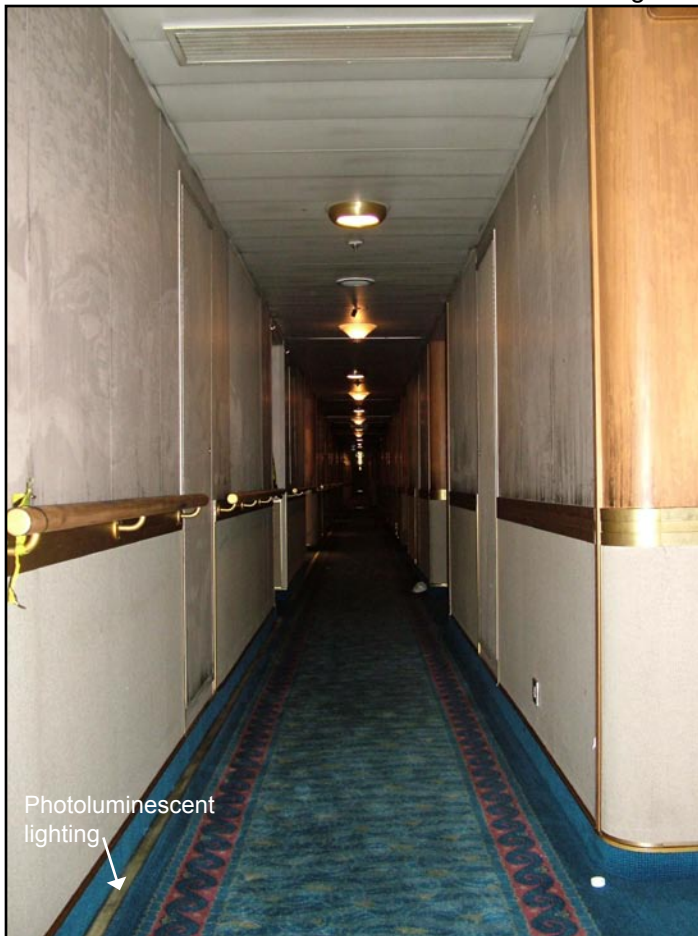
Figure 8

Alleyway in deck 12, zone 3

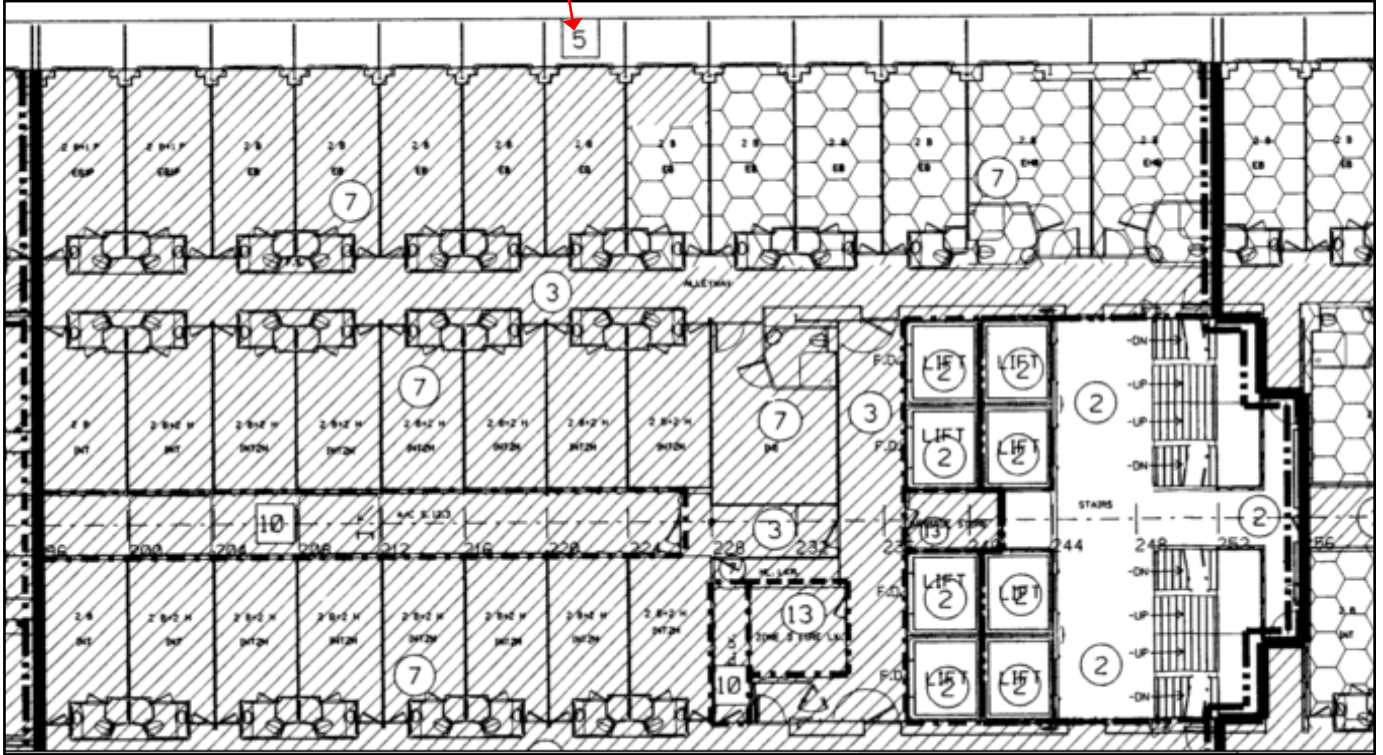
Figure 22

Star Princess has 15 decks and seven main vertical zones⁸ (**Figure 1**). A structural fire plan was provided by Fincantieri, which was approved by Lloyds Register of Shipping and RINA. An extract of the structural fire plan for deck 11 (**Figure 22**) shows that the external balconies were categorised as open deck spaces (category 5) which Paragraph 2.2.3.2 of Regulation 9 of SOLAS defines as:

Extract of fire protection plan for deck 11 on *Artemis* (ex *Royal Princess*)

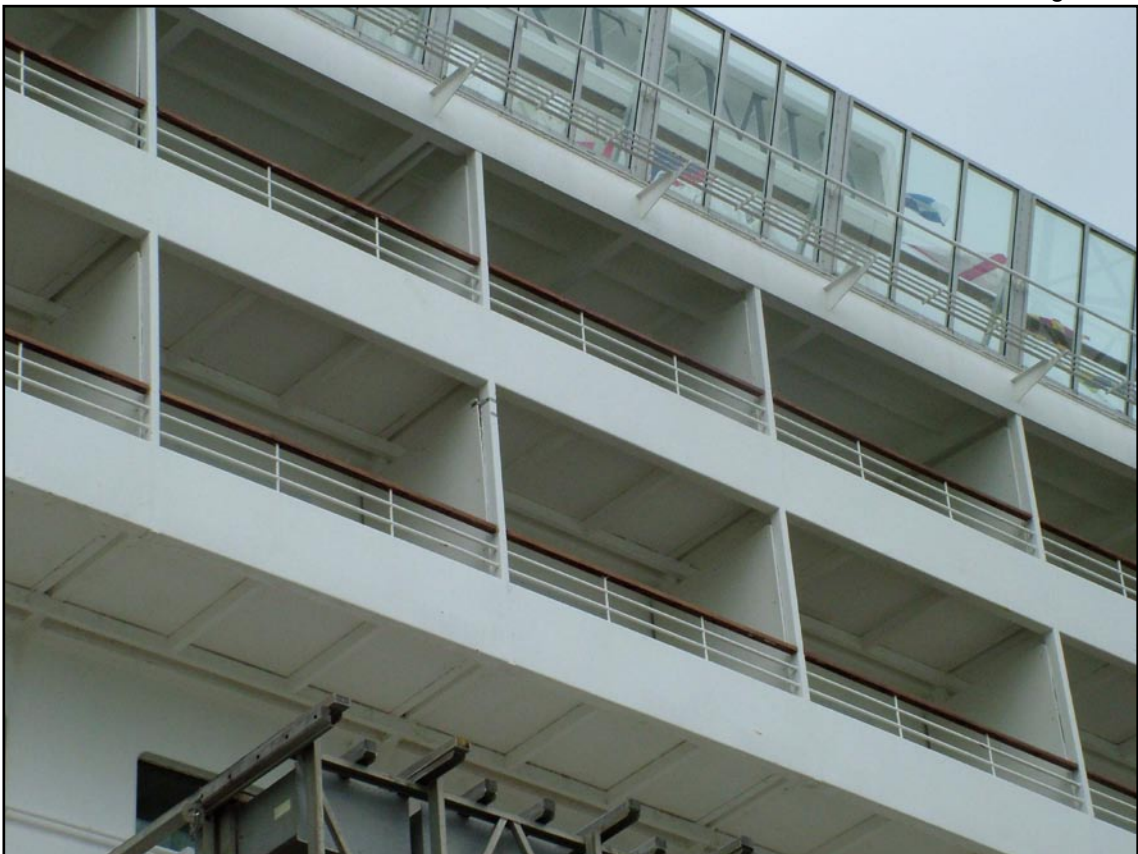
Figure 23

The first ship the MAIB is aware of to have been constructed with external balconies is *Royal Princess* (since renamed *Artemis*), which entered service in 1984 (**Figure 23**). The ship was built in Helsinki, Finland, and was UK registered. Review of the vessel's structural fire protection plan, which was approved by the MCA, indicates that the balconies were treated as open deck spaces, although this was not specifically annotated. The exemptions for doors and glass partitions and windows in 'A' class boundaries were noted on the plan. The balcony partitions on *Royal Princess* were made of GRP on a substantial steel frame, and the decks and furniture were both made of hardwood.

Balconies on board *Artemis* (ex *Royal Princess*)

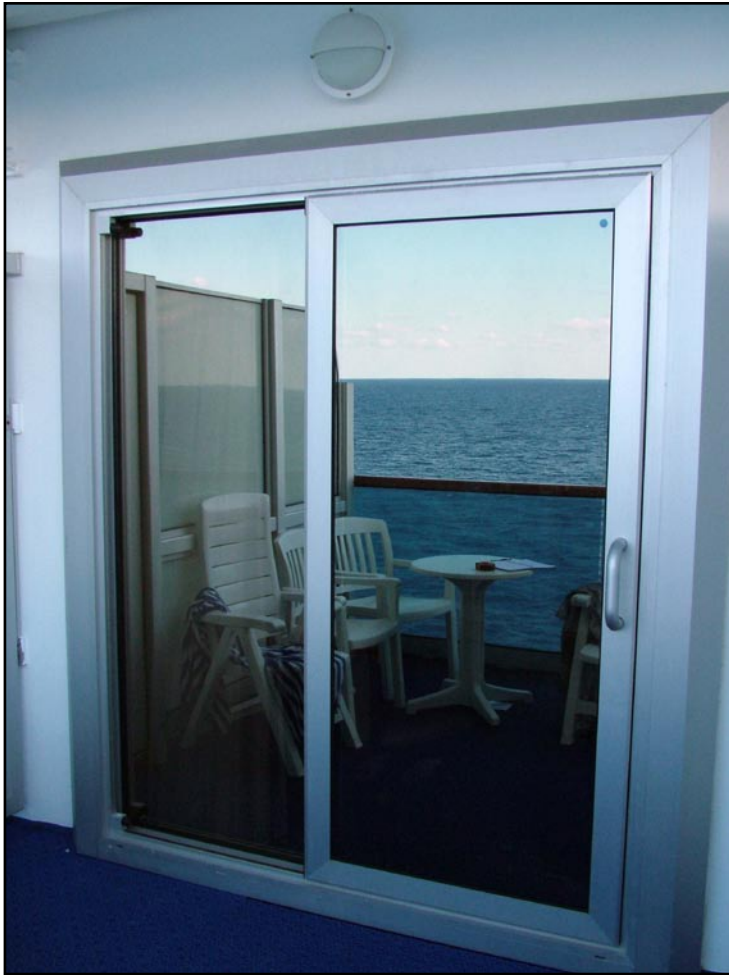
Figure 25

Access to the balconies from the staterooms was via sliding glass doors of similar appearance to those used in many domestic homes (**Figure 25**). The glass used in the balcony doors was double glazed and mounted in an aluminium frame with an overall dimension of 1870mm x 716mm, and a thickness of 25mm. The glass used was 5mm toughened 'float clear' glass, which had been impact tested in accordance with BSI 6202, but was not fire rated.

Balcony doors

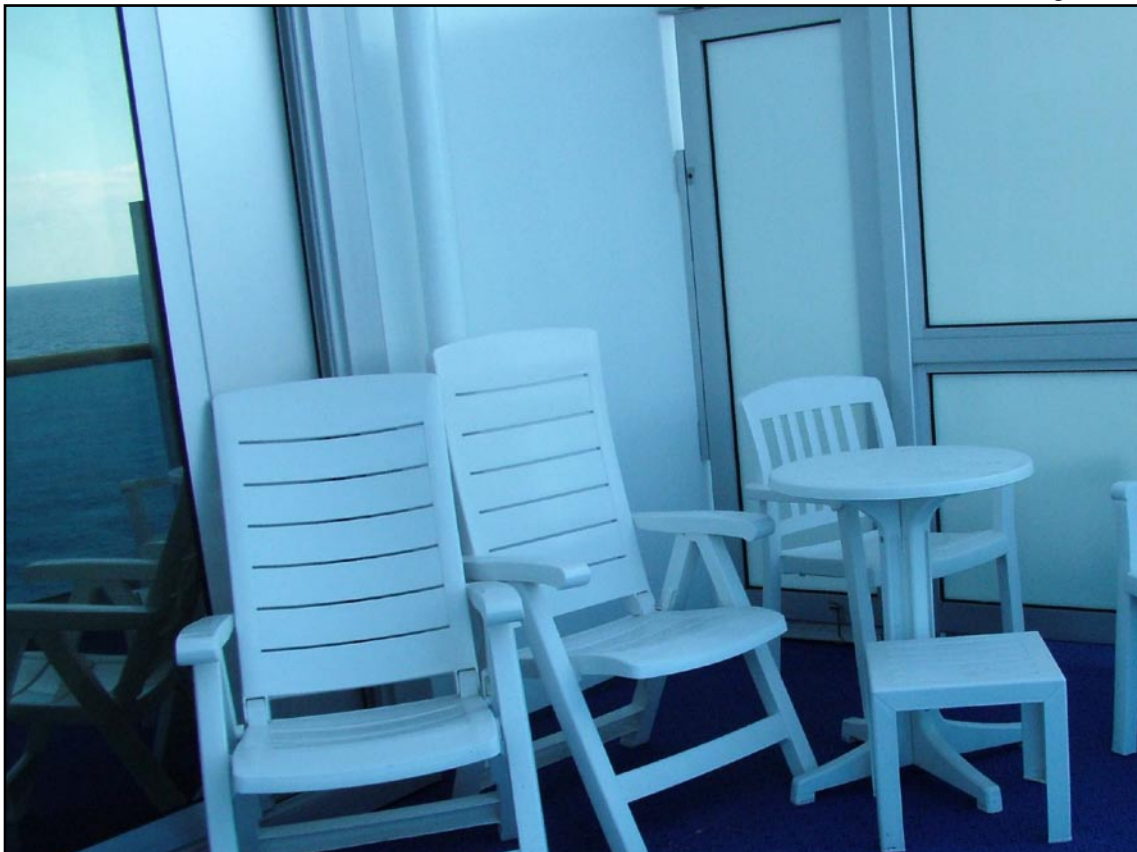
Figure 26

Balconies were separated by vertical partitions (**Figure 26**), which had small gaps at the deck and deckhead. The partitions provided privacy and shelter, and were fitted with a door, which could be locked by a universal square-ended 'T' bar shaped key. The partitions were constructed from 8mm polycarbonate sheet, secured in an aluminium framework. This was one of several types of material used by Fincantieri for balcony partitions, and *Star Princess* was one of 19 ships on which it had used the material. The materials the shipbuilder used on the balconies of other vessels included: acrylic, acrylic –polycarbonate mixtures, and aluminium composite. Materials known to be used for balcony partitions by other ship builders includes glass, steel, high pressure laminated boards, galvanised sheet, and plywood.

The decks of the balconies on board *Star Princess* were covered with a polypropylene tile (**Figure 26**). On decks 9 and 10, the tile was laid on top of a flexible screed coated with polyurethane self-levelling paint, but on decks 11 and 12 it was laid on top of a painted metal deck. Polypropylene tiles were laid on top of the deck coatings to provide a non slip finish and allow surface water to drain. This was one of three types of deck covering used by Fincantieri for this purpose, the others were teak, and a teak effect resin. A balustrade was fitted at the outboard edge, consisting of glass panels topped with a hardwood rail.

Balcony partitions, furniture and deck tiles

Lightweight plastic chairs, table and footstools (**Figure 26**) of the type commonly available for outdoor recreational use were provided for each balcony. The first heat detectors to activate were in staterooms C316 and C318, and items on the balcony of stateroom C316 at the time included two large cotton towels provided by the ship and draped over the plastic chairs, a bathing suit, and a pair of water shoes, all of which had been on the balcony for several hours. The passengers in C318 were smokers, and the last occasion a cigarette was smoked on the balcony was shortly after midnight. The cigarette end was then extinguished in an ashtray. The passengers in C316 were non-smokers, and were travelling companions of the passenger in C318. The door in the partition between the stateroom balconies was unlocked, but it is not certain whether it was open or closed.

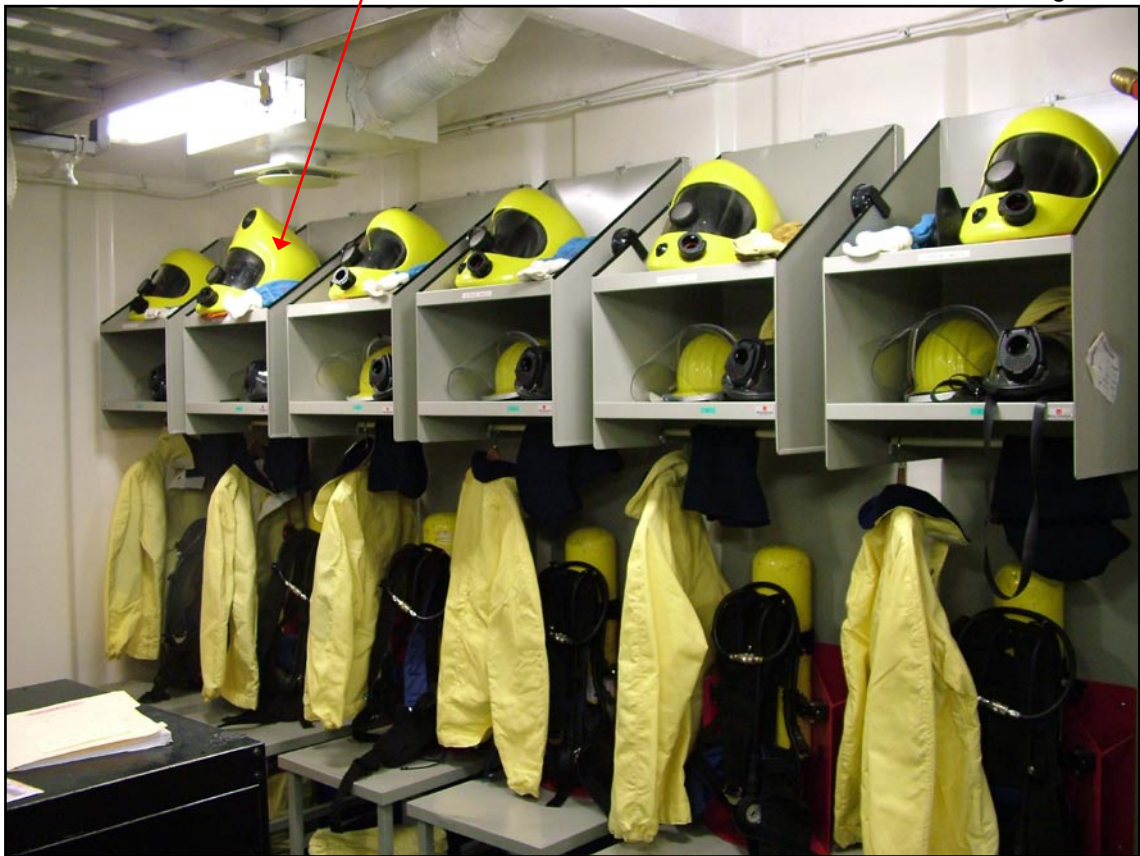
The muster points for the deck and engine fire parties were at their respective fire lockers situated on deck 4. Each party had six crew nominated to dress in fire-fighting suits, gloves, helmets, and boots, and to carry breathing apparatus (**Figure 27**). The helmets were fitted with VHF radios, and one helmet in each team was fitted with a thermal-imaging camera (TIC). A hand-held thermal imaging device, primarily for the

Firefighters' suits and BA
