Report on the investigation of  
the catastrophic failure of a windlass hydraulic motor  
on board  
***Stellar Voyager***  
off Tees Bay  
resulting in a major injury on  
23 March 2009

**Report No 25/2009**  
**December 2009**

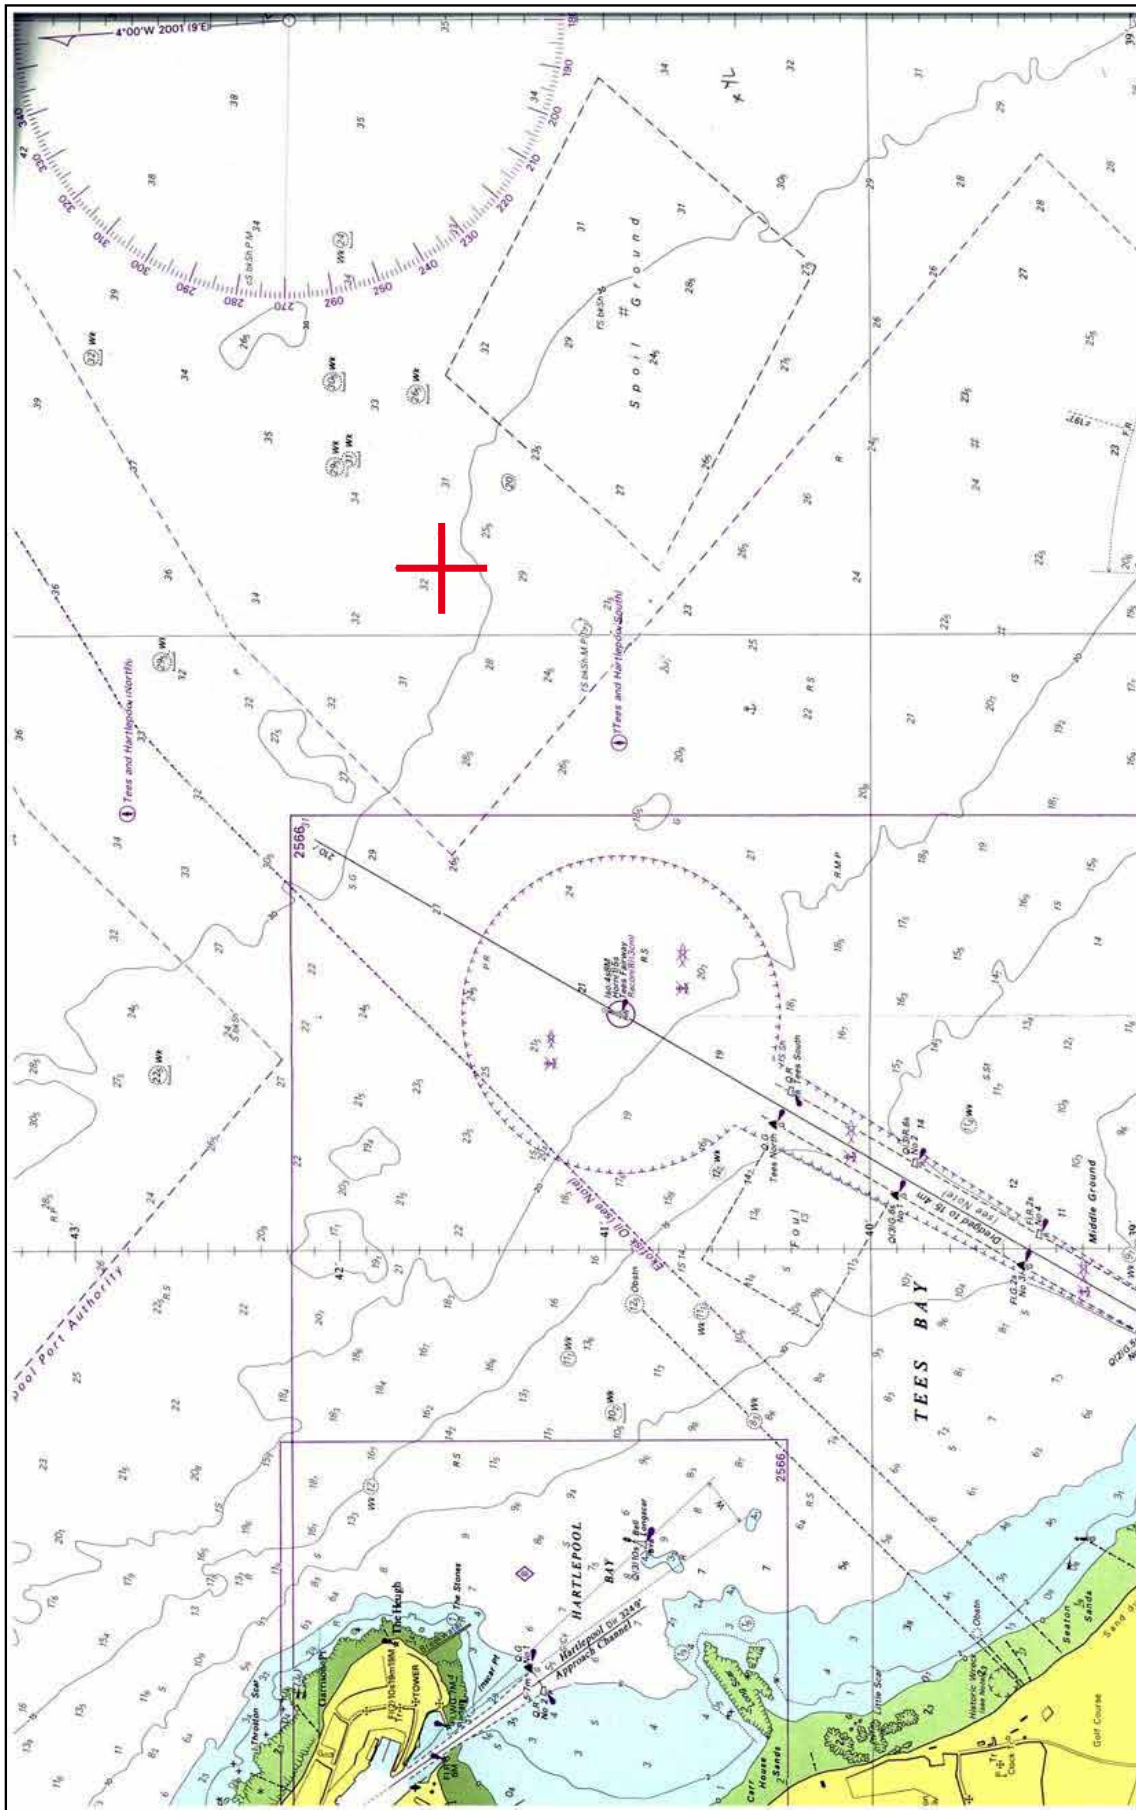
Figure 2

At 1742 on 22 March 2009, *Stellar Voyager* anchored off Tees Bay, England (**Figure 1**). The starboard anchor was used with 8 shackles<sup>1</sup> of anchor chain in the water. When the anchor chain stopper was engaged, a 10cm gap was left between the stopper and a chain link to enable any slippage in the drum band brake to be quickly identified (**Figure 2**). The depth of water was about 38m. The vessel, which was in ballast with a 2m stern trim, was expected to berth in Tees Port on about 27 March 2009.

Location of accident

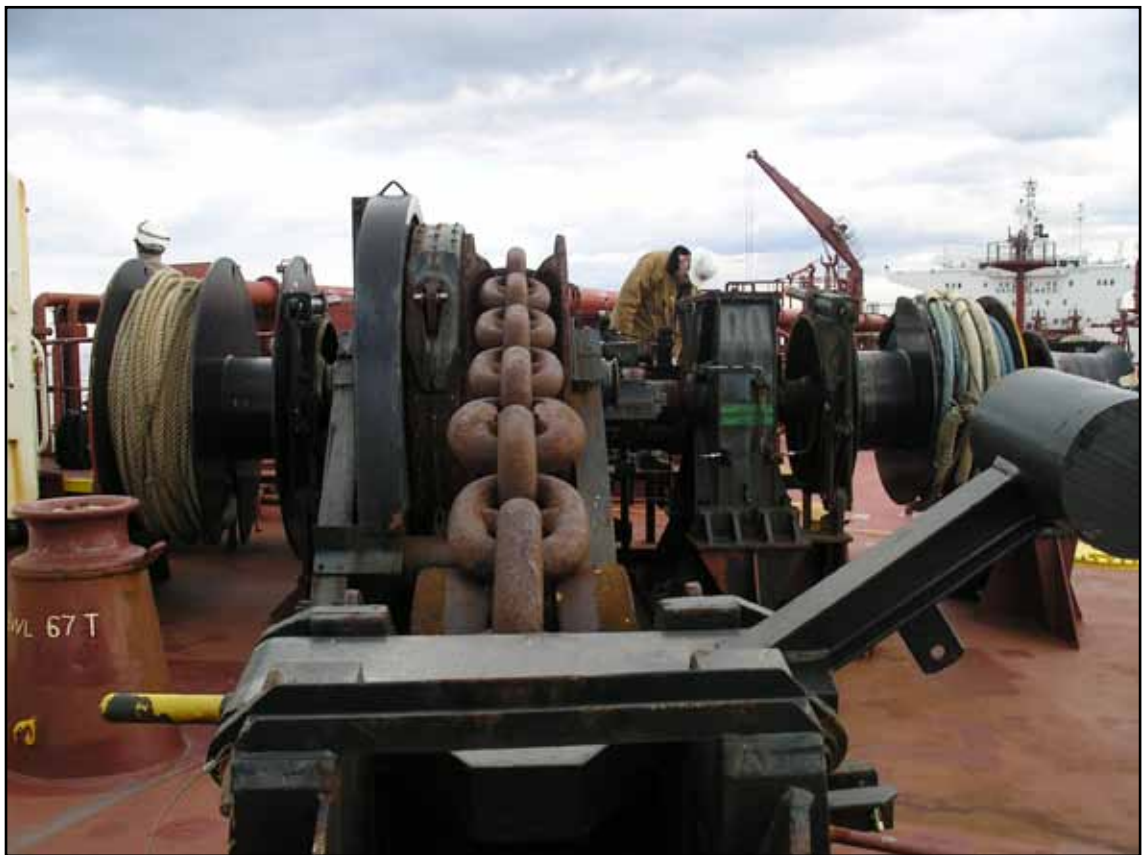
Starboard winch-windlass

The anchor windlass system was supplied by Friedrich Kocks GmbH, Germany. It was electro hydraulically powered and fitted with two independent split drum winches on either side (**Figure 5**). The windlass was driven by a hydraulic motor manufactured by Bosch Rexroth AG, via planetary gears which drove a main gear wheel connected to the anchor chain gypsy wheel through a shaft and coupling arrangement. This double reduction gearing provided a speed ratio of 1168:1. Each windlass had a maximum capacity of 540kN and a nominal speed of 9m/min. The brake capacity was 2475kN.

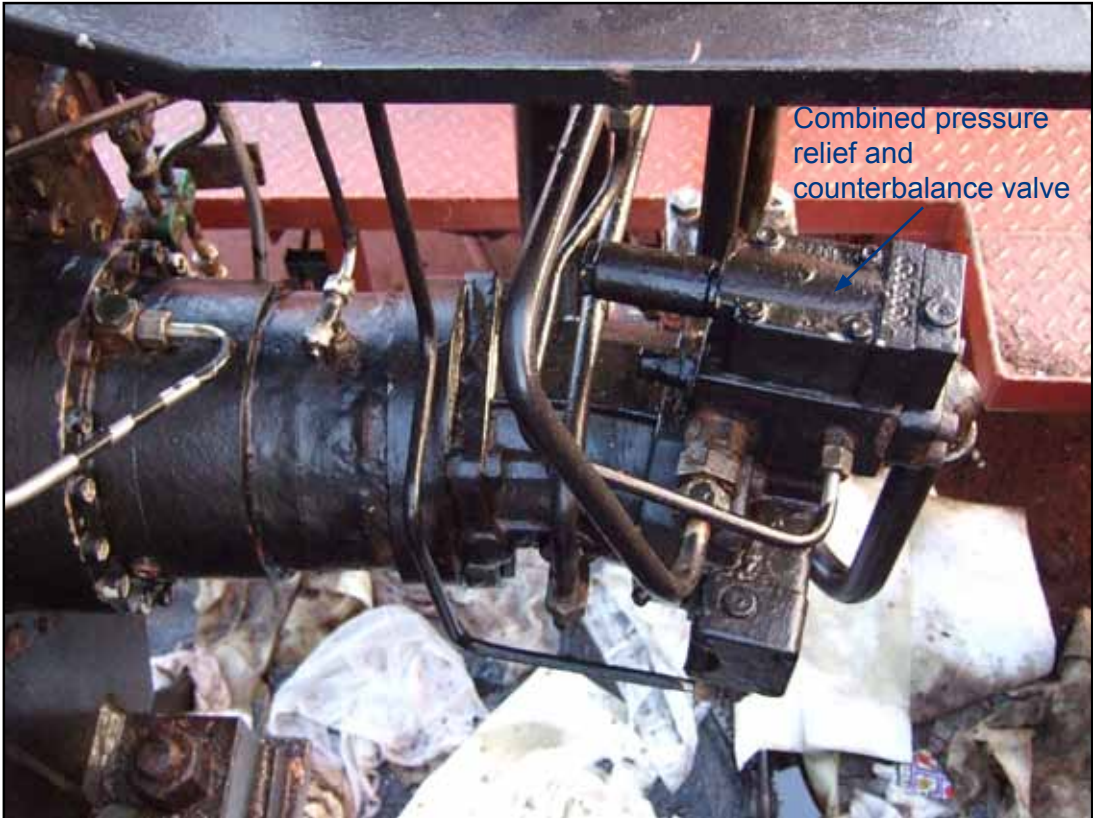
Figure 6

The hydraulic drive motor (**Figure 6**) was a bent axis axial piston variable displacement type. It was bi-directional and was capable of operating at maximum speeds of 3550rpm at 107cm<sup>3</sup> displacement and 6300rpm at 0cm<sup>3</sup> displacement, but had been adjusted to operate at maximum speeds of 1725rpm at 107cm<sup>3</sup> displacement and 4325rpm at 43cm<sup>3</sup> displacement. The oil flow was constant at 190 l/min. The motor output was adjusted by varying the position of a 'lens plate' which varied the stroke length of the seven pistons in the cylinder. The motor was therefore capable of achieving infinite combinations of torque and speed. The central bore of the cylinder carried a hollow spring-loaded pin which kept the cylinder aligned to its rotational axis. A diagram showing the internal components of the motor is at **Figure 7**.

Hydraulic drive motor

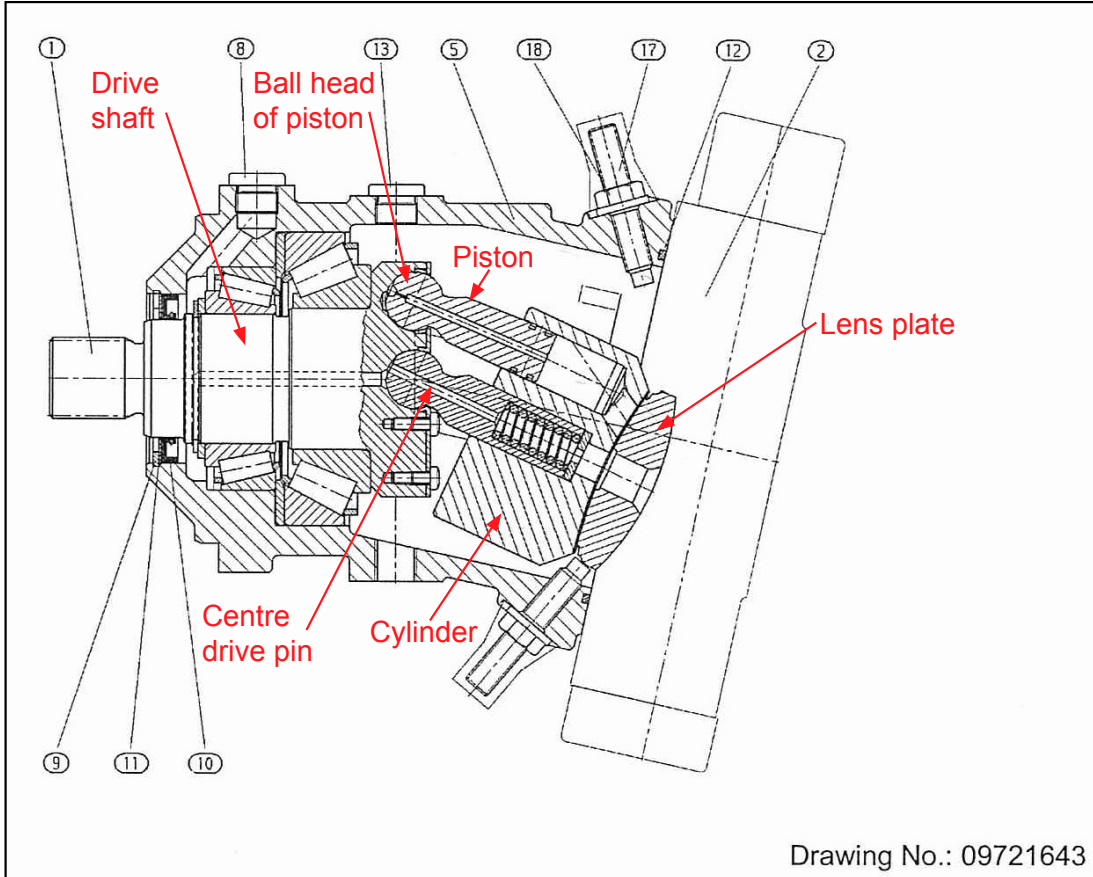
Figure 7

Bent axis axial piston displacement hydraulic motor

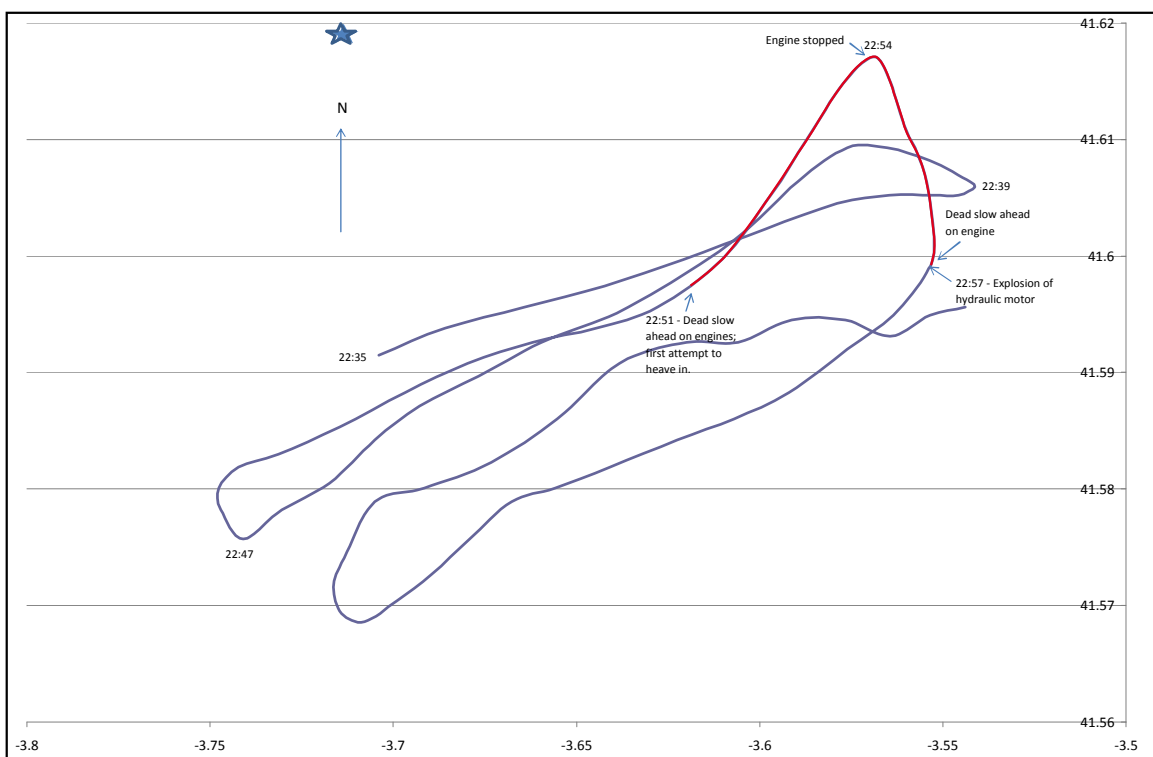
Figure 13

It is evident that when the windlass motor exploded the anchor cable was under sufficient tension to load the windlass beyond its safe operating limit. The master had previously manoeuvred the vessel to slacken the cable, but the delay in releasing the brake resulted in the vessel being set back to its original position by the time the problem with the brake had been resolved (**Figure 13**). This had caused the cable to re-tension, and the master had just started to manoeuvre the vessel for a second time when the accident occurred.

Movement of the ship during the incident
