Report on the investigation of
the engine room fire on board
the passenger cruise vessel

The Calypso

6 May 2006

**Report No 8/2007
April 2007**

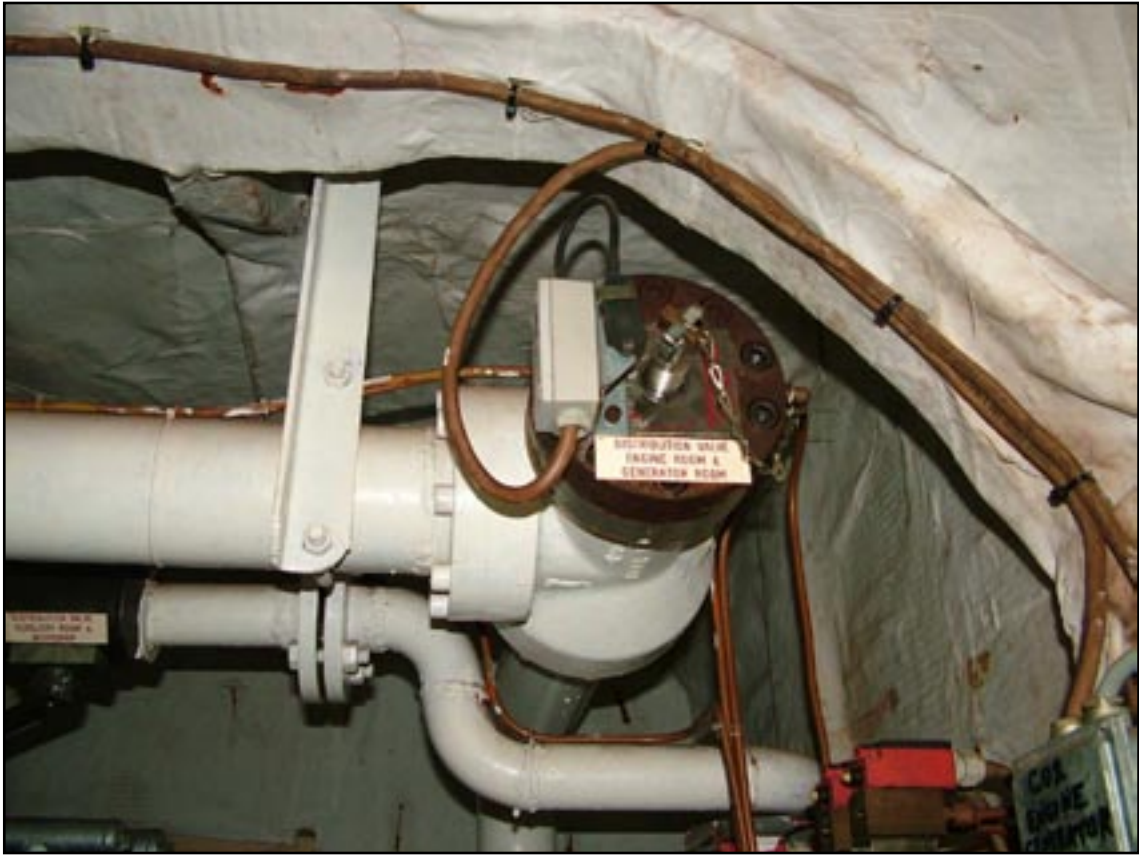
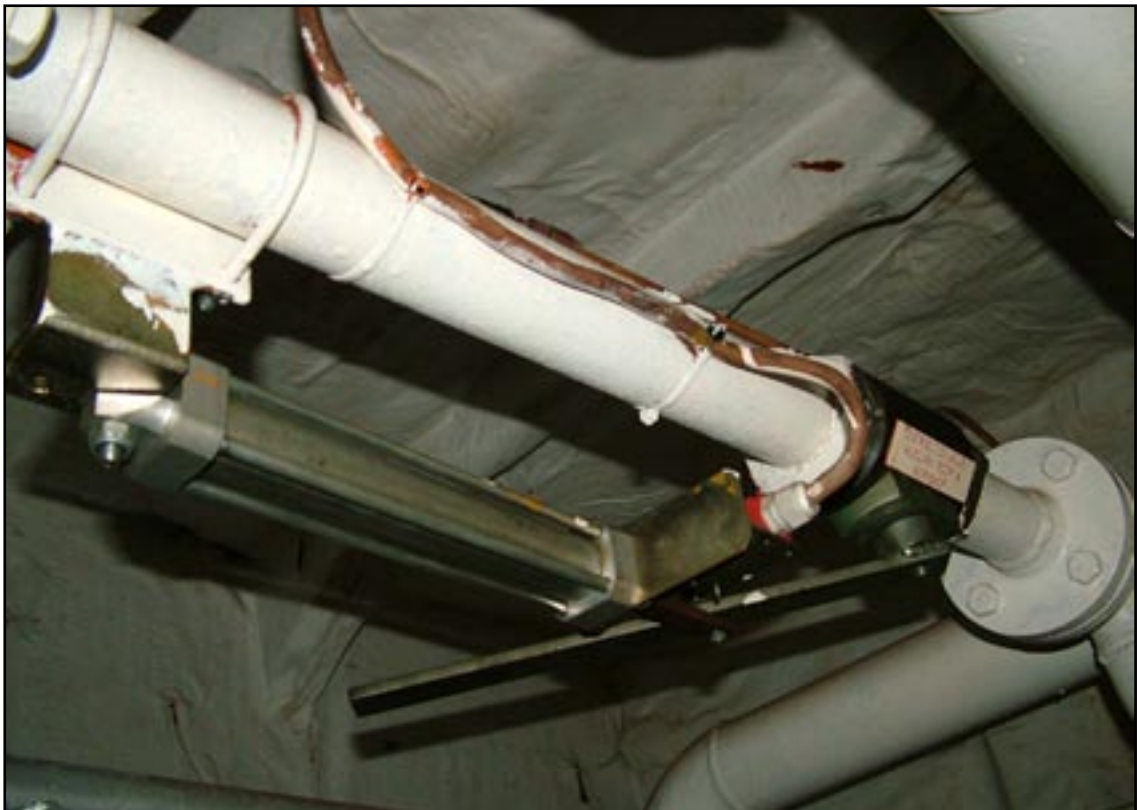
The chief electrician opened the valves on two small bottles on the aft bulkhead, which he believed were the pilot cylinders (**Figure 4**). He then operated the control levers for the engine and boiler room gas supply lines (**Figure 5**), as directed by the posted instructions, and manually opened the distribution valves to the engine room and boiler room (**Figure 6a/6b**). He left the CO₂ room within a few minutes and informed the chief engineer that the CO₂ system had been operated. At 0350, the safety officer contacted the bridge and confirmed that the CO₂ had been released. At about this time, an electrical blackout occurred and the emergency diesel generator started.

Distribution valves

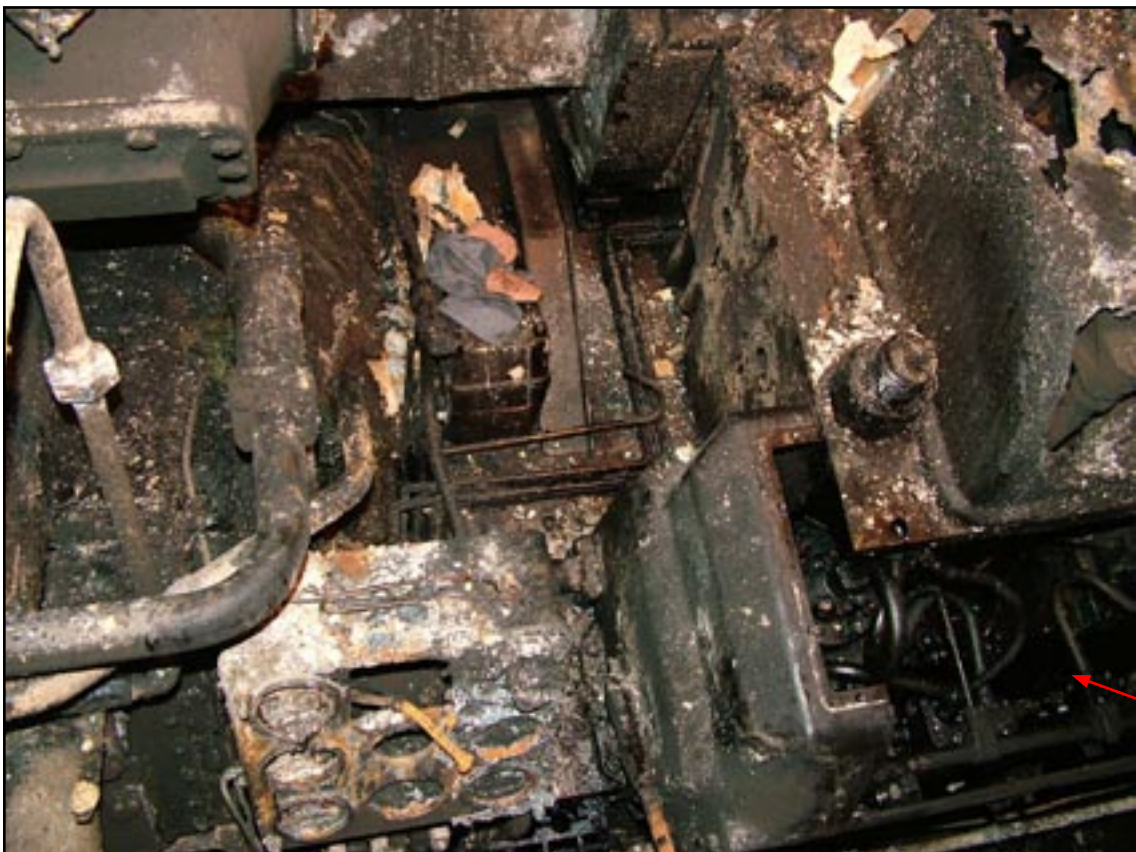
Figure 12

Leading from the forward end of the hotbox, the LP supply and return pipes passed through the end of the hotbox. From the inboard bank, the LP pipes ran outboard (under the turbochargers) and over the "Vee" to connect with the LP pipes from the outboard bank (see Annex 4 – Technical Bulletin). The LP pipes connecting the two banks used two, M10 bolt, flange connections, and were covered with thin "tin plate" spray covers to prevent fuel leakage droplets or mist (under pressure) from coming into contact with the hot surfaces of the turbo charger above, or the exhaust pipes in, the "Vee". The spray covers were intended to be screwed into LP pipe support brackets to hold them in position. The Wartsila supply, LP fuel pipes then connect to shipyard supply fuel pipework on the outboard side of the engine using four bolt flanges.

Forward end of hotbox of starboard engine

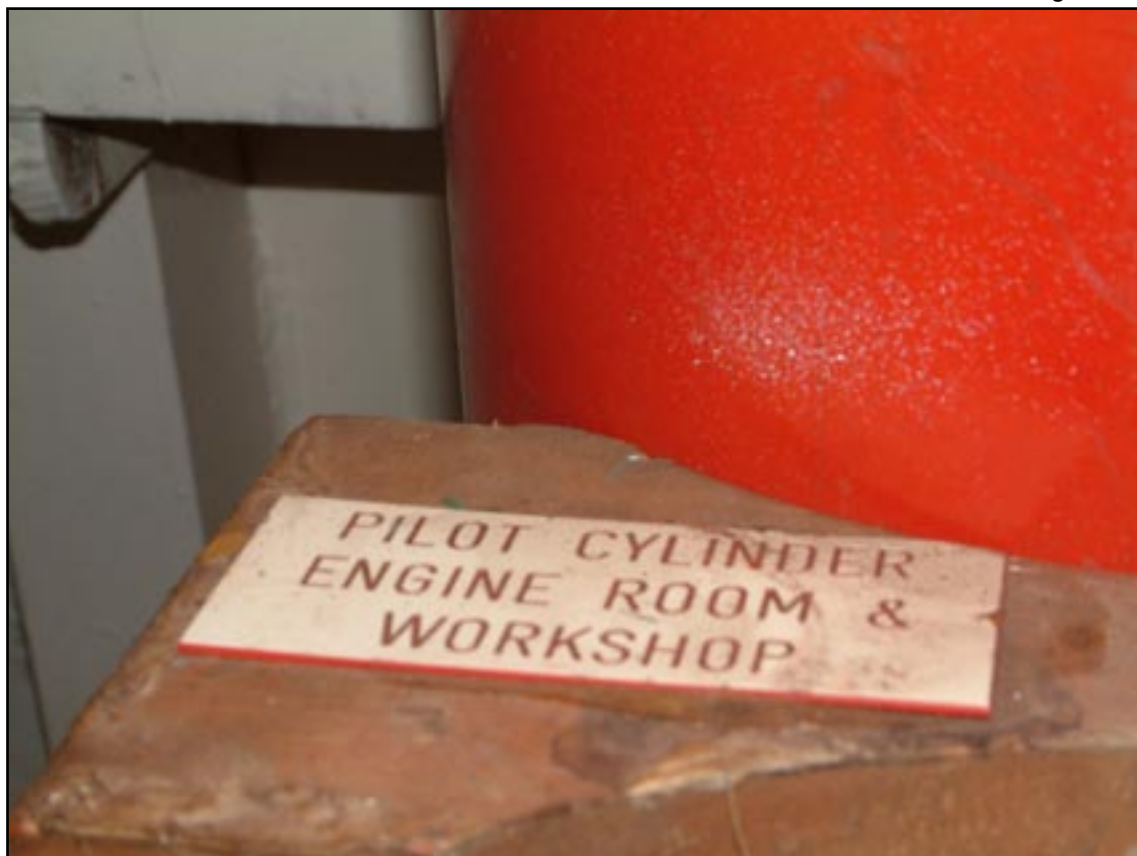
Figure 18

The modification to the system by Ginge-Kerr included two, 45kg, manually operated, pilot cylinders as part of the outboard bank of cylinders. Each pilot cylinder was intended to release the relevant number of cylinders for its specified protected space. Each pilot cylinder had a label identifying its purpose (**Figure 18**).

Pilot cylinder label

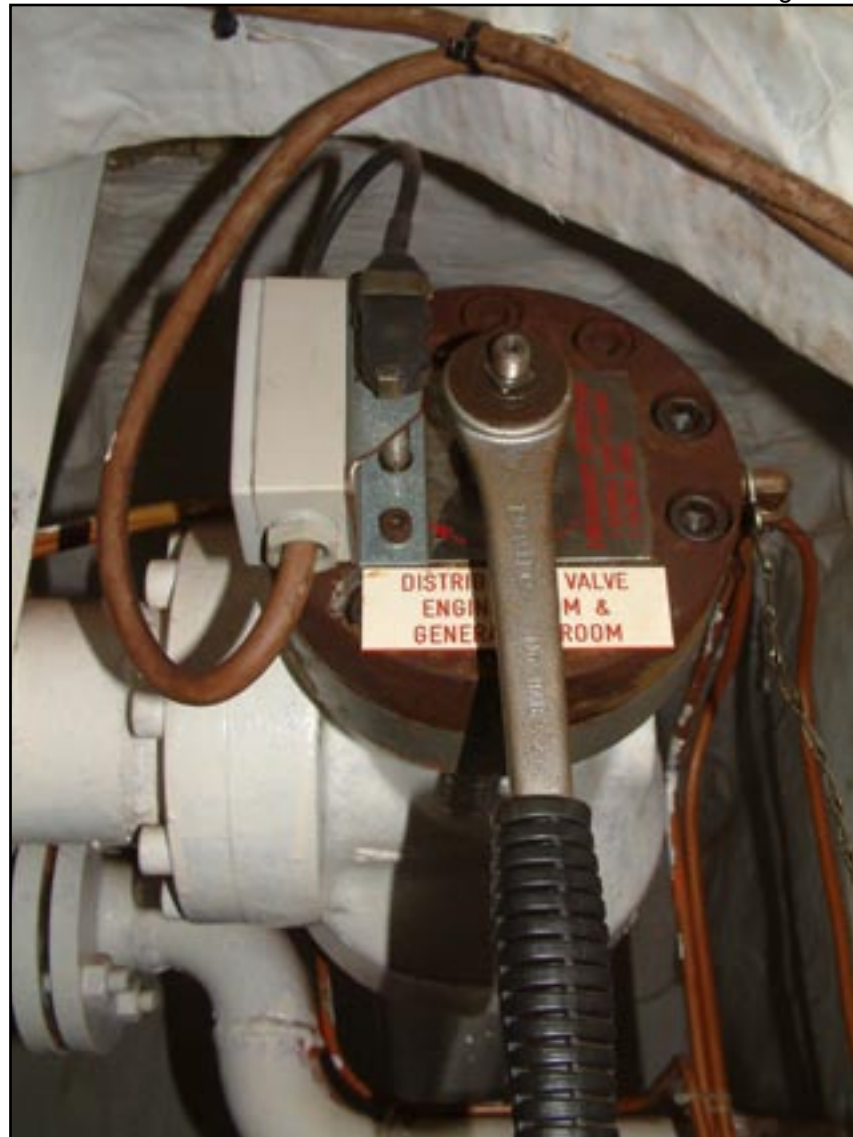
The release of the CO₂ into the two spaces was subject to the operation of pneumatically controlled distribution valves in the two take-off lines from the manifold. The 90° distribution valve for the engine room was piston operated, had a working pressure of 100 bars, and was provided with an indicator pin and switch to show when open. In an emergency, the valve could be opened using a dedicated ratchet handle (**Figure 20**). The distribution valve for the boiler room was opened by a pneumatically controlled cylinder specifically suited to open ball valves. The cylinder had a working pressure range of 10 -100 bar. In an emergency, a handle, extending from the ball valve pivot, could be used to operate the valve manually (**Figure 6b**). Both distribution valves were labelled.

Engine room distribution valve with manual handle attached

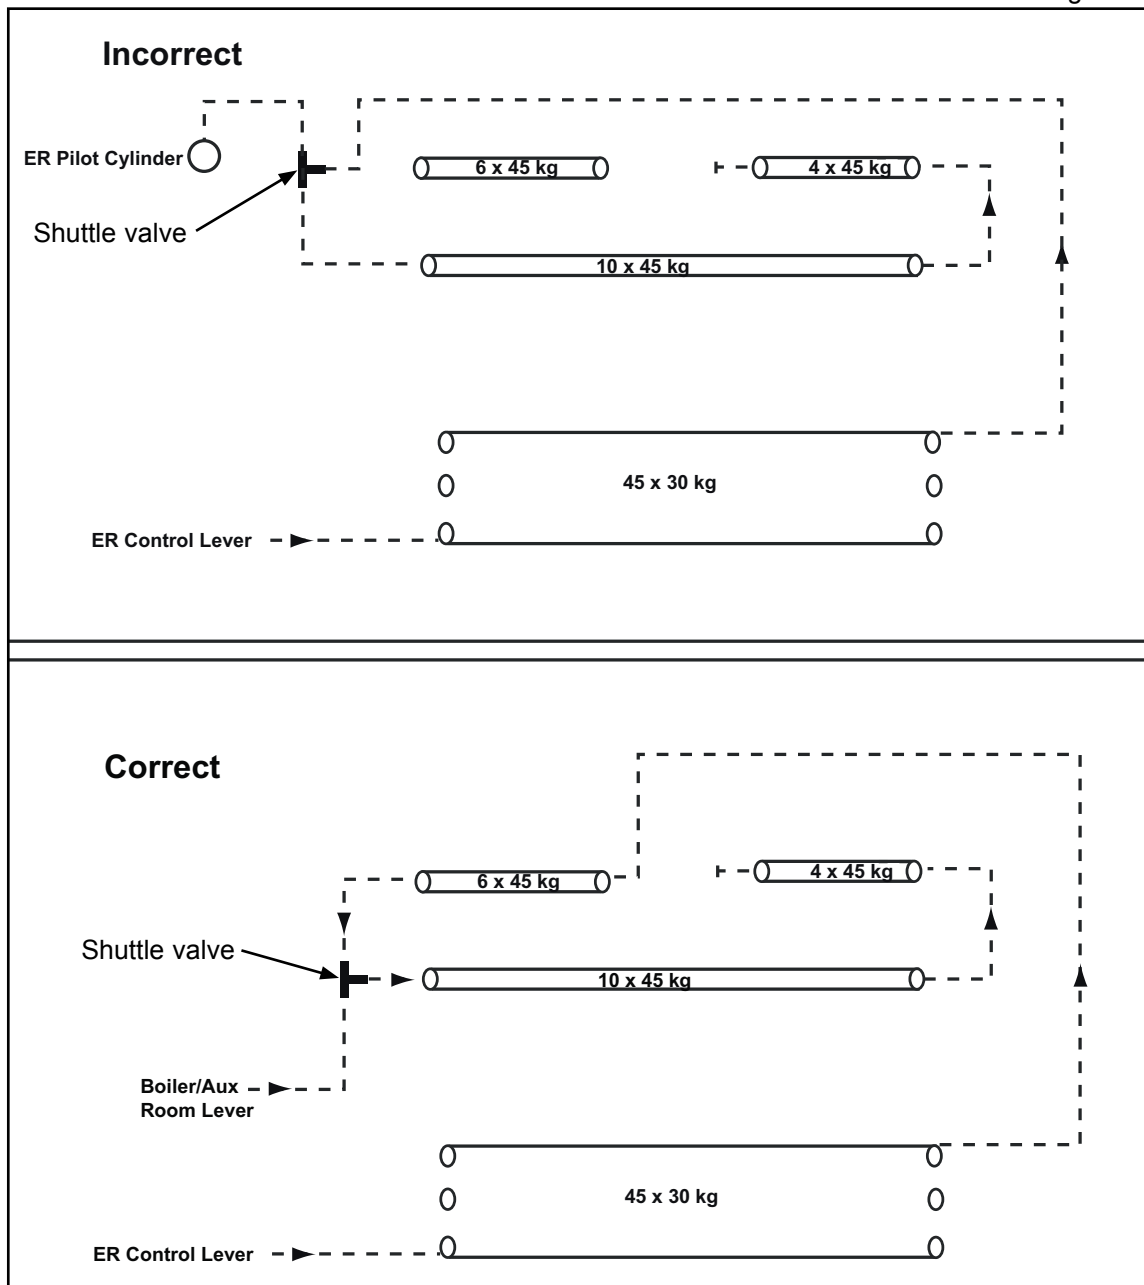
Figure 28

The small bore copper control pipework linking the control switches and CO₂ cylinders included an actuator shuttle valve, in the form of a “T” piece, located near the pilot cylinders. This allowed control gas to pass from either end of the main line of the “T” and leave via the middle port. The shuttle valve was intended to allow the correct number of cylinders to be released depending on whether the engine room or boiler room was to be injected with CO₂ (see **Figure 28**).

The inspection also revealed that the actuator shuttle valve (“T” piece) in the pilot line had been incorrectly fitted, probably from when the system was installed in 1994 (**Figure 28**). This meant that, even if the system for the engine room had been activated correctly, only six of the outboard bank of cylinders would have been released instead of all of them (a total of 51 cylinders instead of all 66). The incorrect fitting of the shuttle valve had not been noticed in any inspections since the system was fitted in 1994. This indicates a general shortfall by both the service agents and ship staff.
