MAIB TRILOGY REPORT

Korenbloem

Osprey III

Optik

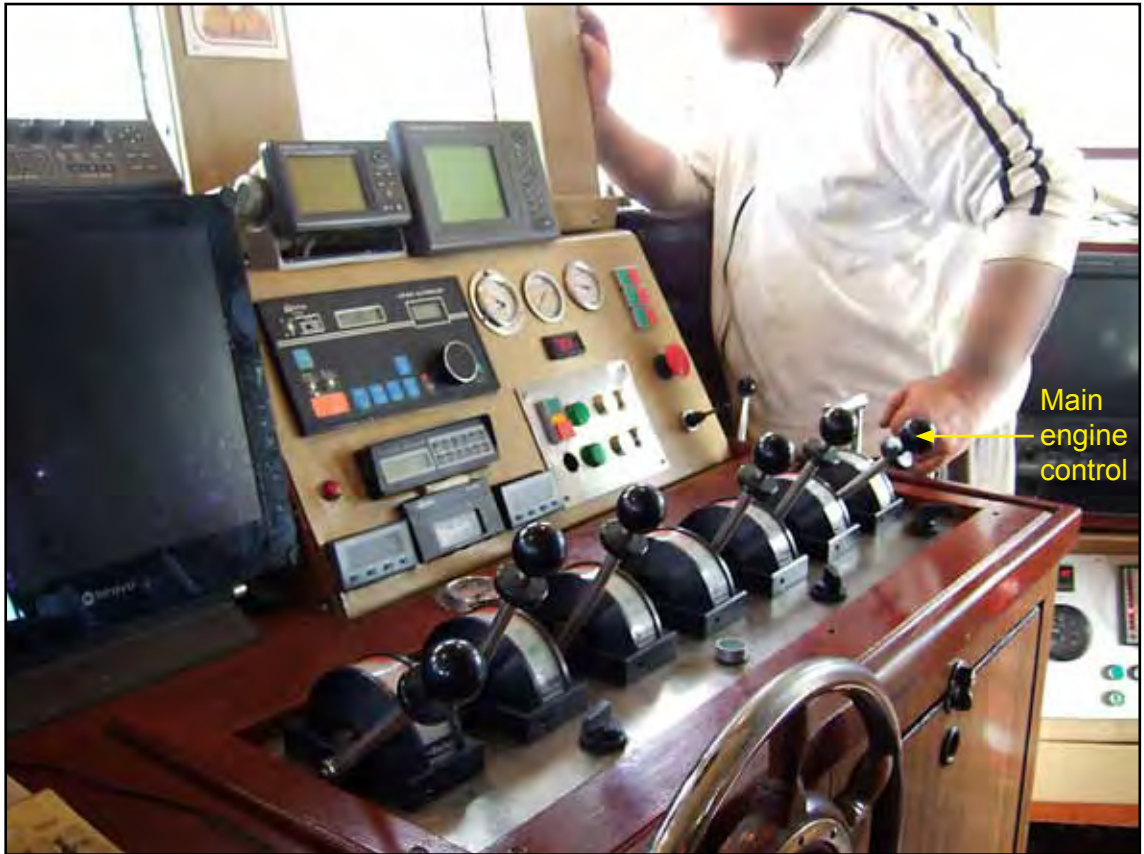
Figure 6

Each of the six winches could be individually clutched in or out; but they were operated simultaneously using a single lever located next to the main engine speed control lever (**Figure 6**).

Winch controls for operating fishing gear

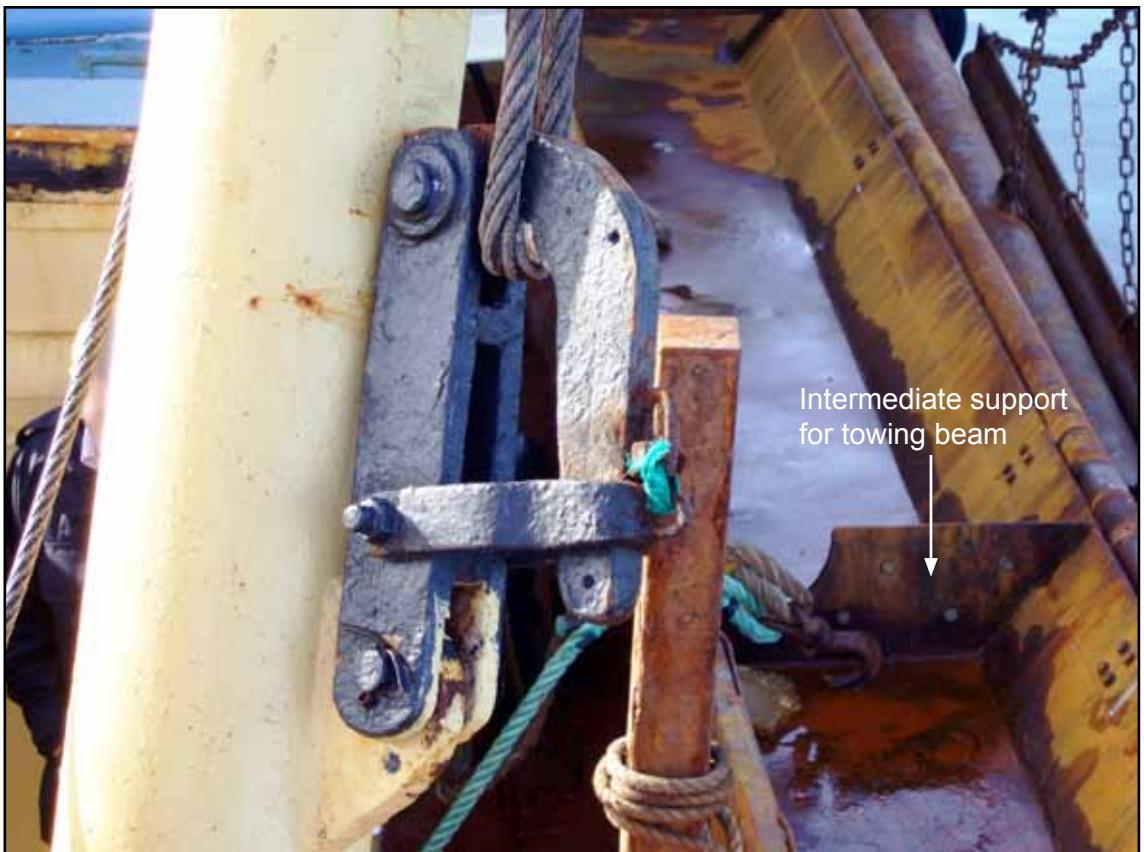
Figure 7

Catches of scallops were emptied into large bins on each side of the main deck. The bins had hydraulically operated rams under them which allowed them to be tipped for emptying any waste material overboard. When not in use, the fishing gear, including the tipping bars and towing beams, were stowed in cradles positioned directly over their respective bins. Intermediate supports for the towing beams were built into the cradle (**Figure 7**).

Intermediate supports for towing beam cradle arrangement

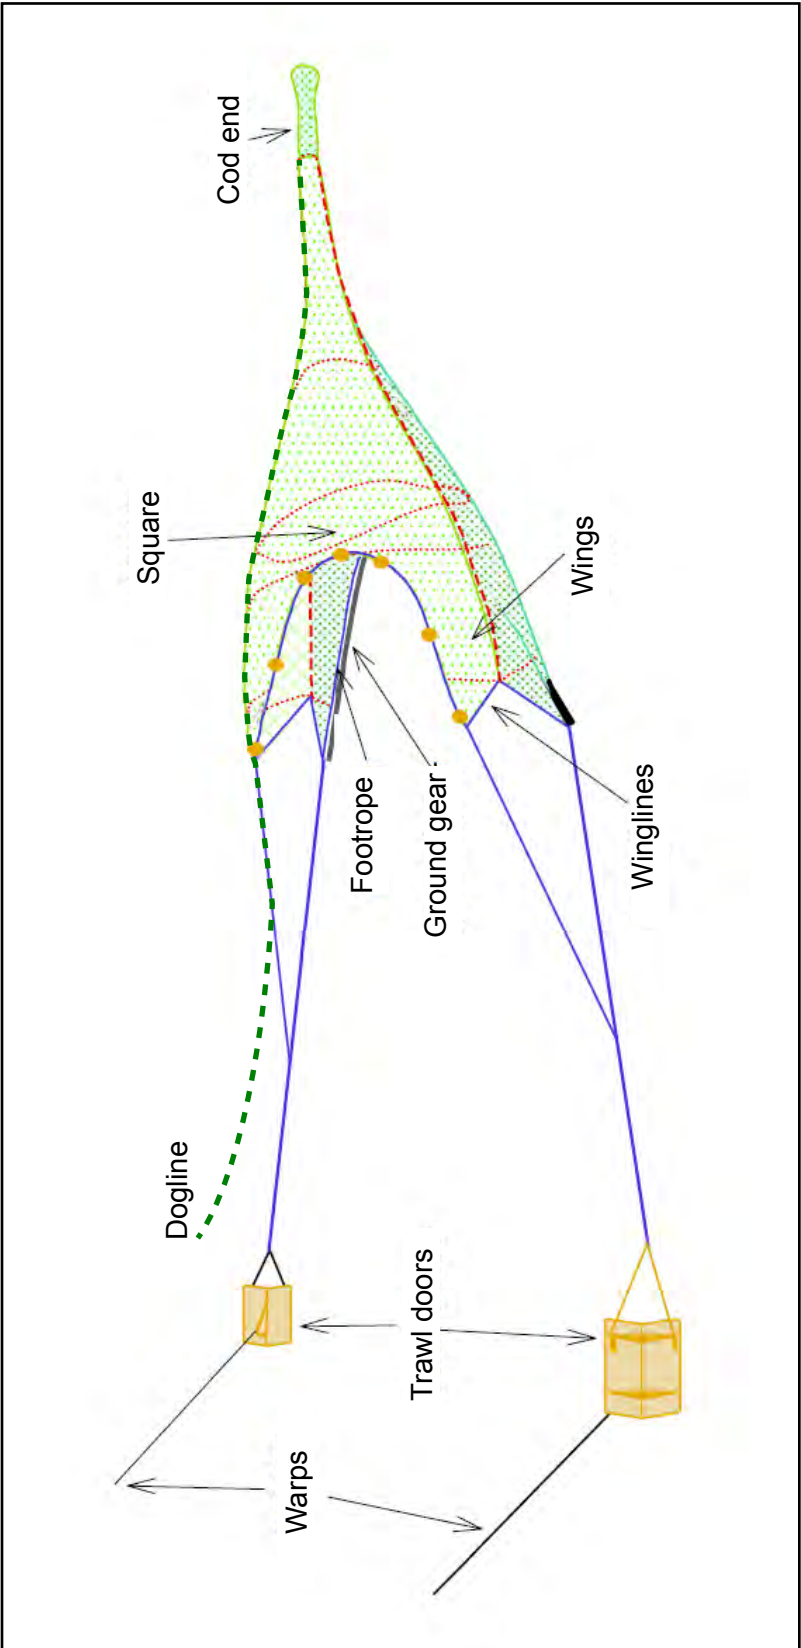
Figure 5

The vessel was designed by Macduff Ship Design Ltd and built by Macduff Shipyards Ltd. She was driven by a Caterpillar 3406-TA engine, which also powered the vessel's hydraulic system. Two bottom trawl nets were stowed on net drums sited near the stern. The starboard net, which was used on 11 November, was designed for rocky seabeds. Its ground gear consisted of a series of discs with rubber spacers attached to its footrope. In addition to the ground gear, the footrope of the net had a flip up line attached to it to prevent large boulders from being swept into the net and causing damage (**Figure 17**). The port net was designed for use with sandy seabeds.

Bottom trawl net

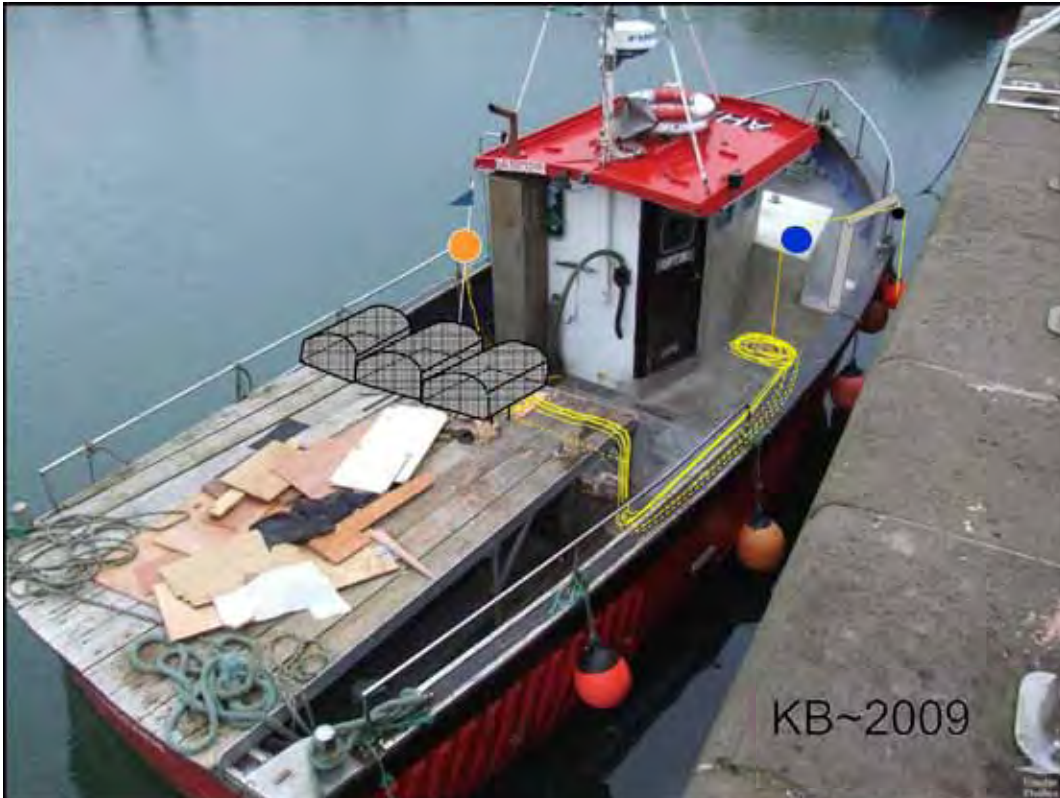
Representation of back rope coiled under the hauler and initial sequence of creels stowed on the shooting table

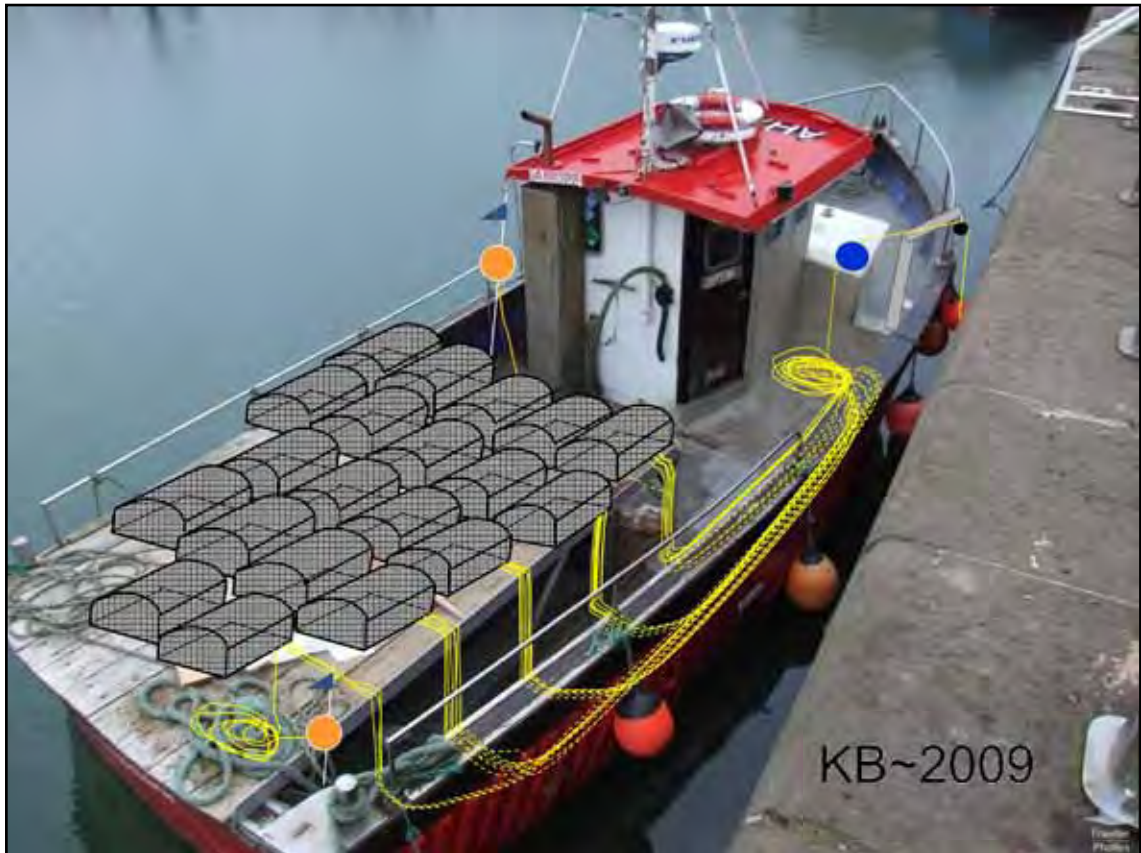
Representation of fleet of recovered creels stowed on the shooting table in preparation for shooting
