Report on the investigation into the contact
made by the tanker
Vallermosa,
with the tankers
Navion Fennia and ***BW Orinoco***
at the Fawley Marine Terminal
on 25 February 2009

Marine Accident Investigation Branch
Mountbatten House
Grosvenor Square
Southampton
United Kingdom
SO15 2JU
Report No 23/2009
November 2009

On 25 February 2009, the oil product and chemical tanker, *Vallermosa*, loaded with a full cargo of 35,000t of jet fuel and bound for the BP Hamble Terminal in Southampton Water, made contact with two oil tankers which were discharging alongside at Fawley Marine Terminal. The accident caused structural damage to all three vessels, minor damage to the jetty and minor pollution.

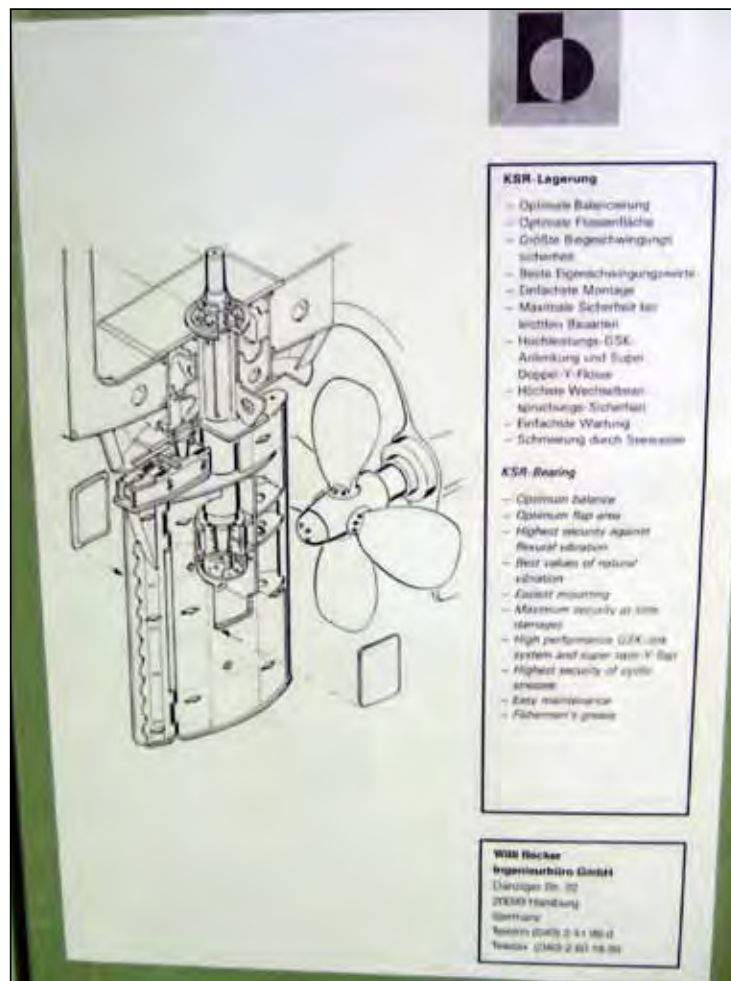
Figure 12

Vallermosa was designed and fitted with a Becker rudder. The main advantage of the Becker rudder (**Figure 12**) is that it generates greater lateral forces than conventional rudders at small rudder angles. The flap at the trailing edge of the rudder turns to almost twice the angle of the main rudder blade. The maximum lateral force was achieved at a main rudder angle of about 35° with the flap at an angle of around 70° from amidships.

Photograph of Becker rudder information

The manufacturer estimated that the Becker rudder was three times as effective as a conventional rudder. The advice posted at *Vallermosa's* steering position (**Figure 13**), located beneath the helm and obscured from the pilot's view warned:

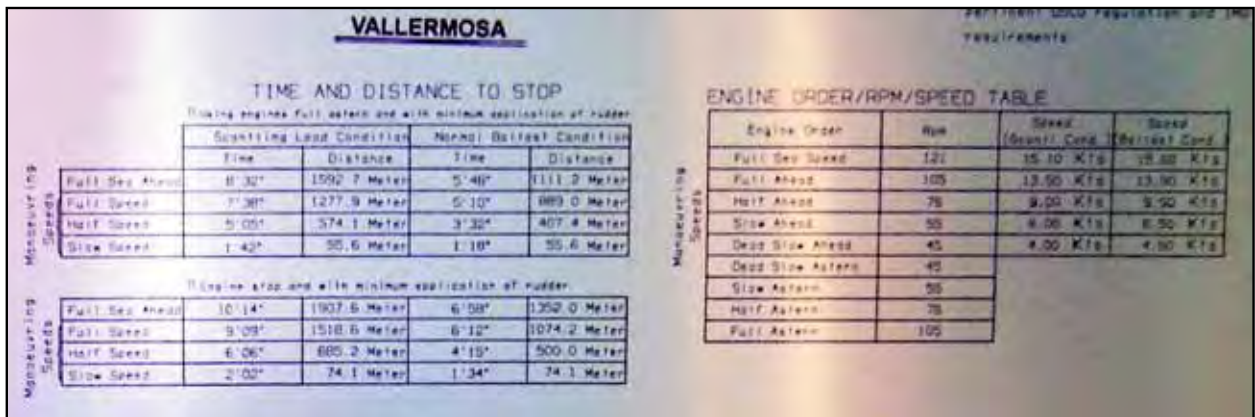
Figure 14

Vallermosa's manoeuvring data was provided to the pilot during the pilot / master exchange discussion held when he arrived on board, and on the pilot card (**Figure 3**). Additional data was available on the bridge, located below the forward bridge window, but the pilot was unaware of it. The stopping data (**Figure 14**) indicates that, for example, with an ahead speed of 9 knots in the loaded condition, had the main engine operated full astern, *Vallermosa* would have stopped in 574.1m (3.1 cables). The effect on the heading, on a vessel which is directionally unstable, is not shown.

Stopping data from *Vallermosa*

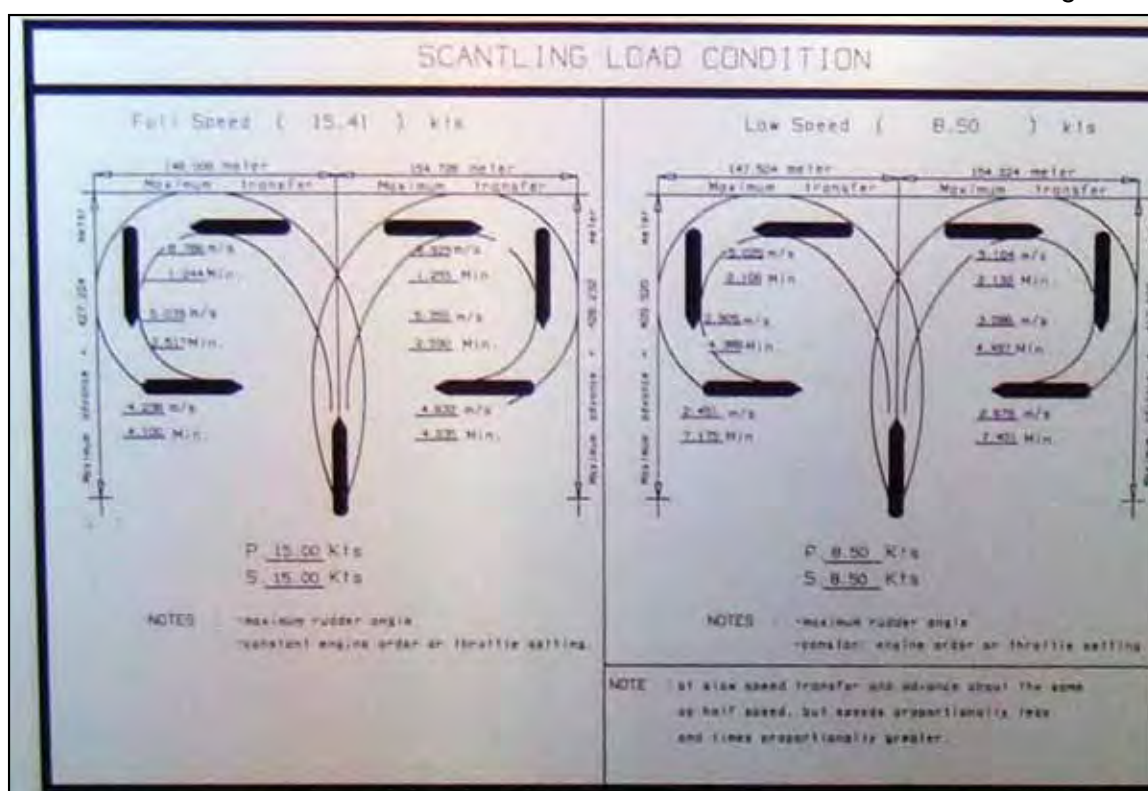
The turning data (**Figure 15**) indicates that in the loaded condition at 8.5 kts with maximum rudder angle and constant engine speed, *Vallermosa* would advance by a maximum of 410m (2.2 cables) and transfer 150m (0.8 cables) during a full round turn. This distance would be affected by the environmental conditions; notably, the advance and transfer could have increased due to the depth of water.

Turning data from *Vallermosa*

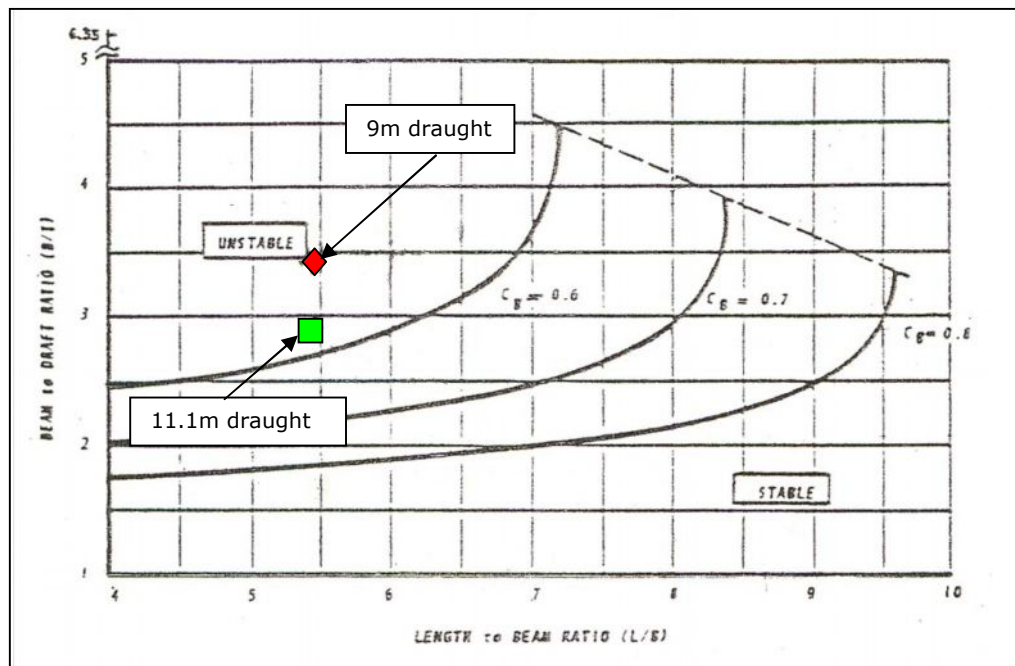
The first plot is shown in Figure 2 and is taken from Reference 1. Boundary lines are plotted as stability boundaries with the "stable" and "unstable" regions marked. It is seen that the ship as originally designed fell on the "unstable" side of the boundary for block coefficients around 0.8 and was improved at the deeper draught, although still classed as unstable.

Figure 2: Directional Stability Check 1 from Reference 1

These two plots suggest that the Vallermosa at the time of the incident may have had a tendency to directional instability as is often the case with ships having block coefficients in excess of 0.8 and length/beam ratios less than 5.5.

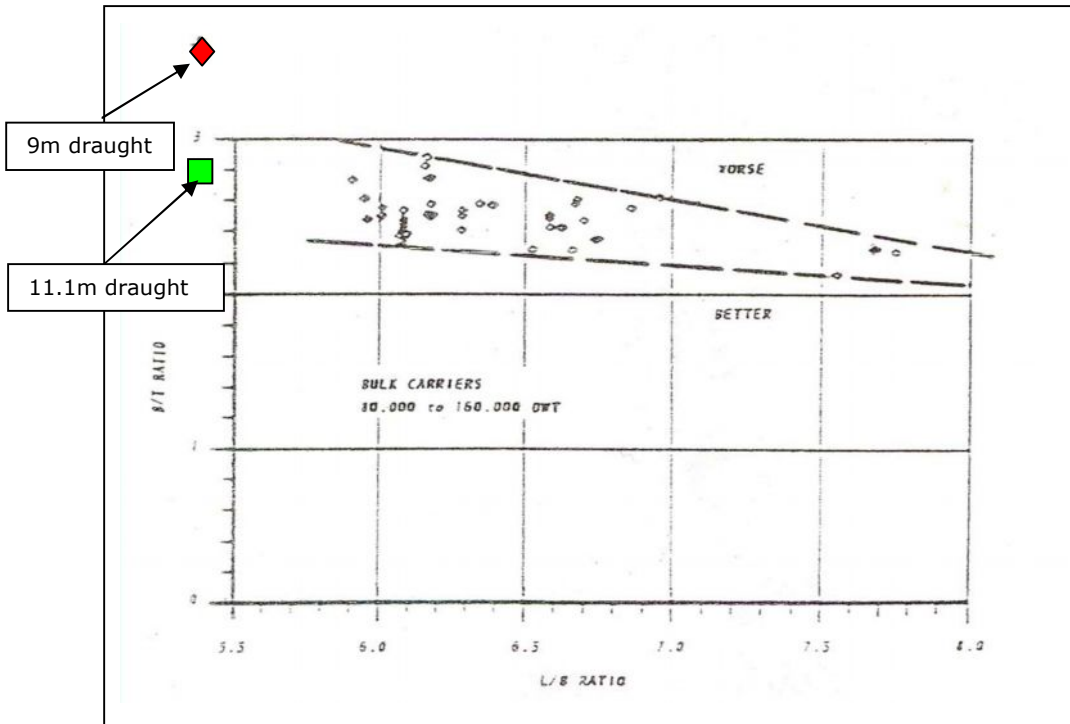
Figure 3 shows an alternative plot from Reference 2 which shows the Vallermosa to be more stable (and just on the stability margin) at the deeper load draught, by virtue of its smaller beam/draught ratio.

Figure 3: Directional Stability Check 2 from Reference 2

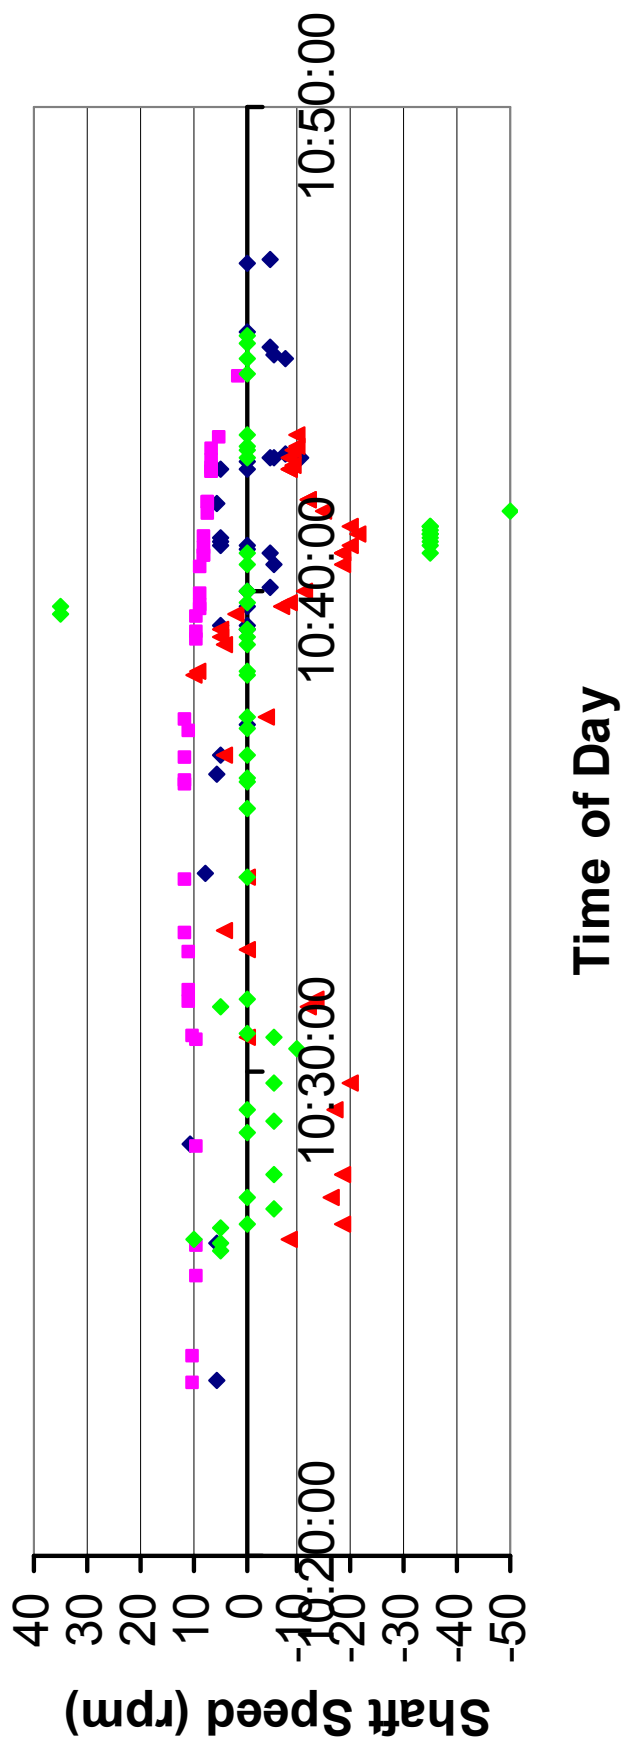
Figure 5: Data from Vallermosa VDR and Bridge Voice Recorder

The period from 10:21 to 10:34 saw the ship navigating the bend round Calshot Spit successfully and heading to leave the Hook buoy to starboard. Figure 5 shows that the overground speed was of the order of 10 knots at this point and reducing, with the engine on slow ahead. Full ahead was achieved at about 10:28, as the ship was turning to port and about to exit the Calshot Spit bend. As can be seen from Figure 6, this may well have been to increase the turn rate to ensure the vessel made the turn, but it was quickly reduced as the vessel came out of the turn, only to be increased quite noticeably again as a further correction to port was made off the Reach buoy. This does not indicate a "good bend" and the upshot was that, as "full ahead" was maintained until about 10:34 (some 6 minutes later), the overground speed had increased to around 11 knots at the end of this leg, with the ship more-or-less steady on course.

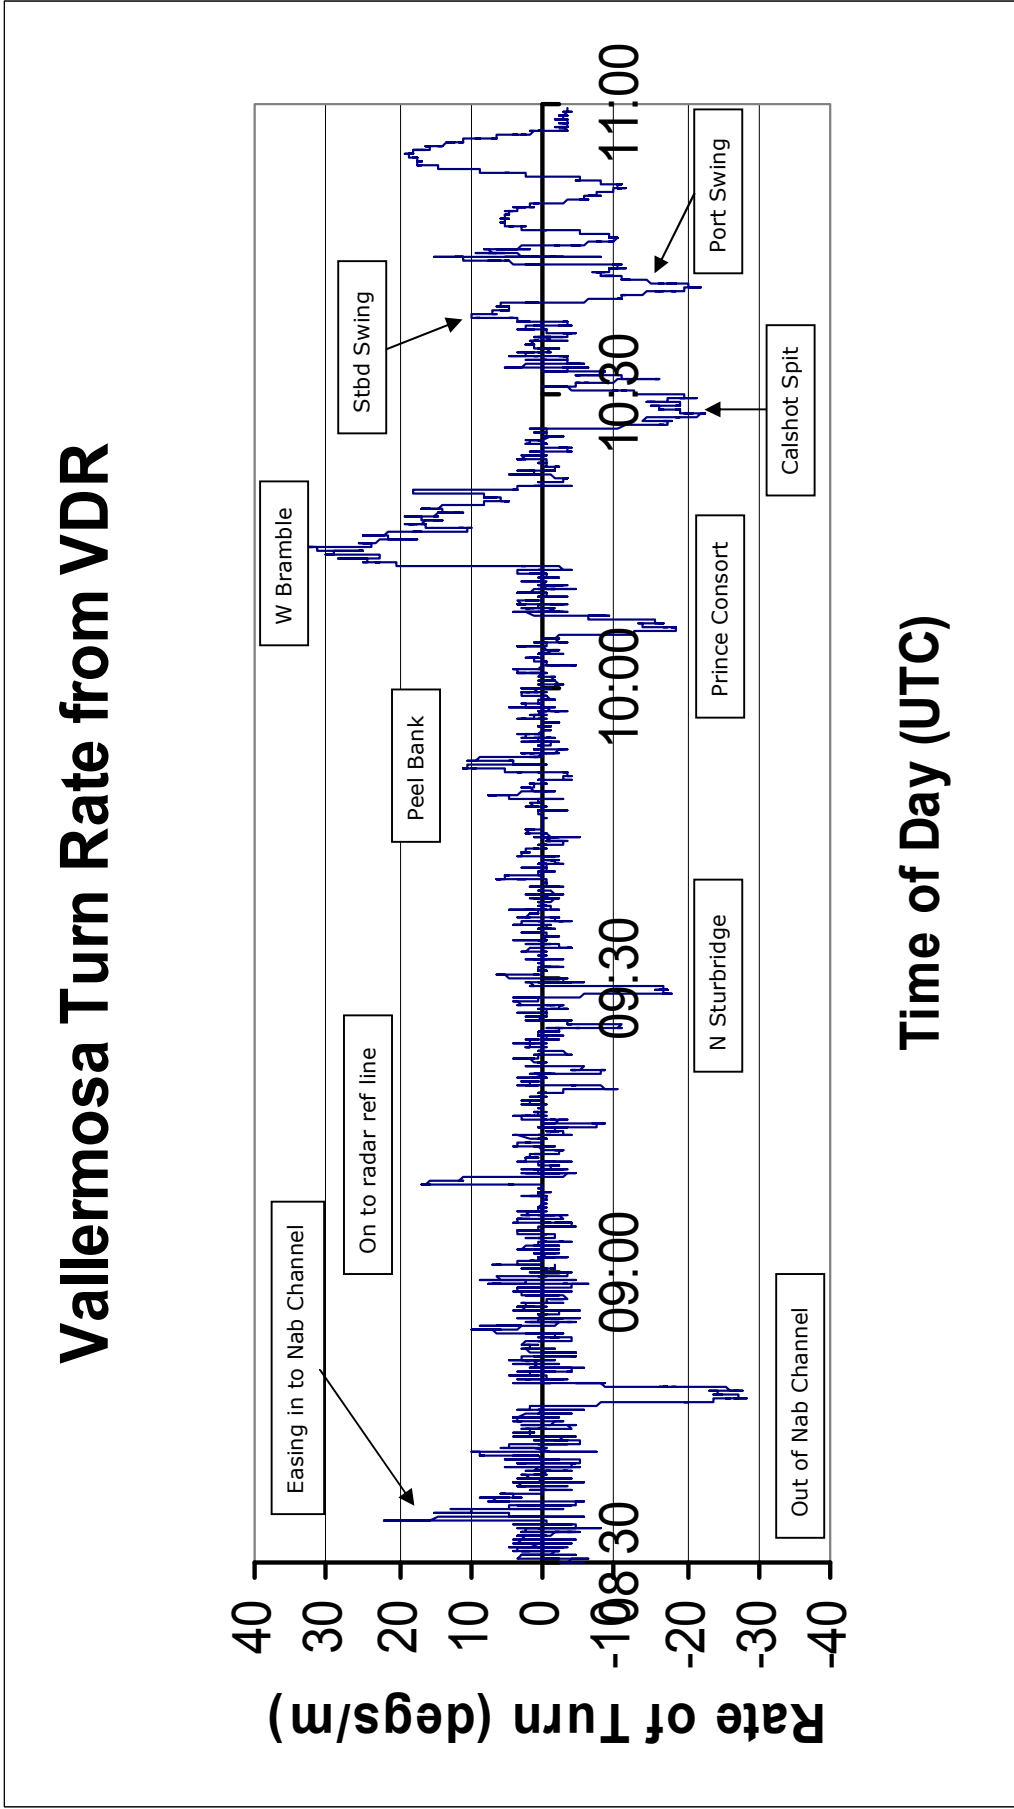
Passage from 08:30 to 10:00 took the vessel from entry to the Nab Channel to Ryde Middle. It is seen from Figure 1 that the track shows no anomalies and the transit over this part of the passage appears quite normal. Figure 6, however, reveals a continuous turn rate variation about zero which reinforces the comment, made in Section 5.2 above, that the ship was not able to steady on a course on a day when the weather was benign. Any turns appear to be hesitant with a number of incremental heading changes, a feature which is seen frequently in the whole passage.

Once again the number of changes in the rate of turn plot in Figure 6 suggests a ship that was slightly course unstable and liable to wander off course if not checked.

Figure 6: Rate of Turn Measurements from Vallermosa VDR
