Report on the investigation of  
a fatal accident on  
***Wellservicer***  
3 miles SE of Aberdeen, Scotland  
1 April 2009

Marine Accident Investigation Branch  
Mountbatten House  
Grosvenor Square  
Southampton  
United Kingdom  
SO15 2JU

**Report No 1/2010**  
**January 2010**

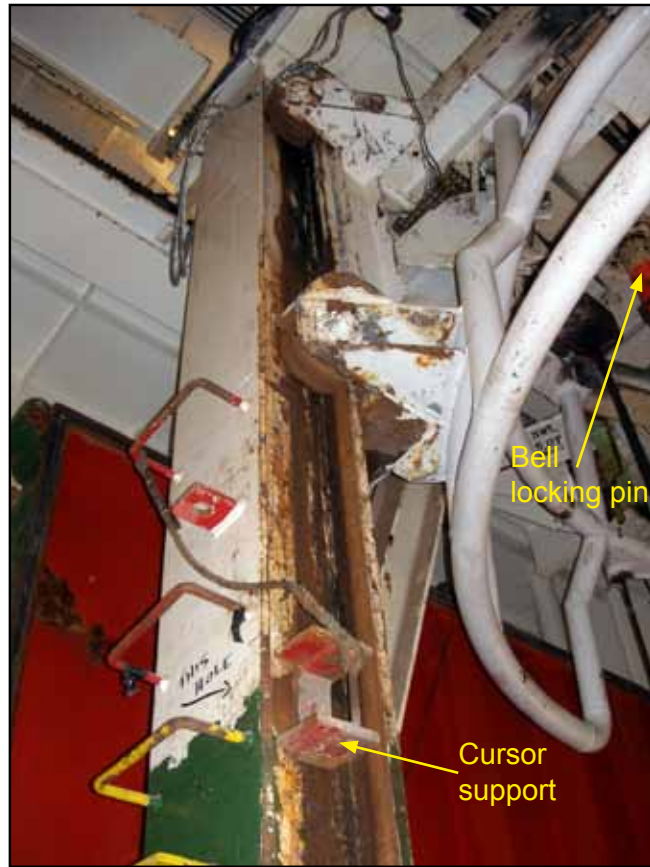
Figure 5

Bell trolley frame port leg, showing cursor support

- In normal diving bell launch and recovery operations, it was routine practice to put the cursor supports in place (**Figure 5**). In the rather different context of the modification process, the need for this routine might not have been evident to riggers focused on the technical challenges of the task<sup>8</sup>.

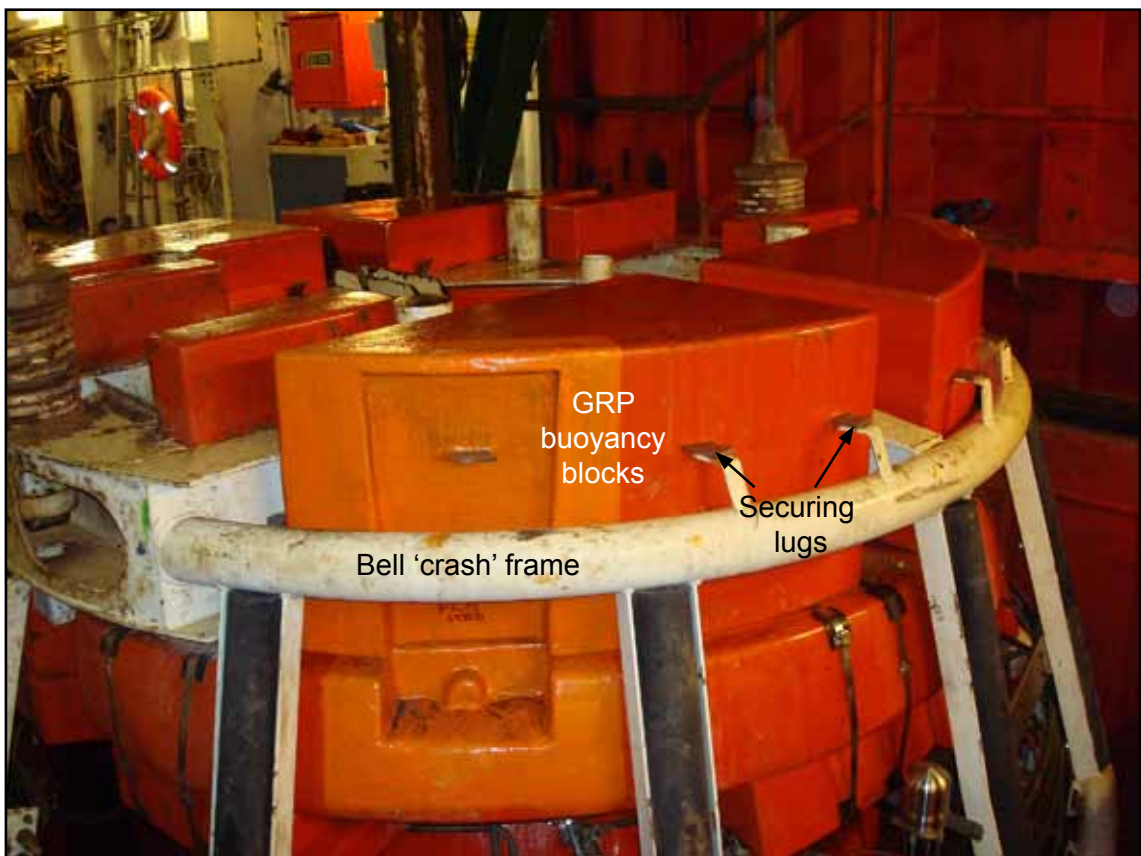
Figure 7

Glass reinforced plastic (GRP) buoyancy blocks attached to the bell (**Figure 7**) needed to be removed for alterations. This was a difficult task due to the close proximity of the cursor and the cumbersome shape of the blocks. It was decided to move the bell and cursor from the TUP trunking to the moonpool, to hang the cursor off from the trolley by means of strops, and to lower the bell to a satisfactory height in the moonpool, thus allowing the blocks to be removed more easily. The bell top also created a convenient working platform to allow work to progress on the cursor suspended several feet above it.

Bell top showing GRP buoyancy blocks

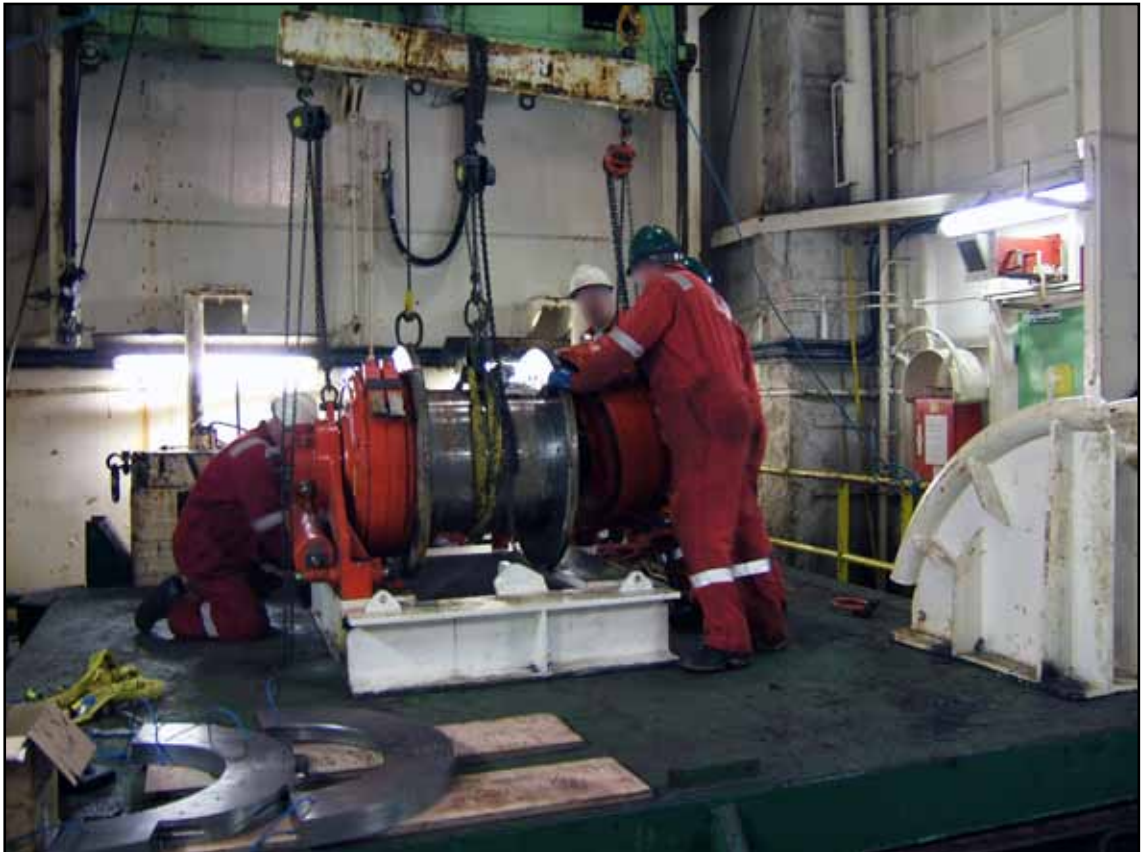
Figure 16

testing also included evaluation of the winch drum braking systems. Following load testing, the winch was stripped down into its component parts again before being transported to the dry dock in Holland. The components were hoisted from the dry dock bottom into the vessel up through the forward moonpool, and then re-assembled on board the vessel (**Figure 16**) before being installed on top of the bell trolley.

Winch being assembled in bell hanger
