Report on the investigation of the collision between

Gas Monarch and Whispa

6 miles ESE of Lowestoft

**Report No 25/2007
December 2007**

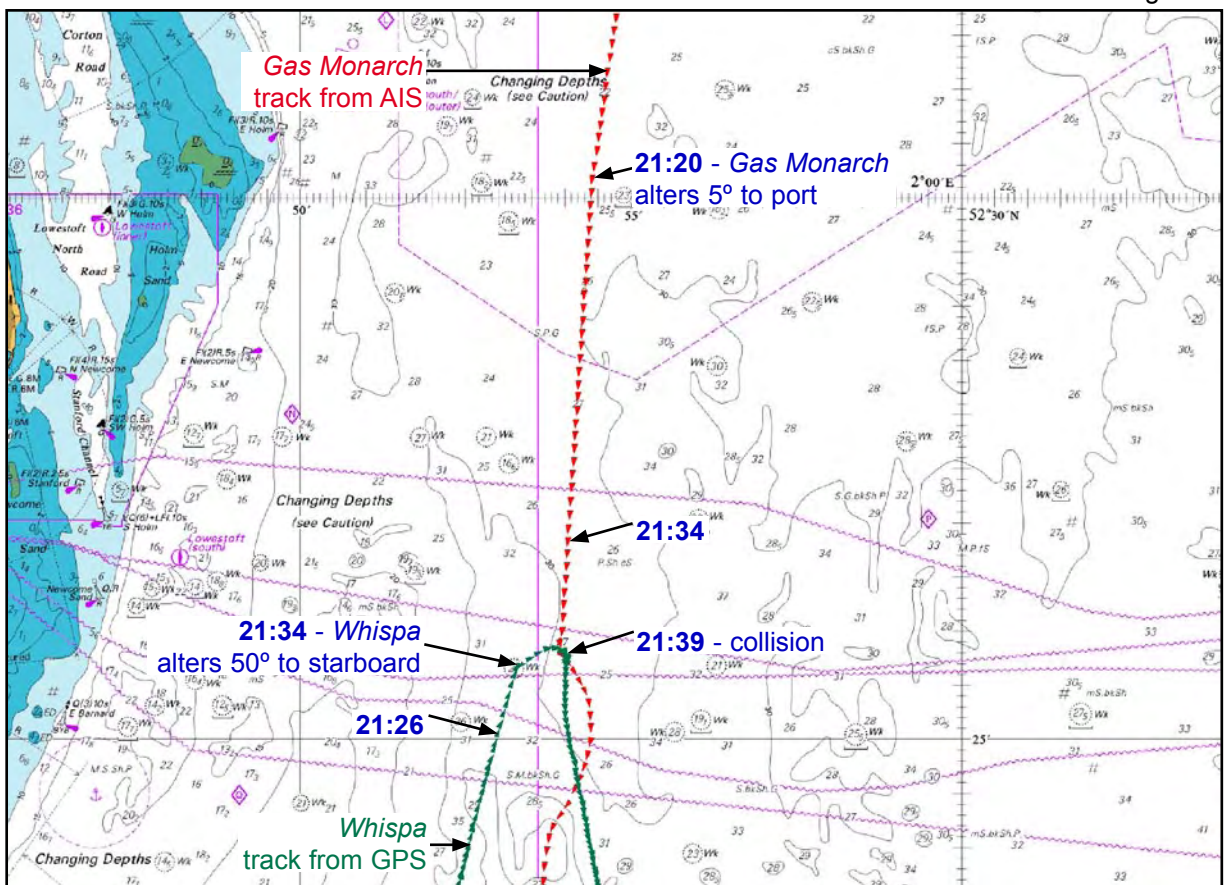
Figure 4

about 5.5 miles (**Figure 4**), the 3/O altered 5° to port to create a starboard to starboard passing situation. By appraising the contact's radar trails, the 3/O estimated the resulting CPA would be approximately 1nm on *Gas Monarch's* starboard side. As the vessels closed to 3 miles (**Figure 4**), the trails of *Whispa's* radar contact indicated to the 3/O a reduced CPA of 0.7nm to starboard. When the vessels were just less than 3 miles apart, the yacht's radar contact was lost from both radar screens of *Gas Monarch*.

Relative tracks of *Gas Monarch* (reproduced from AIS) and of *Whispa* (reproduced from GPS)

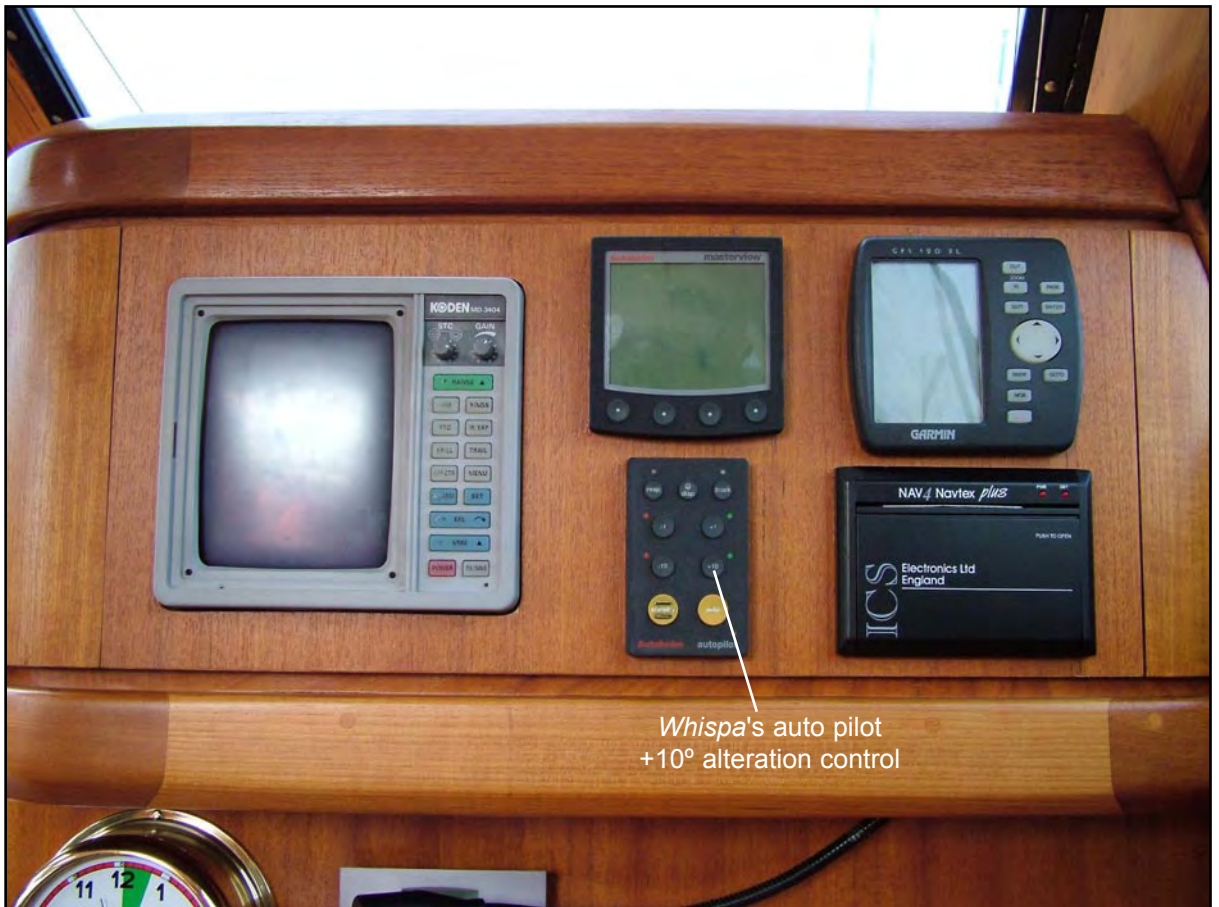
Figure 5

Whispa's skipper believed that a collision situation was unfolding, and before the contact entered his radar's alarmed guard zone, which was set at 2.5 miles, altered *Whispa*'s course 50° to starboard by pressing the autopilot 10° course alteration button 5 times in succession (**Figure 5**). The yacht skipper then reduced the range on the radar to 3nm, which he believed would display range rings at 0.5 mile intervals, and continued to monitor the contact. However, instead of tracking clear down his port side as expected, the contact appeared to still be coming towards the yacht, now from a relative bearing of 50° on the port bow. As the vessels drew closer, *Whispa*'s skipper altered a further 20° to starboard, but still the radar contact continued to close on a steady bearing. The yacht skipper rushed from the navigation station to the cockpit, put the engine on to full ahead, switched off the autopilot and put the yacht on a course 085°. As he stared into the dark, a spotlight was suddenly shone onto the yacht for some 6 to 8 seconds. The light destroyed the skipper's night vision, but as he threw the vessel hard to starboard he was able to identify a bulbous bow bearing down on him shortly before it collided with *Whispa*'s port quarter.

Whispa's control console
