**Report on the Investigation**  
**on the Capsize of the**  
**UK Registered Fishing Vessel**  
***CATRINA NNI94***  
**South of Newhaven**  
**on 13 October 1998**

*Catrina*, a dual purpose stern trawler/twin beam scallop dredger of 11.96 metre registered length, broached and capsized at about 1305 on 13 October 1998 about 8 cables south of Newhaven breakwater light. The crew of two were thrown into the water and rescued by the fishing vessel *Boy Antony*; none was injured. The vessel was returning from a fishing trip with a small catch of red mullet. The wind was south-south-westerly force 5 and a steep 2m sea was on *Catrina*'s port quarter.

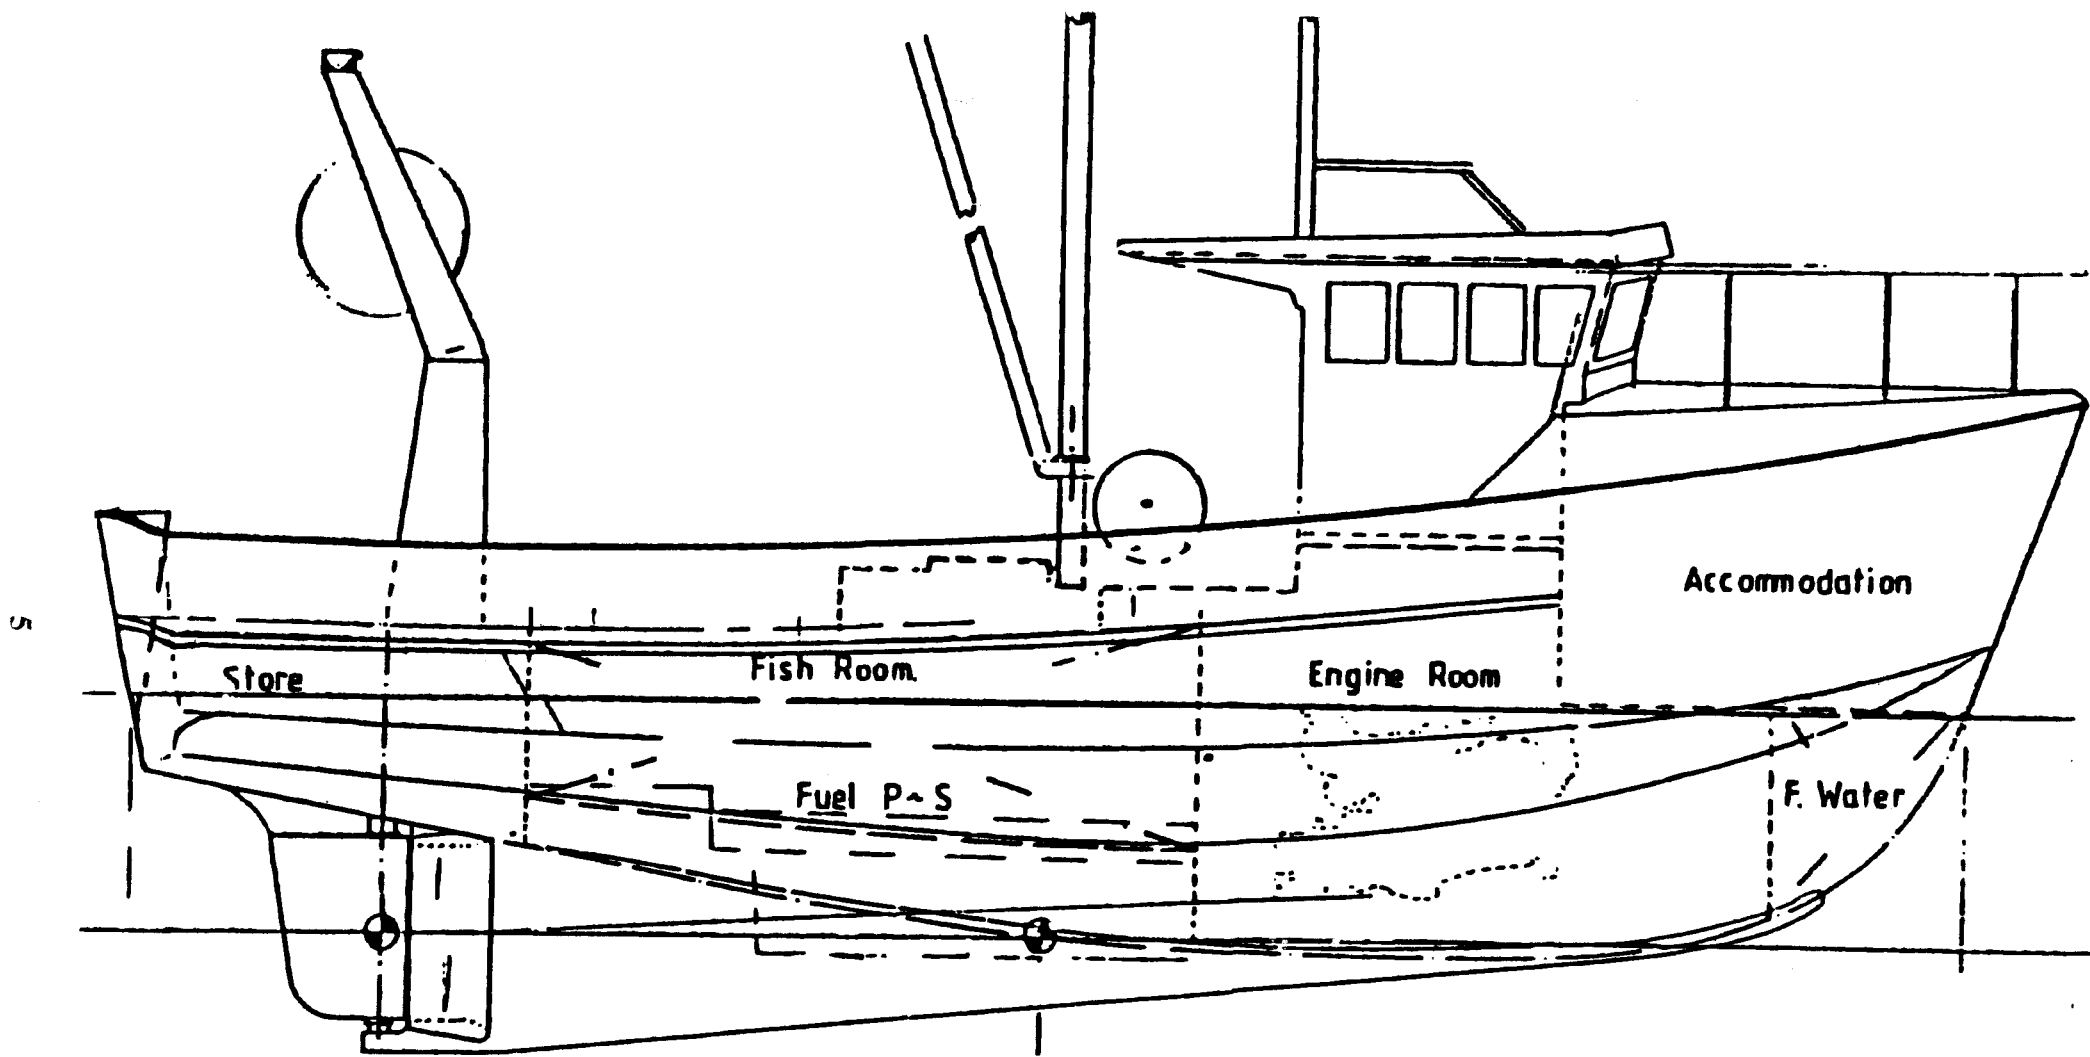
Layout of *Catrina*

On 4 September 1998 *Catrina* sank while alongside in Newhaven. The cause of the sinking was a leaking stern gland which was repaired by fitting a new stern tube to the vessel. To do this a large portion of the skeg had to be cut away and the ballast inside the skeg removed. Both were restored before the vessel was put back into service.

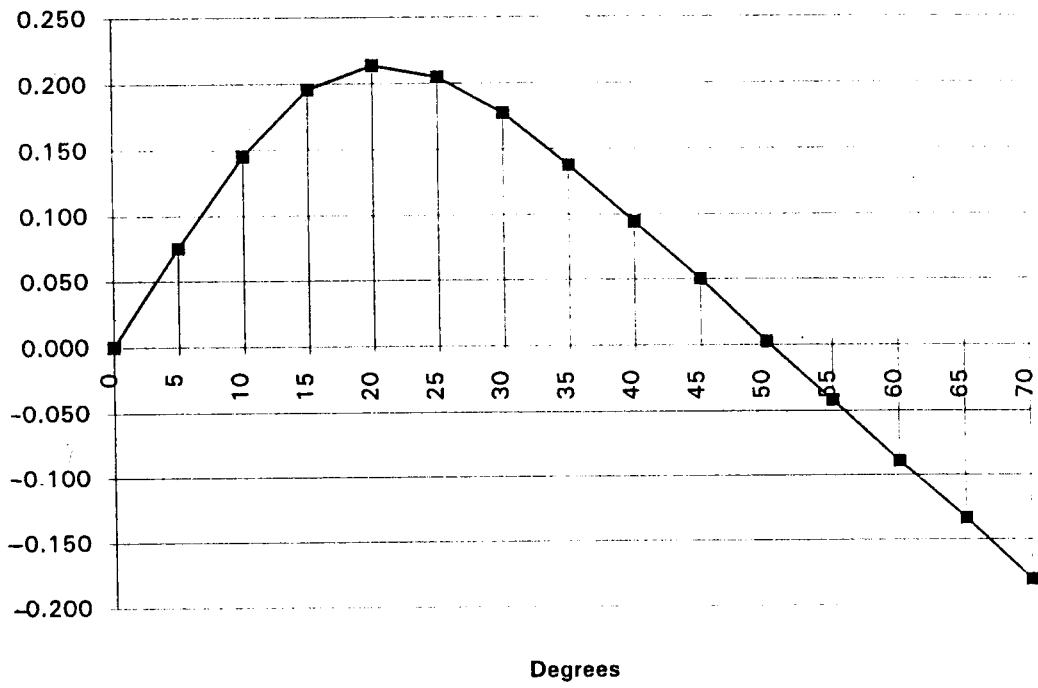
GZ Fluid Plot

The stability of *Catrina* did not meet the recommended minimum standard for beam trawlers (**Figure 8**). However, since the accident occurred while the vessel was on passage, it is probably more meaningful to compare her stability with that recommended for non-beam trawlers (**Figure 9**). This is because the extra margin of stability for beam trawlers was included for their more onerous fishing operations. *Catrina* still failed the criteria but, with the exception of the angle of maximum righting lever, only marginally. For this reason the capsizing of *Catrina* was most unusual.

The MAIB knows of no other fishing vessel of less than 12m registered length, and whose stability so nearly met the recommended standard, being overwhelmed solely by adverse sea conditions. This fact has led the inspector to question the validity of the earlier assumption that the stability of *Catrina* could be estimated reasonably accurately from that of *Carina* and to conclude that it was possibly substantially less.

STABILITY	SUMMARY	MINIMUM	ACTUAL
		BEAM TRAWL	
AREA UNDER GZ CURVE	UP TO 30 DEG	METRE RAD	0.066
AREA UNDER GZ CURVE	UP TO 40 DEG	METRE RAD	0.108
AREA UNDER GZ CURVE	BETWEEN 30-40		0.036
MAXIMUM GZ		METRES	0.213
ANGLE OF HEEL AT WHICH	MAX GZ OCCURS	DEGREES	25
MAXIMUM GZ BETWEEN	30 - 90	DEGREES	0.24
GM SOLID			0.871
FREE SURFACE CORRECTION			0.002
GM FLUID			0.42
			0.869
