Report on the investigation of  
a lifeboat accident on

**mv *Galateia***

Seaforth Docks, Liverpool

**Report No 25/2002**  
**July 2002**

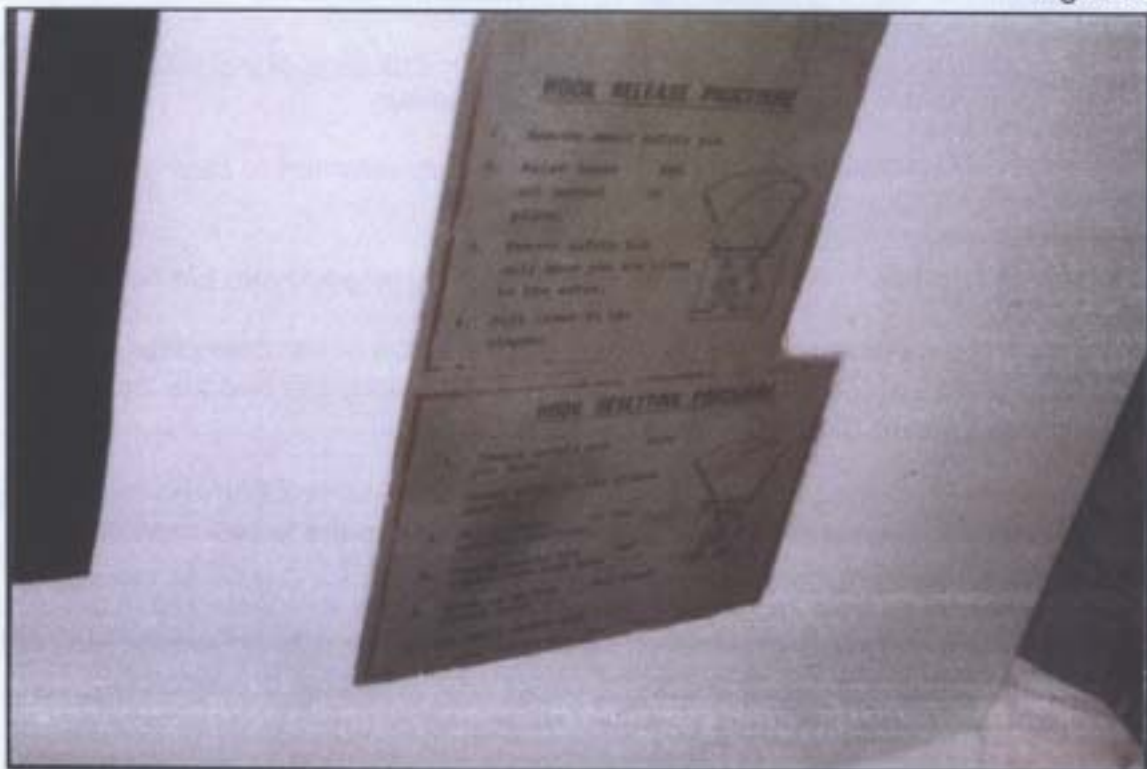
Figure 2

Operating instructions pasted on inside of lifeboat canopy

2.3.1 The lifeboat release instructions pasted on the inside of the lifeboat canopy were not very clear, nor were the item numbers clearly legible. In fact, some of the item numbers had completely worn off. As these are critical in identifying the order in which the procedure is to be followed, their loss greatly increased the chances of a mistake being made. The warning notice, which was part of the instructions supplied by the manufacturing company to the MAIB, was not included in the procedural notices pasted on the internal lifeboat canopy. That notice included a pictorial illustration of the correct cam plate position, as well as the correct position of the locking pin before lifting. The lifeboat manufacturers subsequently confirmed that this "Warning" notice was sent out in August 1997 to all users who could be identified. *Galateia's* owners could not be found at that time and, therefore, no notice reached them, hence the omission. That omission has since been rectified and "Warning" notices have been sent to the vessel for inclusion in the safety manual and to be pasted on the inside of the lifeboat canopies.

While waiting for the exercise to start, neither the master nor the chief officer read or studied the instructions and procedures pasted on the lifeboat canopy. Although those instructions were well worn and difficult to understand, it was still possible to see that there was a second small safety pin mentioned in the procedure. That fact alone should have caused them to delve deeper into how the whole operation worked. Unfortunately, they also failed to study the ship's safety manual - this also contained detailed instructions as to how the system was operated and how it worked.

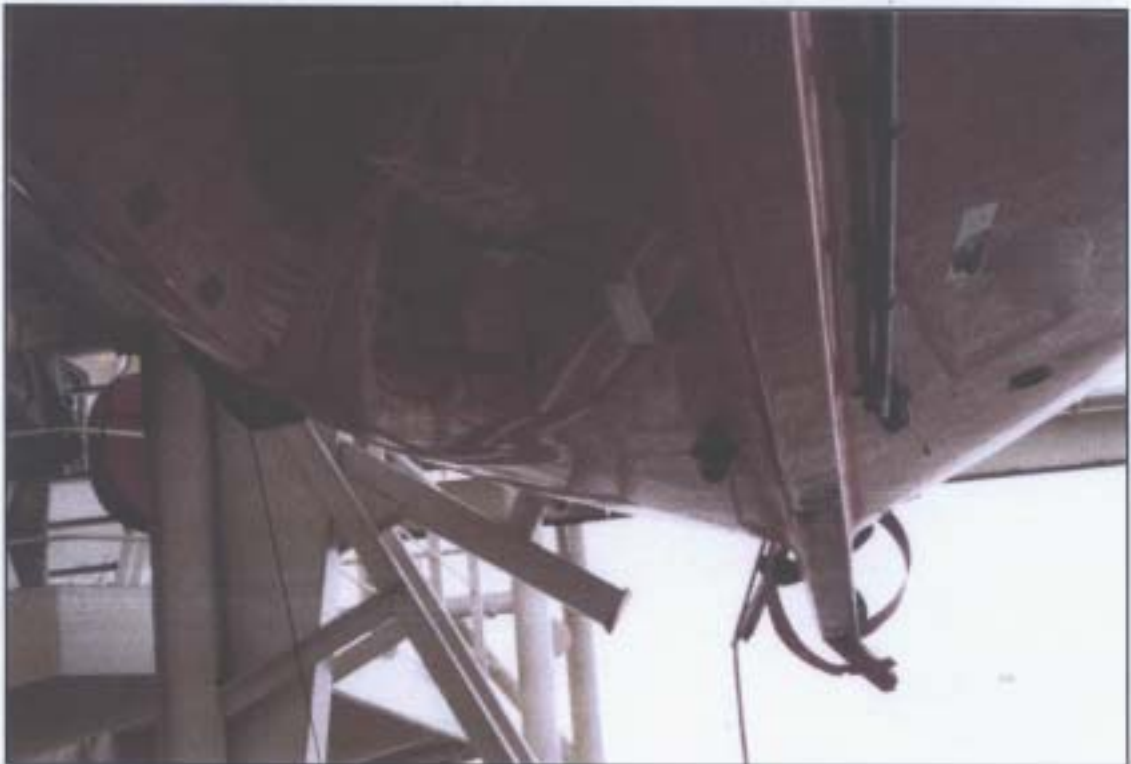
Figure 14 - Damage to hull due to striking deck equipment during fall

An examination of the lifeboat showed that the rudder, propeller guard ring and skeg were damaged, with scrape marks and two hull penetrations; one on the port side and one on the starboard side. Additional hull damage may become evident during detailed examination at the repair yard. Some damage was also present on the aft end of the canopy together with apparently minor damage to internal fittings.
