Report on the investigation of  
a fatal accident on board  
***Gemma Fidelis (GY 419)***  
9 miles east of the River Tees  
on  
23 October 2001

Marine Accident Investigation Branch  
First Floor  
Carlton House  
Carlton Place  
Southampton  
United Kingdom  
SO15 2DZ

**Report No 24/2002**  
**July 2002**

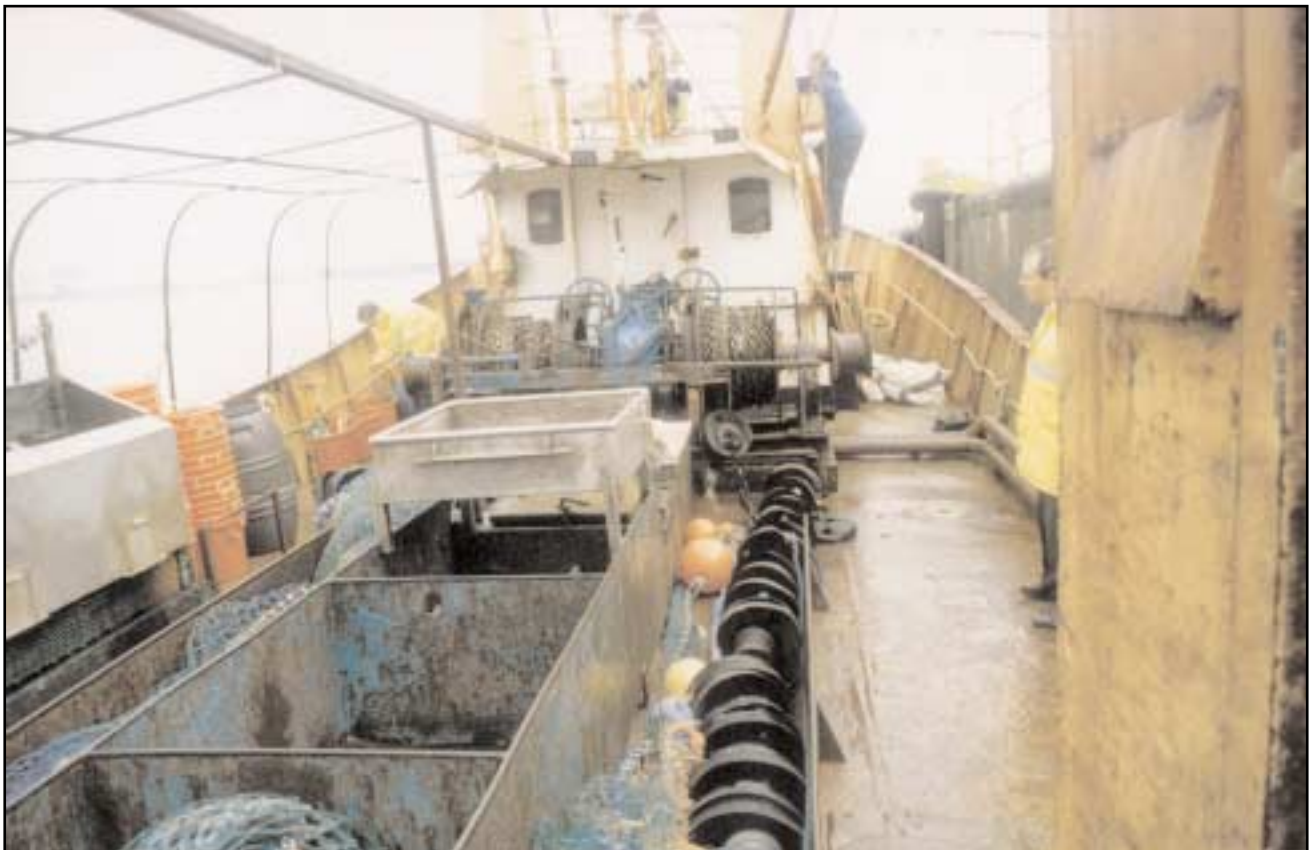
Figure 2

On the main deck the wheelhouse was situated forward. Immediately aft of the wheelhouse was the main trawl winch and working deck, which incorporated centre pounds and longitudinal channels for storing the trawl and ground gear when in the hauled-on-deck position (**Figure 2**).

Aft deck
