Report on the investigation of  
the cargo shift, abandonment, and grounding of

***mv Kodima***

in the  
English Channel

**Report No 1/2003  
January 2003**

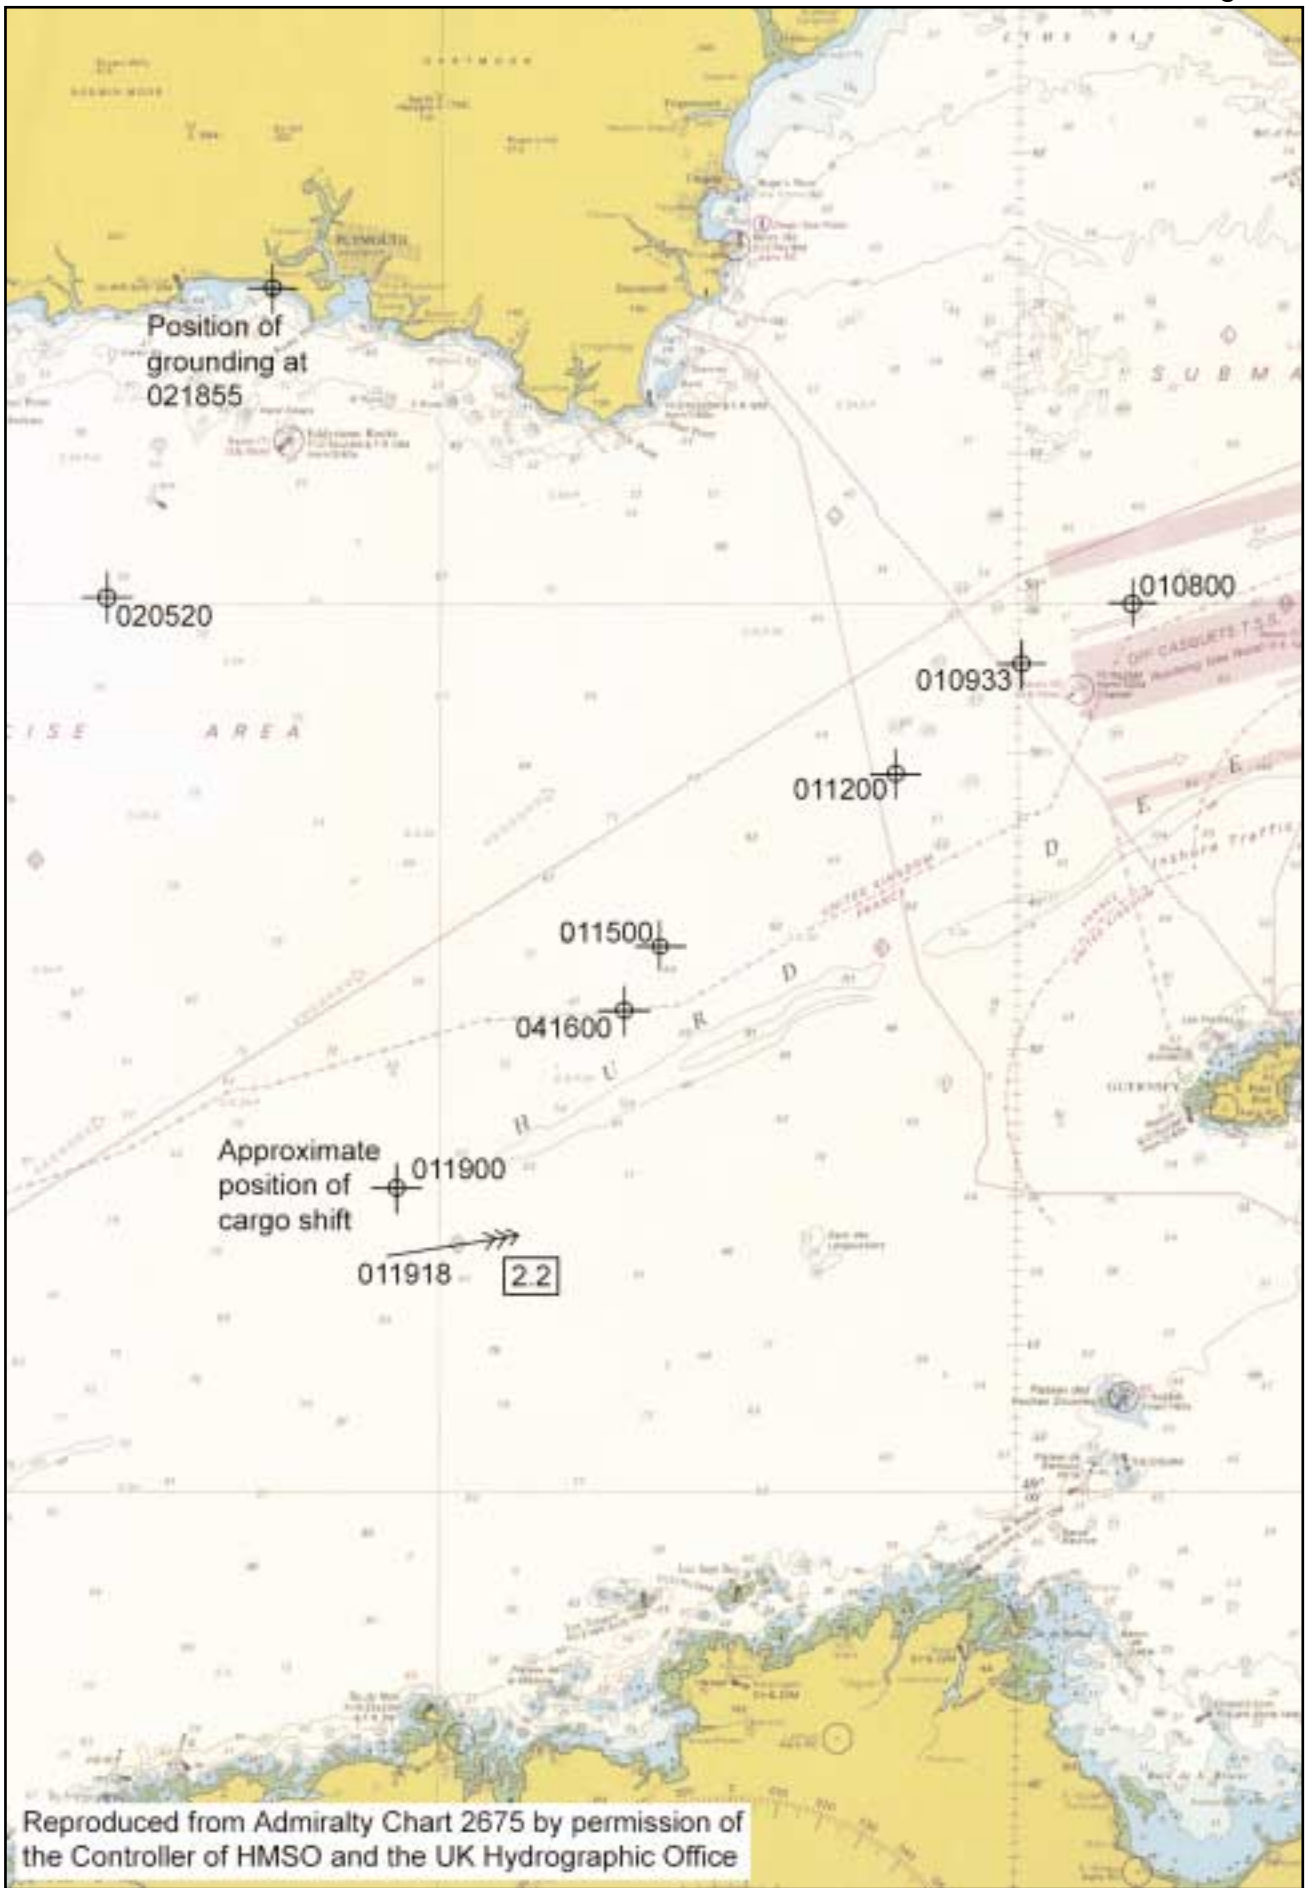
Approximation of *Kodima's* track

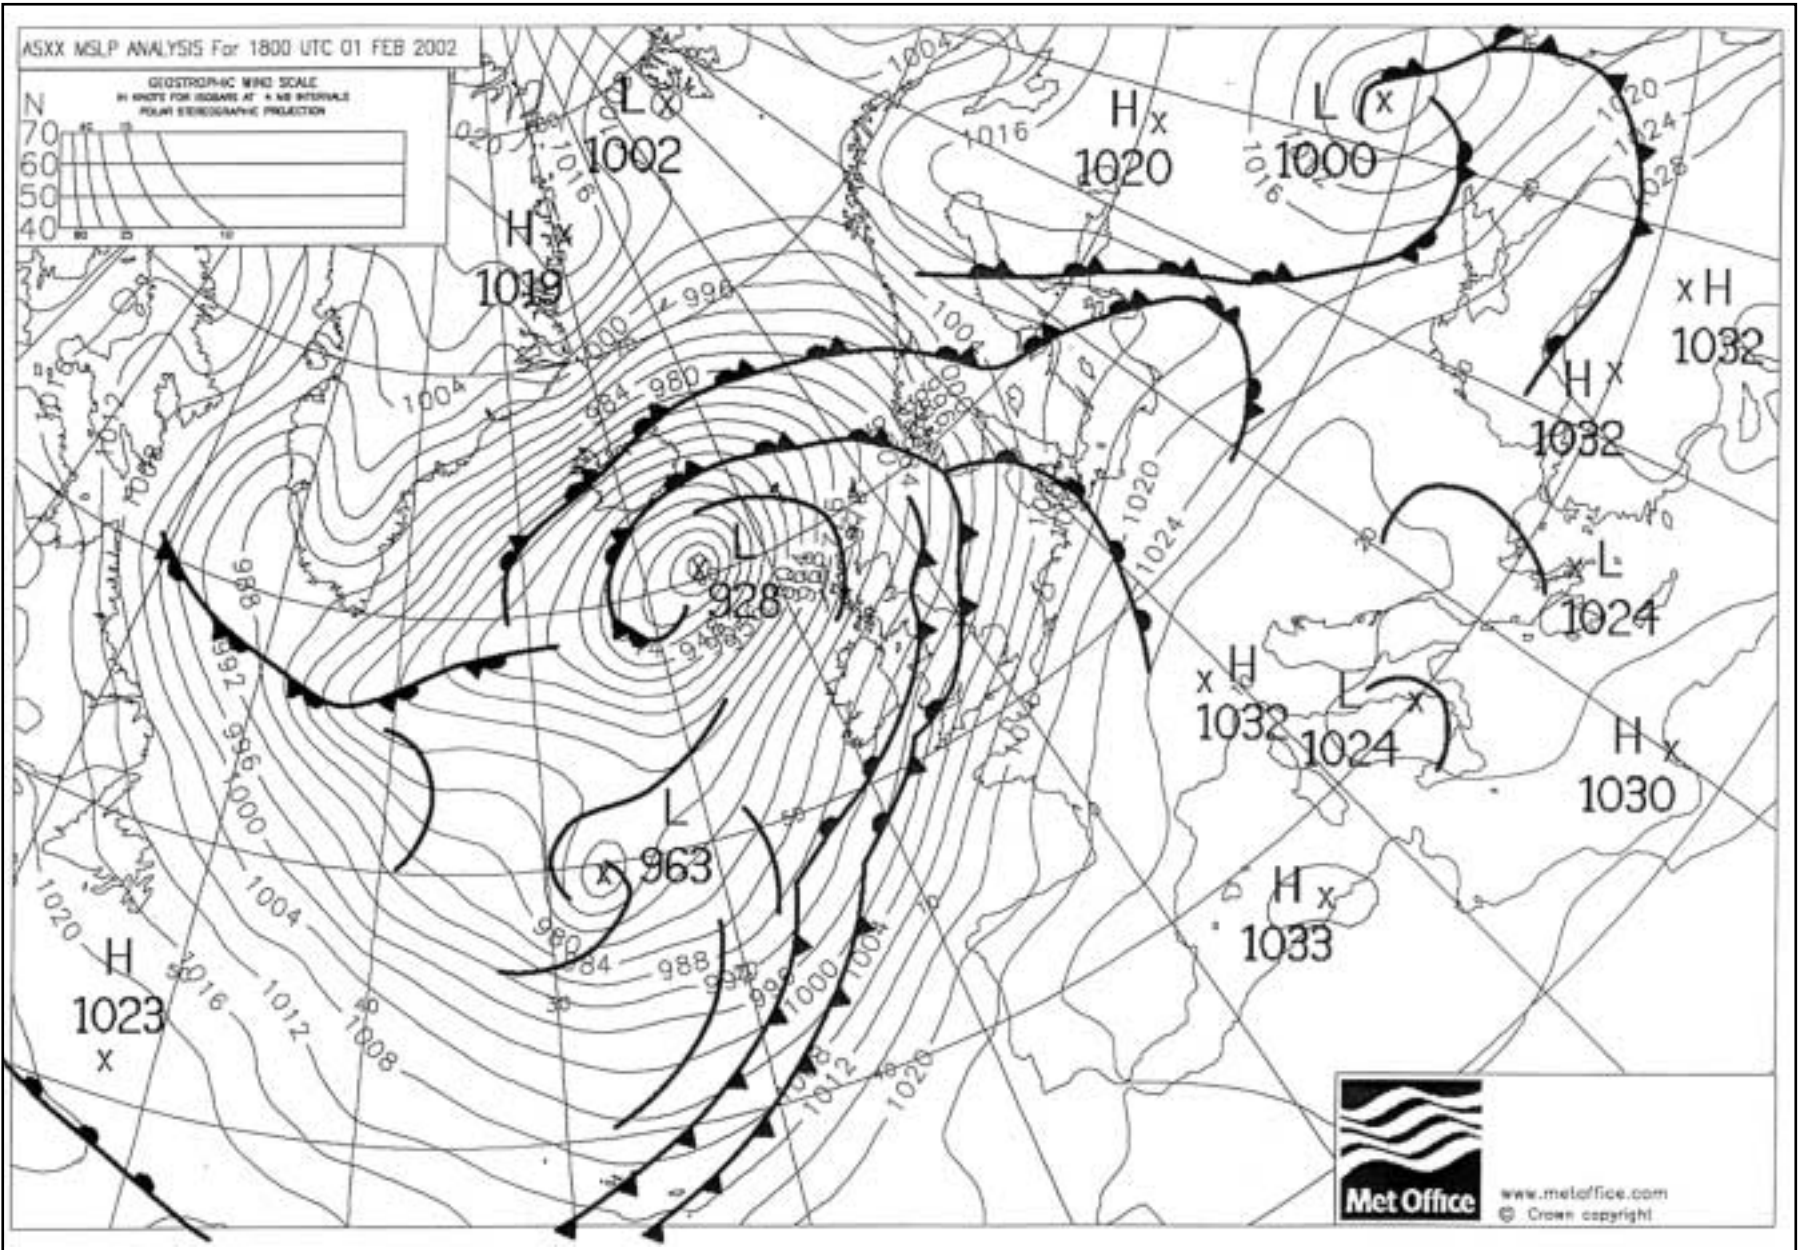
Figure 2

The surface analysis, and its corresponding model of winds and significant wave heights for 1800 on 1 February produced by the MO (**Figures 2 and 3**), show that wind was south-west gale force 8 gusting 9, and that the expected significant wave height was between 6m and 7m. Wind speeds recorded in the deck log indicate that the wind gusted to between storm 10 and violent storm 11 on occasions. Sunset was at 1708, civil twilight was at 1746, and nautical twilight at 1825. Moonrise was at 2021. It was spring tides, HW Dover was at 1328, and *Kodima* was in the influence of a south-westerly tidal stream until about 1830, when it turned east-north-easterly. At the time of the cargo shift, the rate of the tidal stream was about 1.5 knots.

Surface analysis for 1800 UTC on 1 February 2002

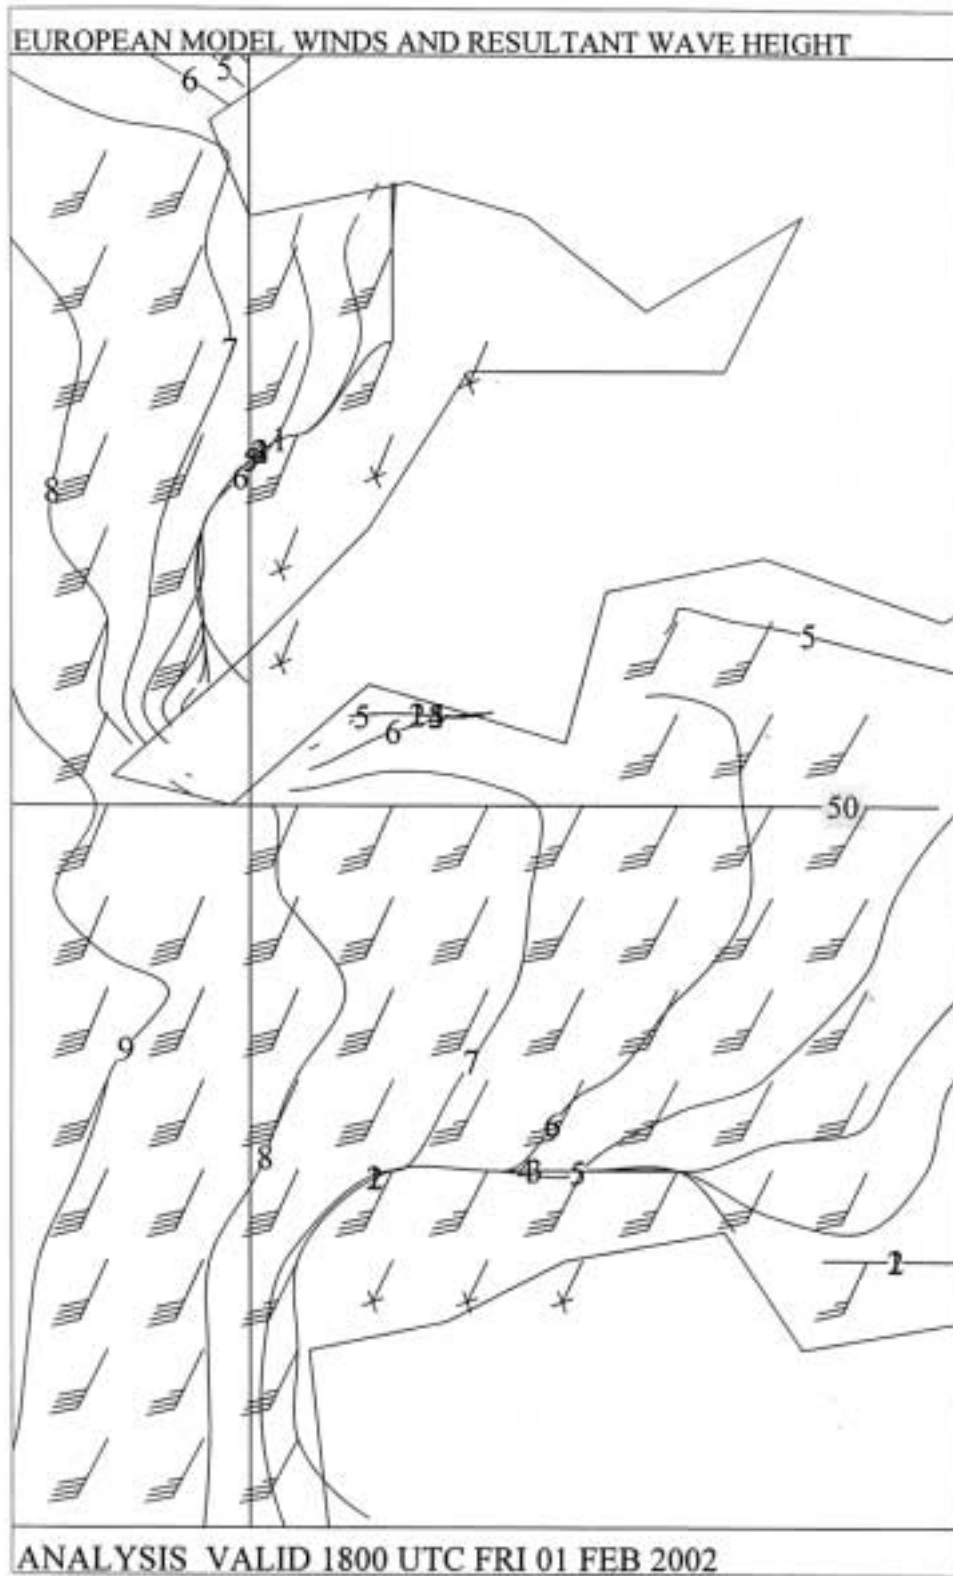
Diagram showing predicted significant wave heights at 1800 on 1 February 2002

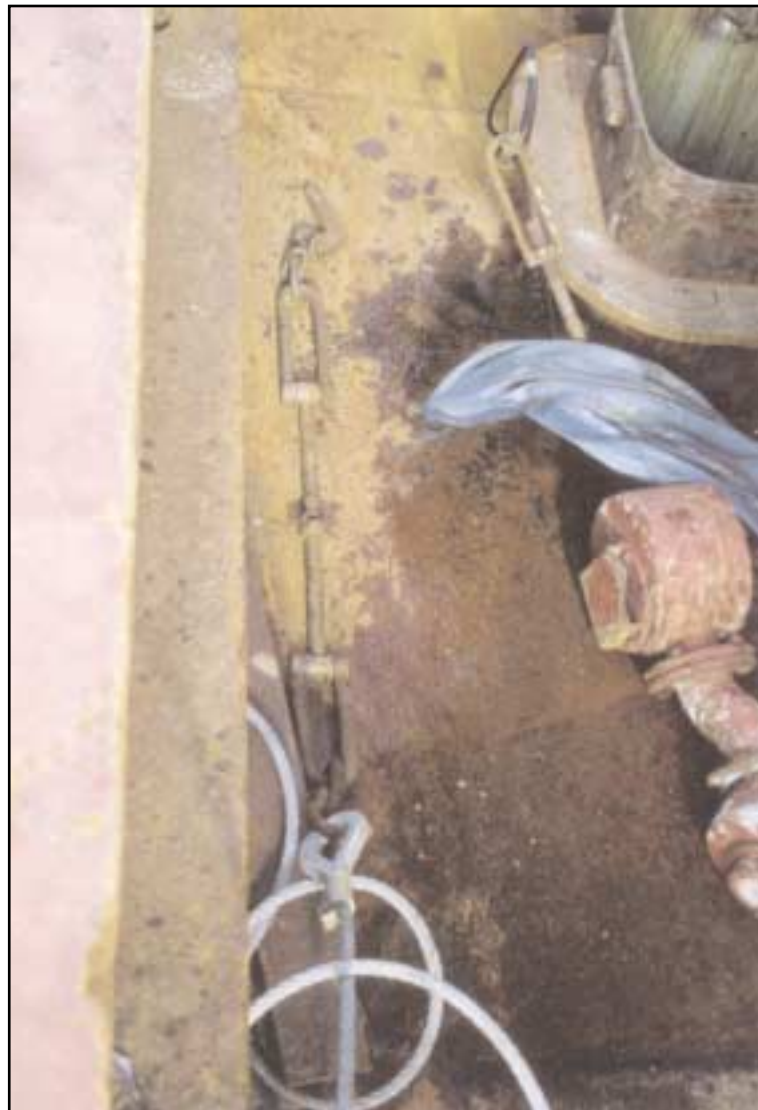
Figure 4

Forty-four lashing wires, secured to strong points on the deck at intervals of about 1.5m, were fitted. The wires were of 16mm diameter and were tested and certified in 1997 by the Russian Register of Shipping. Integral to the wire lashings were a turnbuckle to allow tightening, a pelican hook for quick release, and chain for adjustment of length (**Figure 4**).

Photograph showing wire lashing with turnbuckle and pelican hook

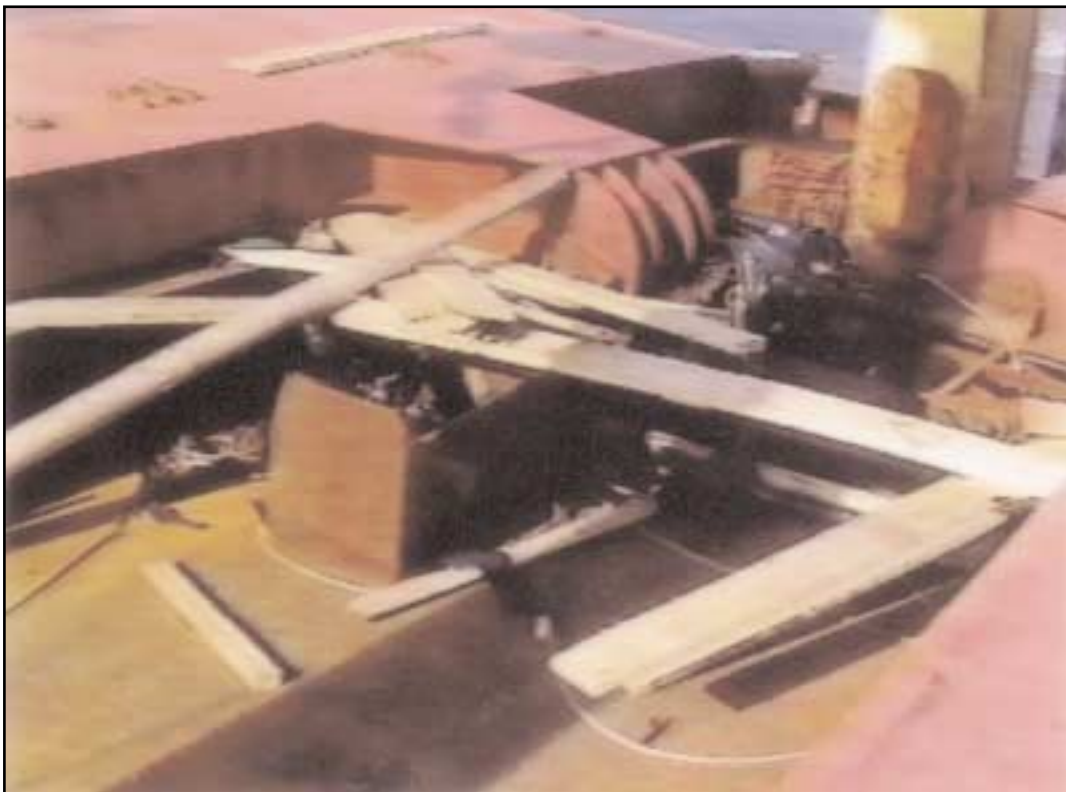
Loading of the holds was completed on 23 January. Before loading on top of the hatch covers could begin, however, it was necessary to place packages in the wells between the hatches (**Figure 5**), and on deck between the hatch comings and the bulwark (**Figure 6**) to facilitate a level stow and avoid large void spaces.

Photograph showing space between hatch hold covers

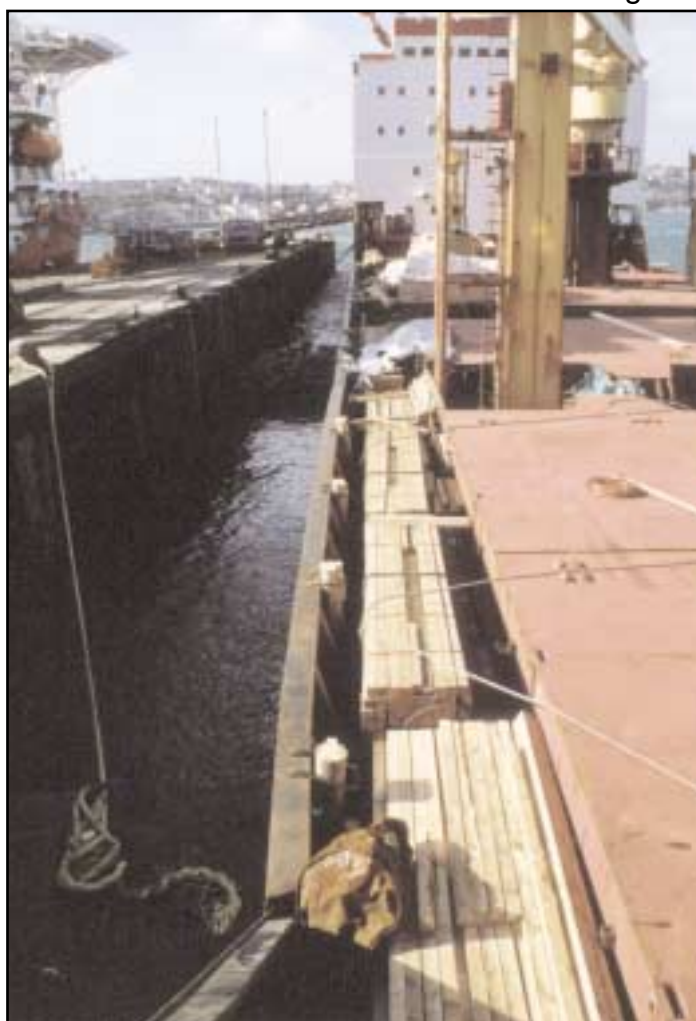
Figure 6

Photograph showing packages placed between the bulwark and hold hatch covers

The achievement of a compact stow, when loading timber cargoes, is essential, but can also be extremely problematic. In this case, difficulties were caused by the difference in height between the deck and the top of the hatch covers (**Figures 6 and 15**), the presence of the wells between the hatches (**Figure 8**), the numerous obstructions in the stowage area (**Figure 15**), and the differing lengths of the timber packages. Although such difficulties made the presence of some void spaces unavoidable, appropriate measures to keep these to a minimum appear to have been taken, and there is no evidence to suggest that the stow was not compact. In particular, the repacking and placement of timber packages in the gaps between the bulwarks and hatch coamings was a prudent action to take.

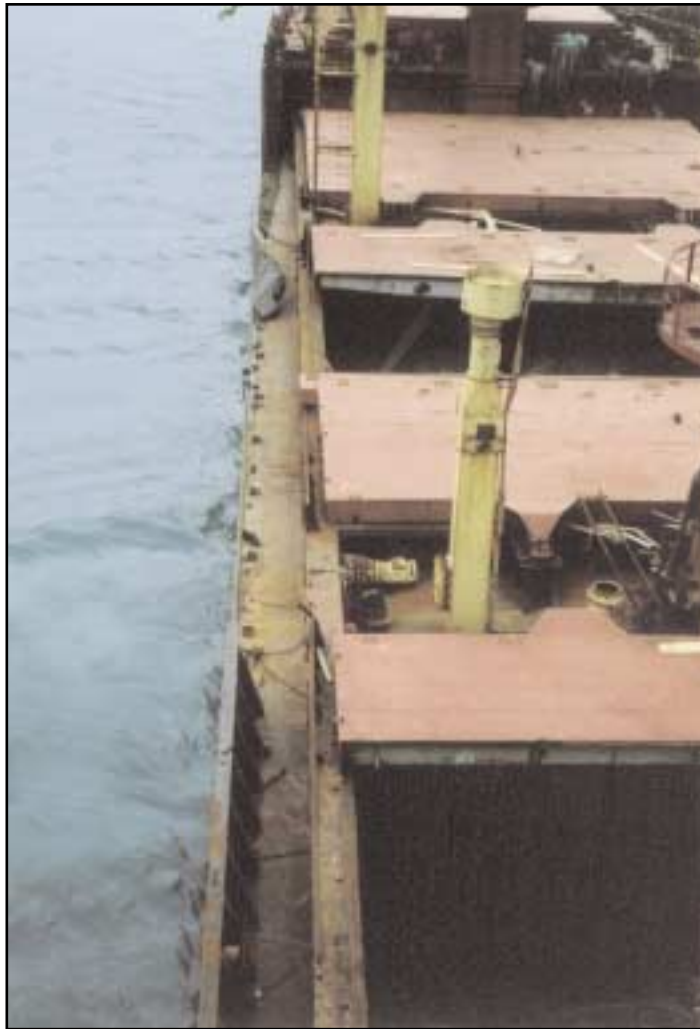
Figure 7

Two gangs of stevedores were used, one starting at the forward end of No 2 hold hatch cover, and the other starting at the aft end of No 4 hold hatch cover. Both worked towards each other. Packages were packed around obstructions on the deck, including hold air vents (**Figure 7**), over sounding pipes (**Figure 8**), and dunnage was placed on top of the packages located between the hatch coamings and ship's-side bulwarks to keep the stow level. Other than in the wells between the hatches, all of the timber packages were stowed longitudinally and, after the first tier had been loaded, the stevedores placed 5cm thick dunnage along the outer edge of the stow in order to angle the outer packages inboard slightly. Three tiers of timber packages were stowed on the hatch cover to hold No 2, and four tiers on the hatch covers to holds No 3 and No 4, with fewer packages being used on the uppermost tiers. The chief officer estimated that the height of the deck cargo was slightly less than 4m above the hatch covers. The length of the stow was about 66m, being from immediately forward of the main superstructure, to aft of the forecastle housing.

Photograph showing hold air vents

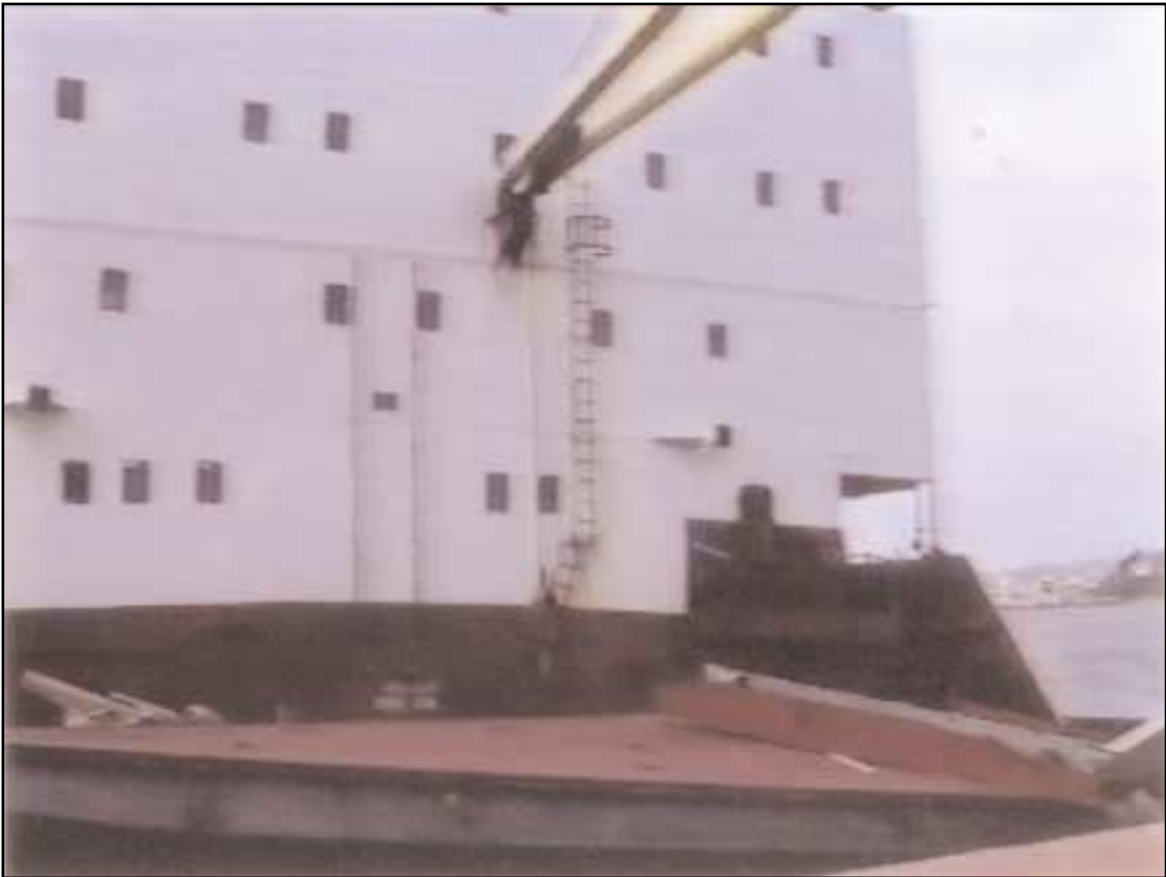
The deck cargo filled the fore and aft passageways on both sides of the ship in way of the hatch covers to holds No 2, No 3, and No 4, and as the ship did not carry equipment to provide secure and safe access along the length of the stow, none was rigged. Access to the forecastle was via a ladder at the front of the main superstructure (**Figure 9**) then across the top of the deck cargo.

Photograph showing ladder used to access the top of the timber deck cargo
