Report on the investigation of failure of

lifeboat winch brake on

***Marine Explorer***

**Report No 2/2002**  
**January 2002**

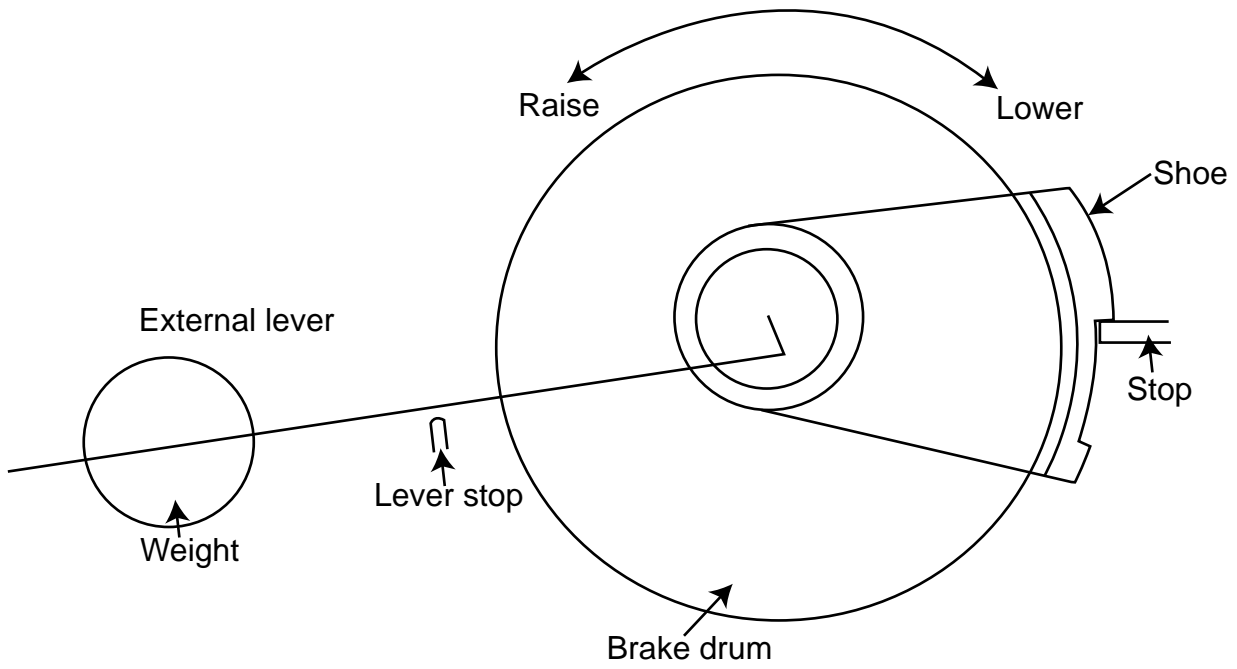
Figure 5

- drum mounted on brake shaft;
- sector shaped shoe bearing on the outer surface of the drum;
- eccentric; and
- external hand lever (**Figure 5**).

Gravity on hand brake system with brake applied

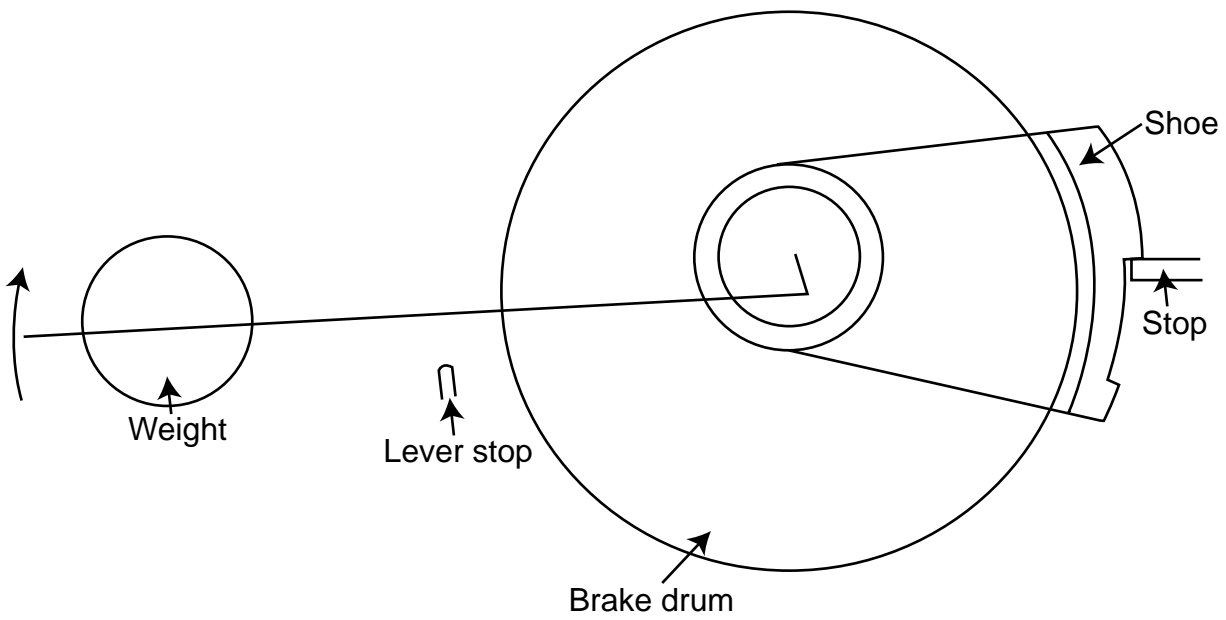
Figure 6

Also mounted on the eccentric, but housed behind the brake casing's cover, is the brake shoe. The eccentric passes through the brake cover and transmits motion of the handle to the brake shoe. Lifting the handle moves the shoe radially, outwards, so freeing it from the drum (**Figure 6**). As the shoe acts on the outer diameter of the drum, releasing the lever pulls the shoe on to the drum and applies the brake.

Brake released by raising lever

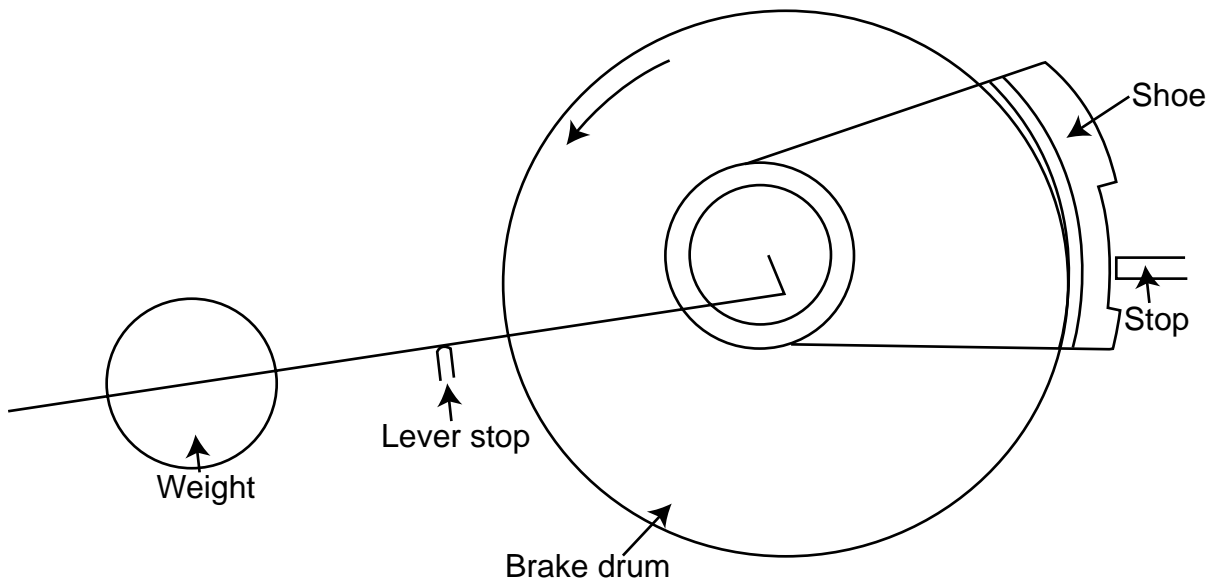
Figure 7

This stop not only limits the shoe's movement when the brake is applied, but it also retains the shoe in position when the hoisting motor is operating under power. The geometry of the eccentric and brake shoe causes the shoe to lift when the motor is turning the brake drum. Only a small amount of lift is required to release the shoe from the drum and thus also release the brake (**Figure 7**). Excessive lift is prevented by the stop. This allows the winch to hoist freely.

Automatic release of brake when hoisting
