Report on the investigation of the loss of

***Vertrauen (BF 450)***

19 July 2001

**Report No 29/2002  
August 2002**

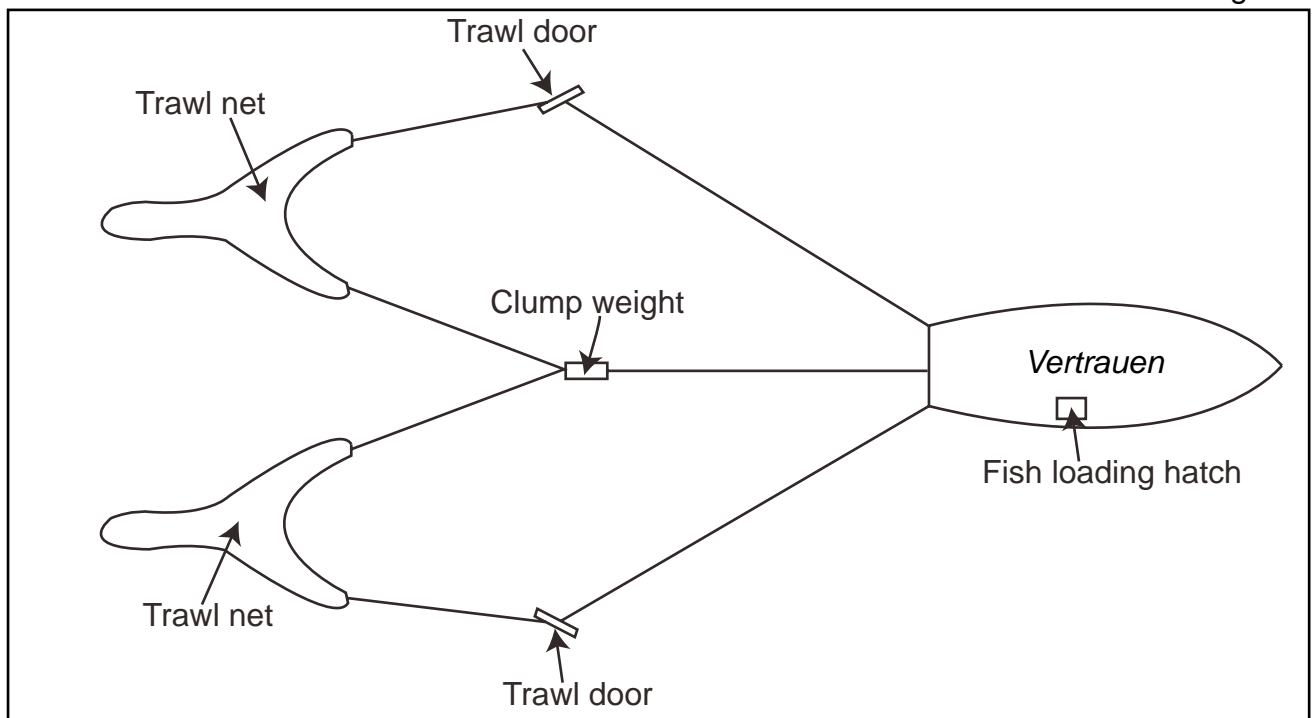
Figure 8

*Vertrauen* used a twin trawl deployed from the stern (**Figure 8**). A bottom trawl was used, and prawns were the main catch on her final fishing trip. The trawls were stowed on net drums located on the aft deck. When the net was on board, it was handled mainly using a crane, on the end of which was a rotating drum, referred to as the power block. The net was deployed over the side using the power block. Once the net was streamed aft, it was controlled by the winch, to which were attached the two trawl warps. The trawl was usually towed for about five or six hours. When the tow was finished, the gear was hauled using the winch. When the gear was on the surface, the power block was used to move the starboard trawl from aft to the starboard beam. The gilson was then attached to the cod end, and the catch was lifted by hauling the gilson through a

Diagram of twin trawl arrangement
