Report on the investigation of
the collision between

Amenity and Tor Dania

South of Grimsby Middle, the River Humber, UK

**Report No 20/2005
November 2005**

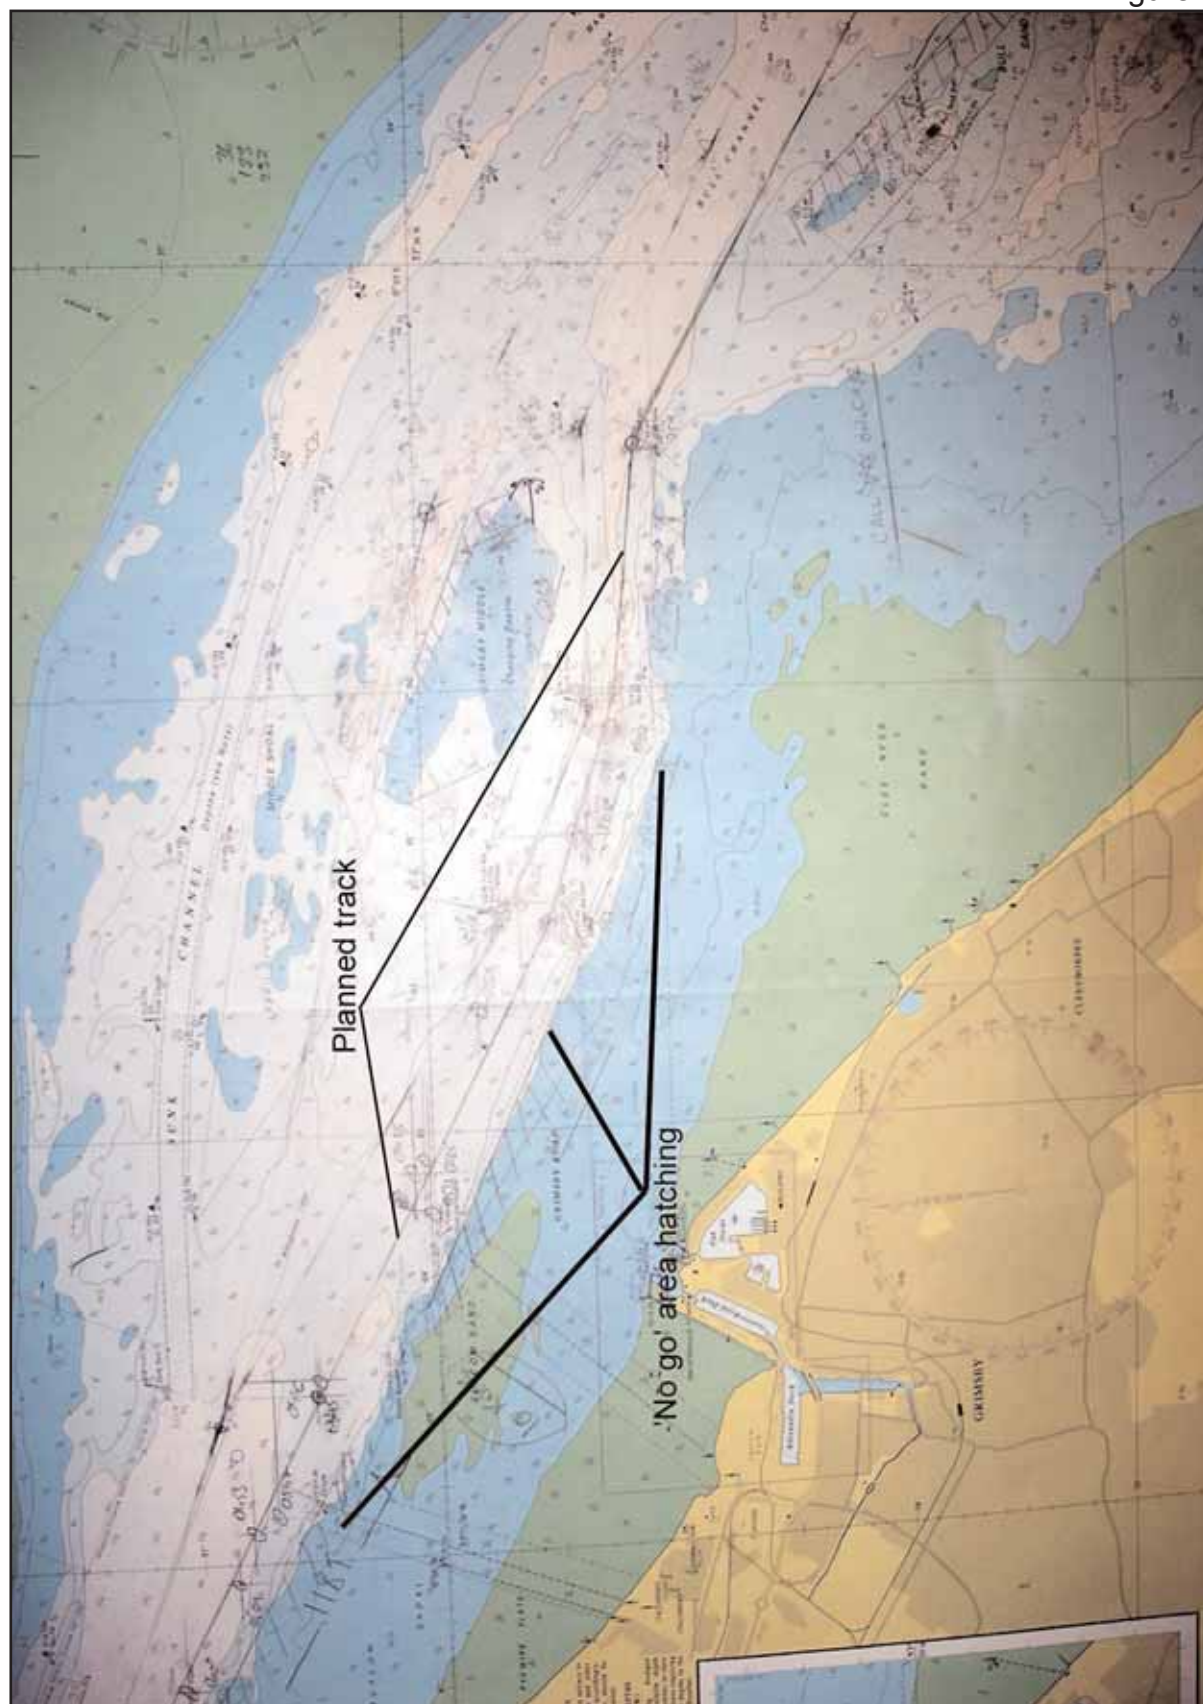
Figure 4

Chart in use on Amenity

In this perceived emergency situation, *Amenity's* master's decision to go astern is questionable. The decision was based on the fact that he thought that *Tor Dania* was now on a collision course and crossing his bows from port to starboard. His chart (**see Figure 4**) shows that he had hatched off all charted depths less than 5m, from the contour lines on both sides of the channel.

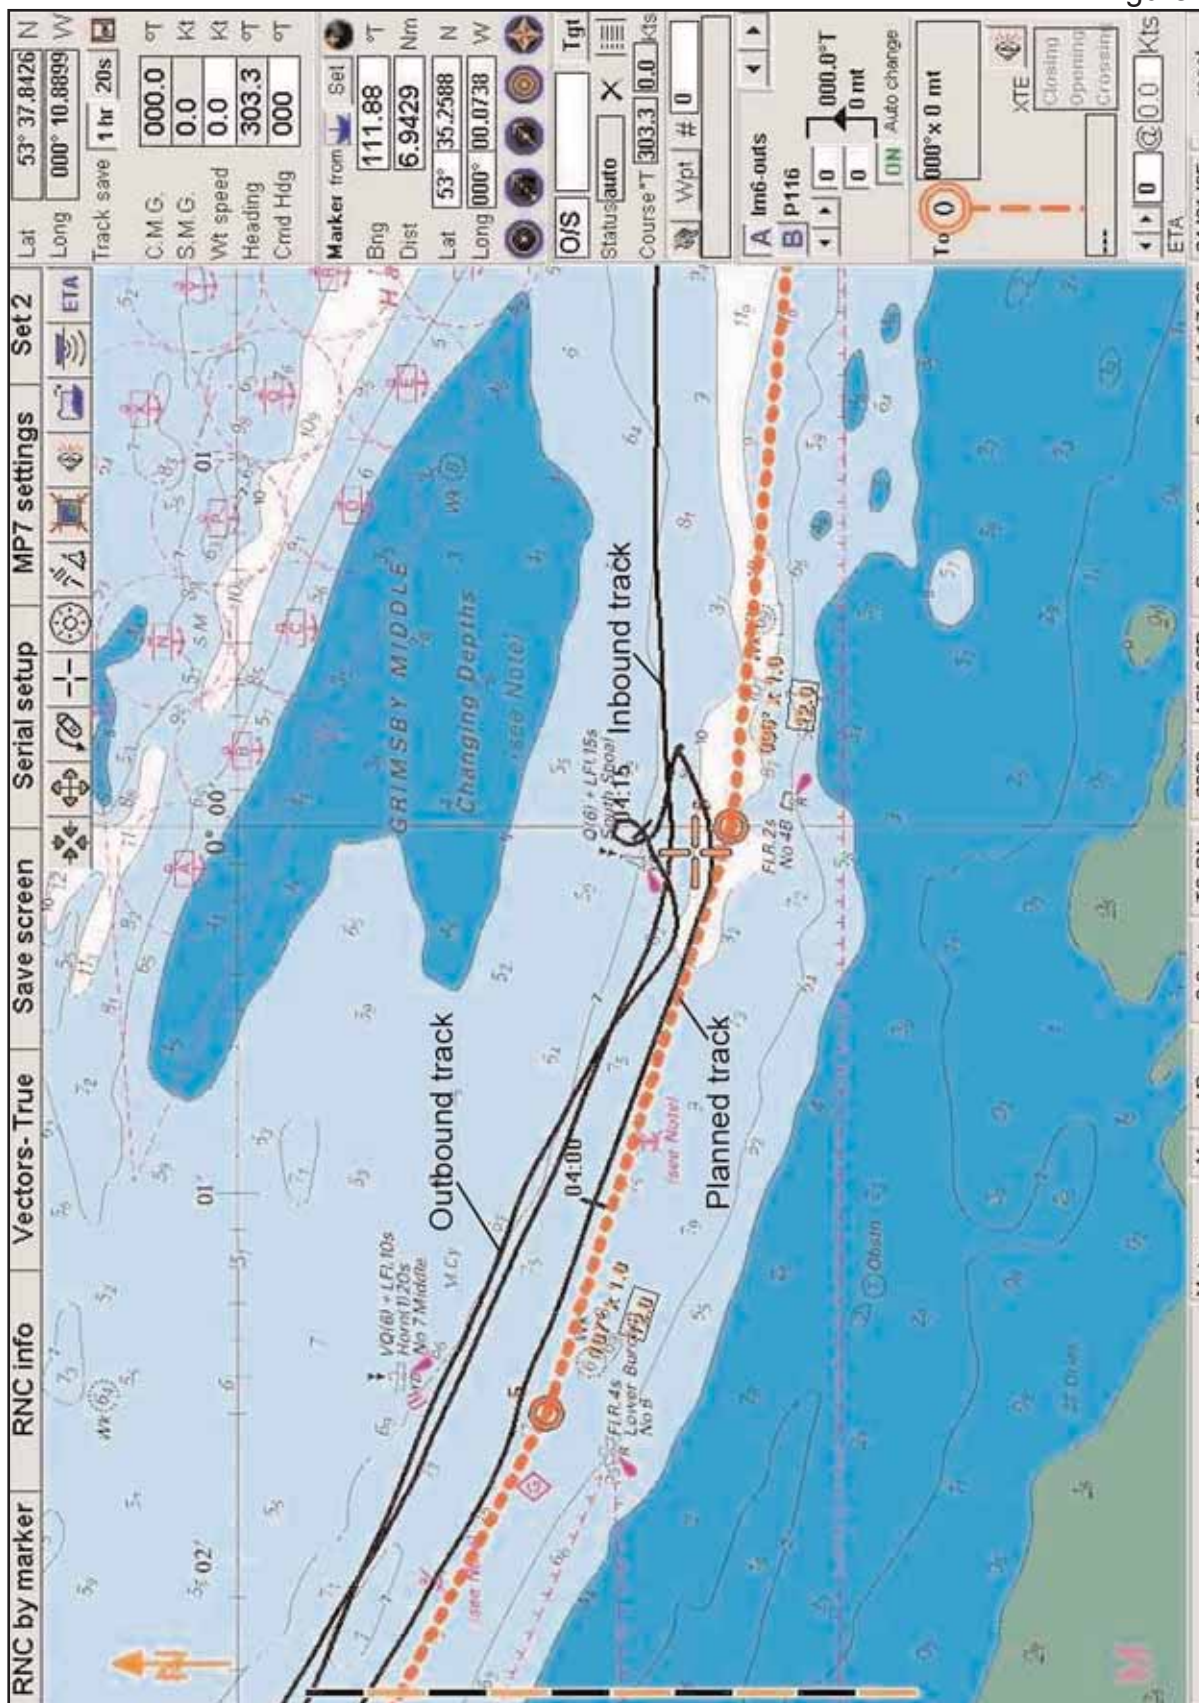
Figure 5

The master was acquiring radar targets ahead to monitor their speed and heading and the risk of collision. However, he was not overlaying radar targets on the ECS or making use of the available Automatic Identification System (AIS) information. The ECS displayed the planned track and waypoints as shown in **Figure 5**, a screenshot taken from *Amenity*'s ECS taken after the accident.

Screenshot from Amenity ECS

Amenity was equipped with a Microplot 7 Mariner ECS supplied by Sea Information Systems Ltd. This had recorded positional data over the preceding 24 hours. However, it was not possible to replay this data dynamically, although a static screen shot was available. This showed the vessel's planned and actual track, both at the time of the accident and on her inbound passage to IOT. It is shown in **Figure 5**.

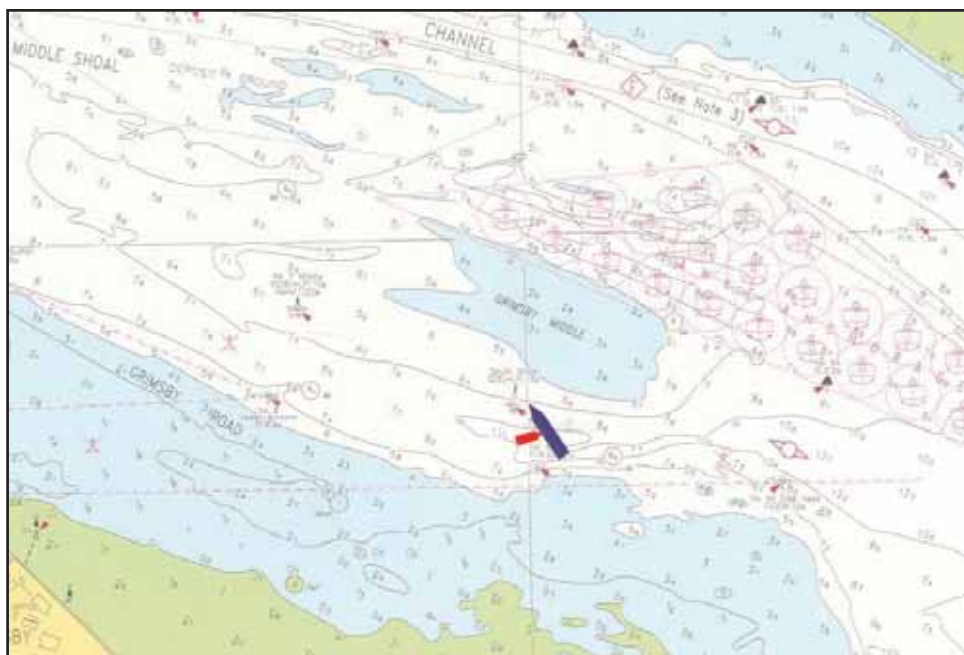
Figure 10 - 0407:50

At 0407 (**Figure 9**), the master of *Tor Dania* noticed *Amenity* starting to alter course to port, and initially he thought that she was making her turn for the No.4B buoy. However, when the vessel continued to alter course, he realised that a collision was inevitable, and ordered the helm hard to starboard to reduce the angle of impact. The collision occurred about 30 seconds later (**Figure 10**), and at 0407 50 *Tor Dania*'s master reported the collision to VTS.

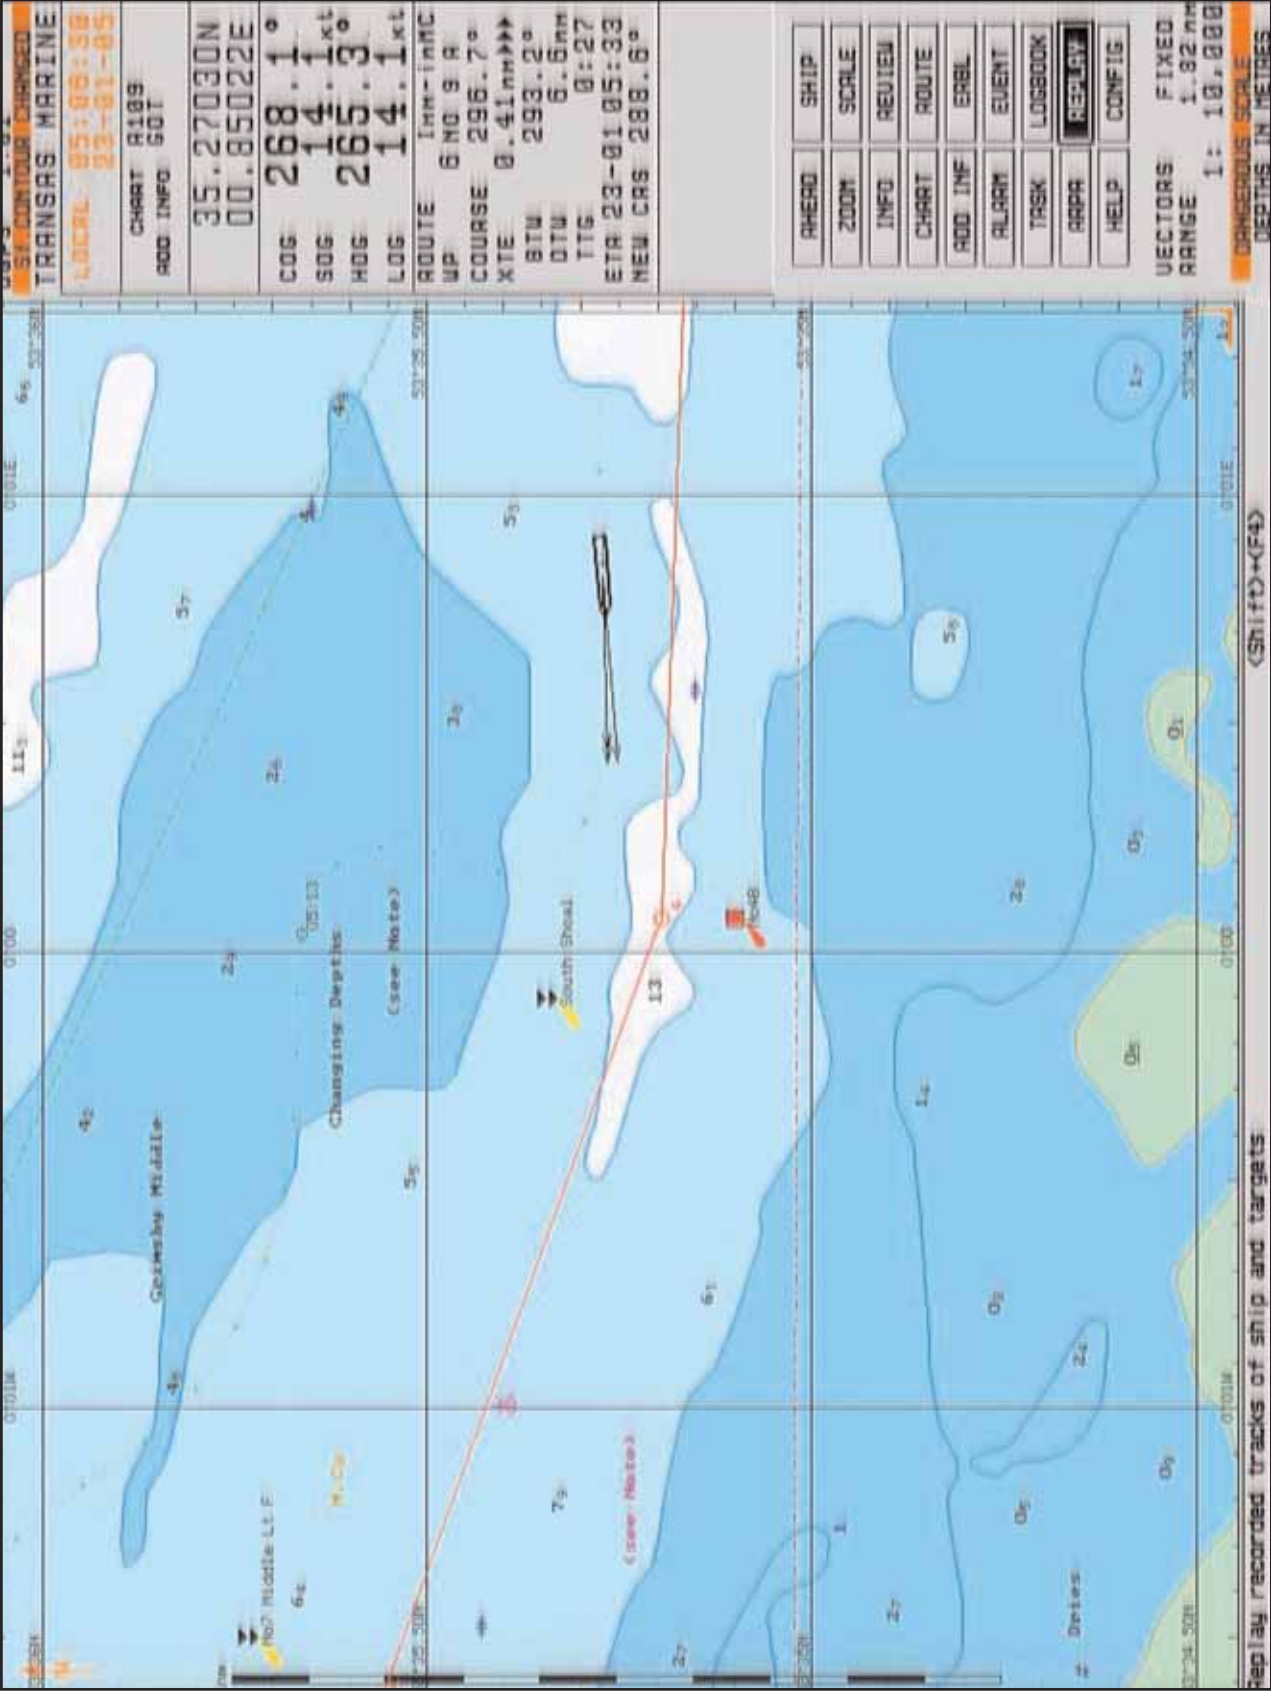
Figure 11a

At 0406 (**Figure 8**), *Tor Dania*'s master altered course to port to clear South Shoal buoy. *Tor Dania* overshot the turn fractionally, coming round to about 264° before adjusting course a little to starboard to pass close to the south of the South Shoal buoy. The vessel was to the north side of the channel, making good 14 knots. A snapshot taken from the vessel's ECS display is shown in **Figure 11a**.

Screenshot from Tor Dania's ECS showing position, course and speed at 0406

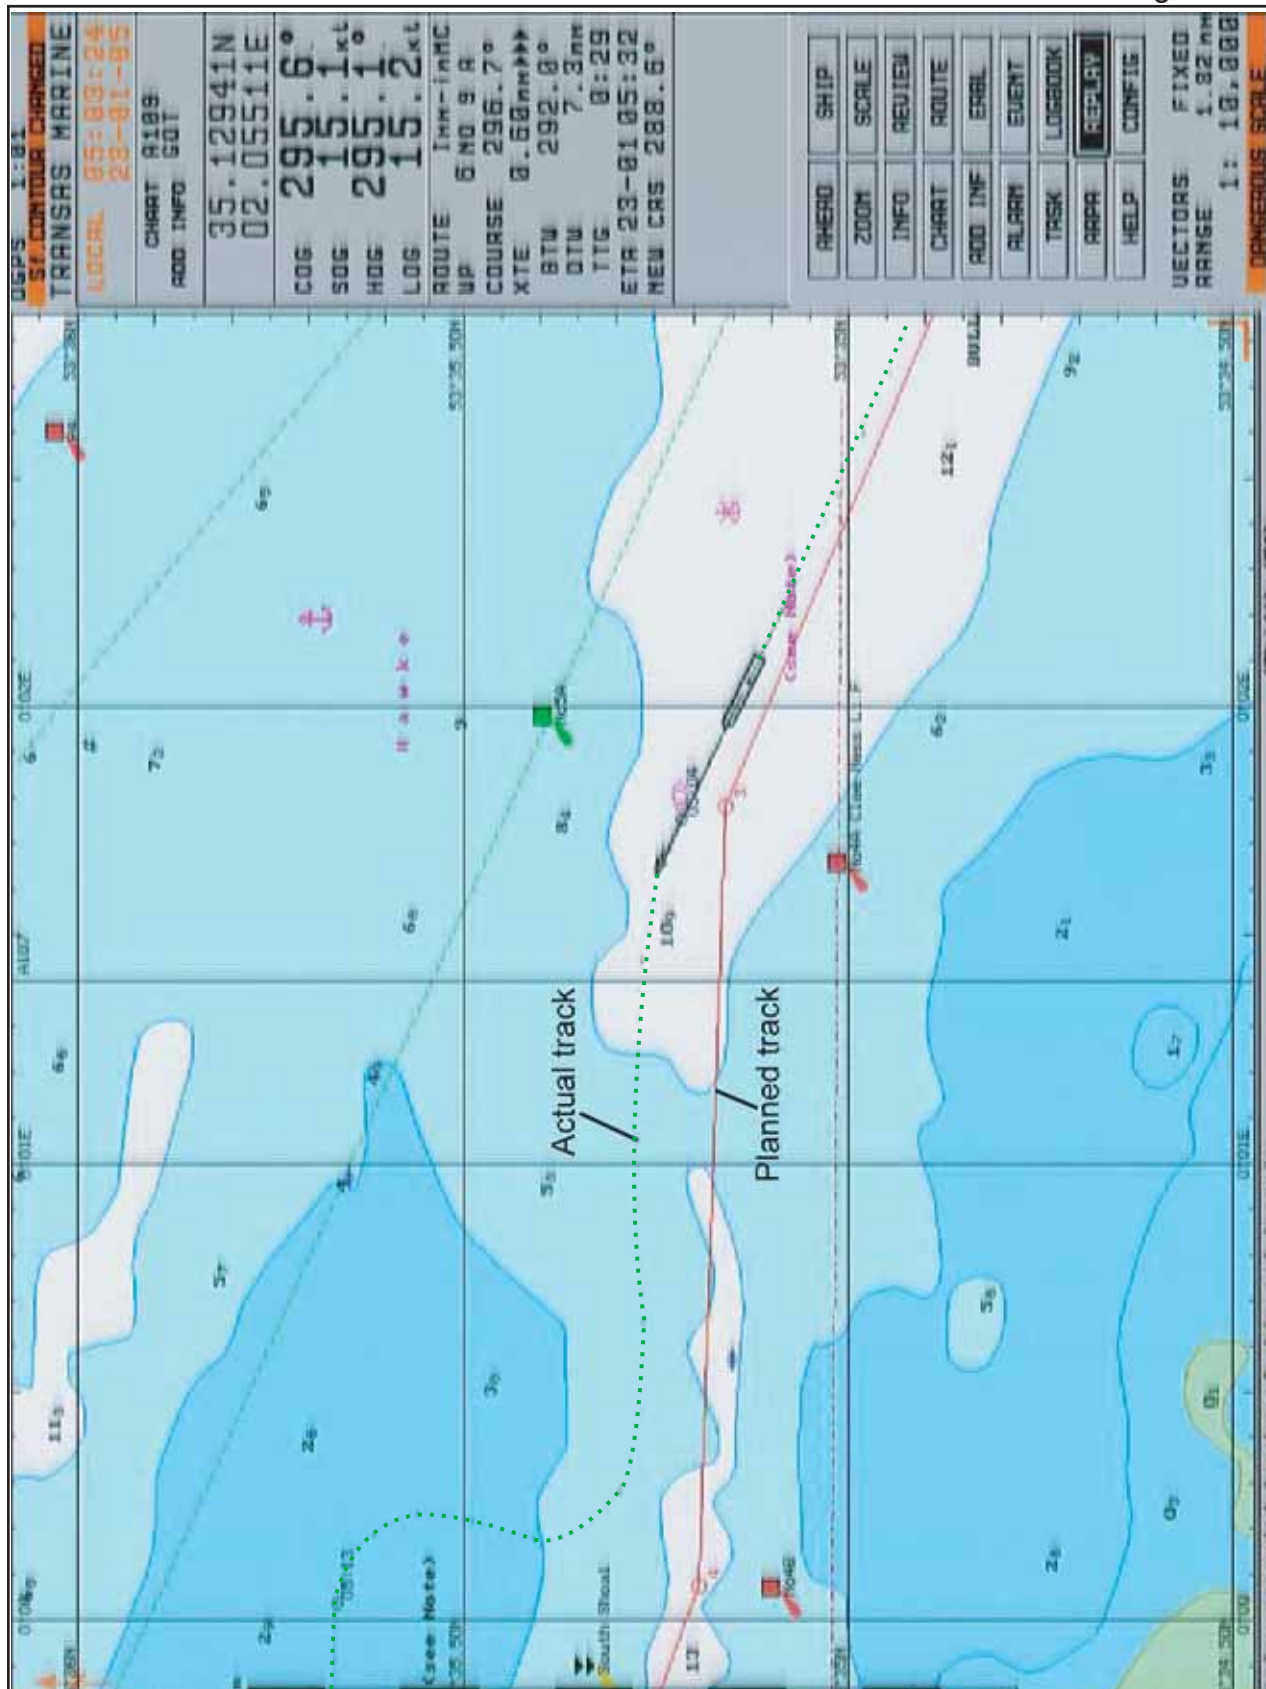
Figure 11b

The above information was available on board *Tor Dania* as a real time playback, superimposed over the Transas vector charts. The MAIB was able to take a copy of this playback for further analysis. A snapshot is shown in **Figure 11b**.

Screenshot from *Tor Dania's* ECS showing intended and actual track

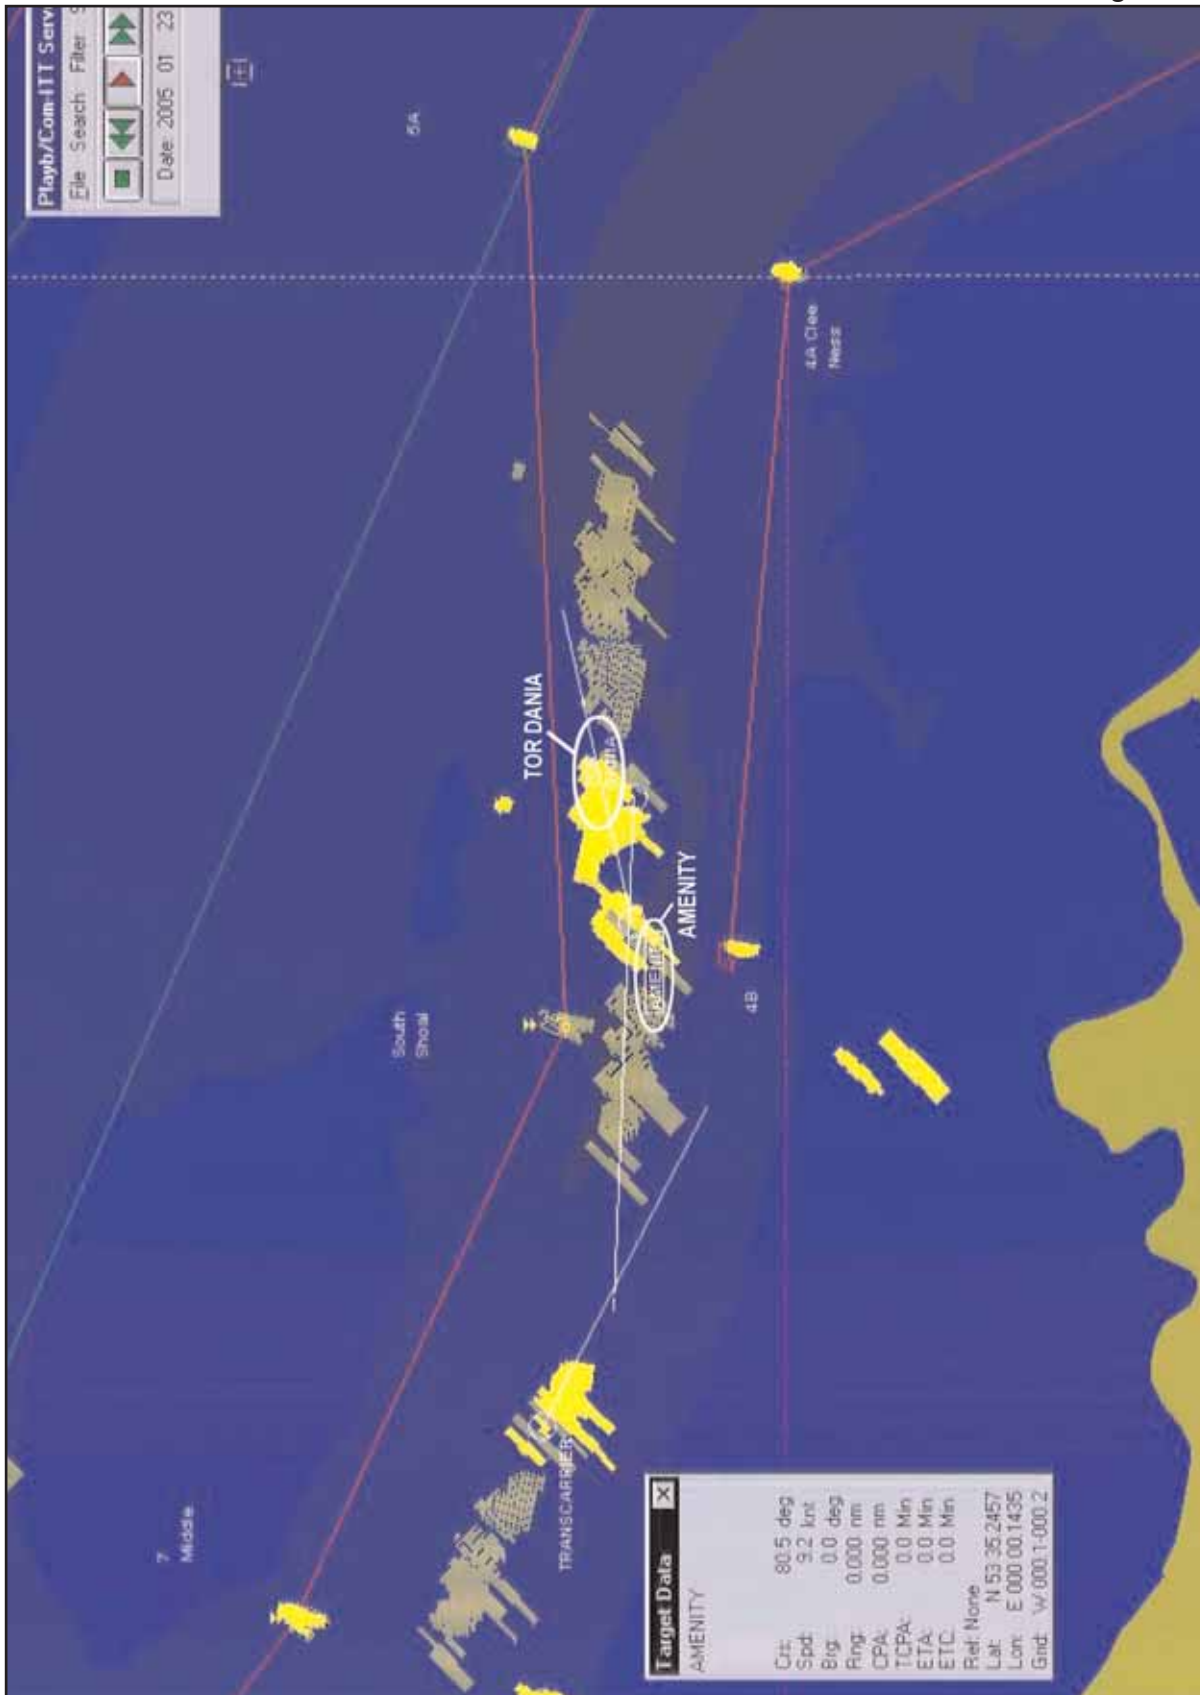
Figure 12

Screenshot from APB HES VTS VTMIS

Additionally, ABP HES VTS was equipped with a Vessel Traffic Management and Information System (VTMIS) supplied by Kongsberg Nor Control IT. This recorded the radar data for the morning of 23 January 2005. This data was replayed for the MAIB in a variety of modes to obtain the greatest possible accuracy from the information displayed. These replays were recorded by the MAIB for further analysis. A snapshot taken from one of them is shown in **Figure 12**.
