Report on the investigation of the  
capsize of an un-named

**Haitian sloop**

***Sea Quest***

**Report No 17/2007**  
**August 2007**

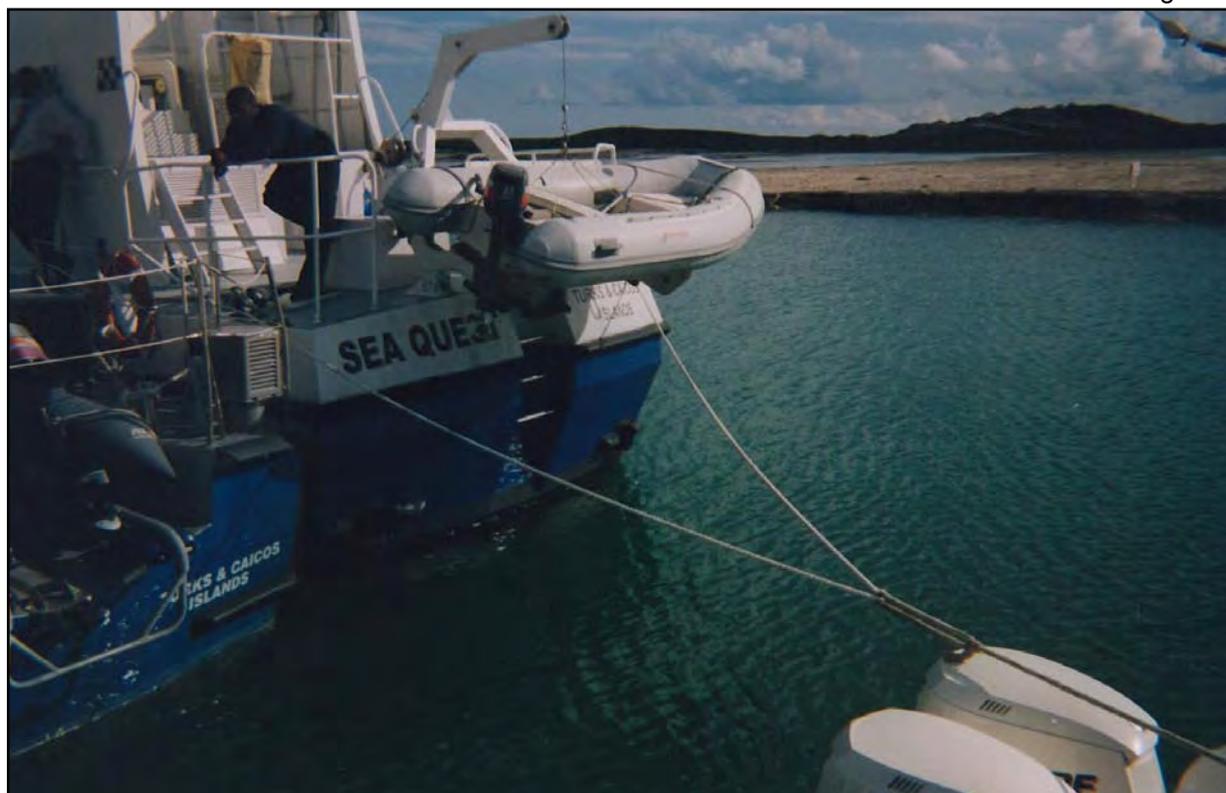
When delivered to the TCI police force, *Sea Quest* was supplied with a tow line in cases of propulsion failure or, if necessary, to tow another vessel. Two 7 tonne bollards were fitted, one to each side of the stern quarters. Doubling as mooring and towing bollards, they were designed to accept a bridle arrangement across the stern, through which the eye of the tow line passed (**Figure 5**). As built, *Sea Quest* had a total engine power of 1100HP, but recent replacement of both engines had increased her power to 1640HP. Working on 50% of total power, with 100HP equating to 1 tonne bollard pull, *Sea*

*Sea Quest* - towage bridle

*Quest* was originally capable of towing with a little over 5 tonne bollard pull. It was not envisaged that the vessel would be engaged in towing operations over long distances, or that the towing speed would be in excess of 5 knots.

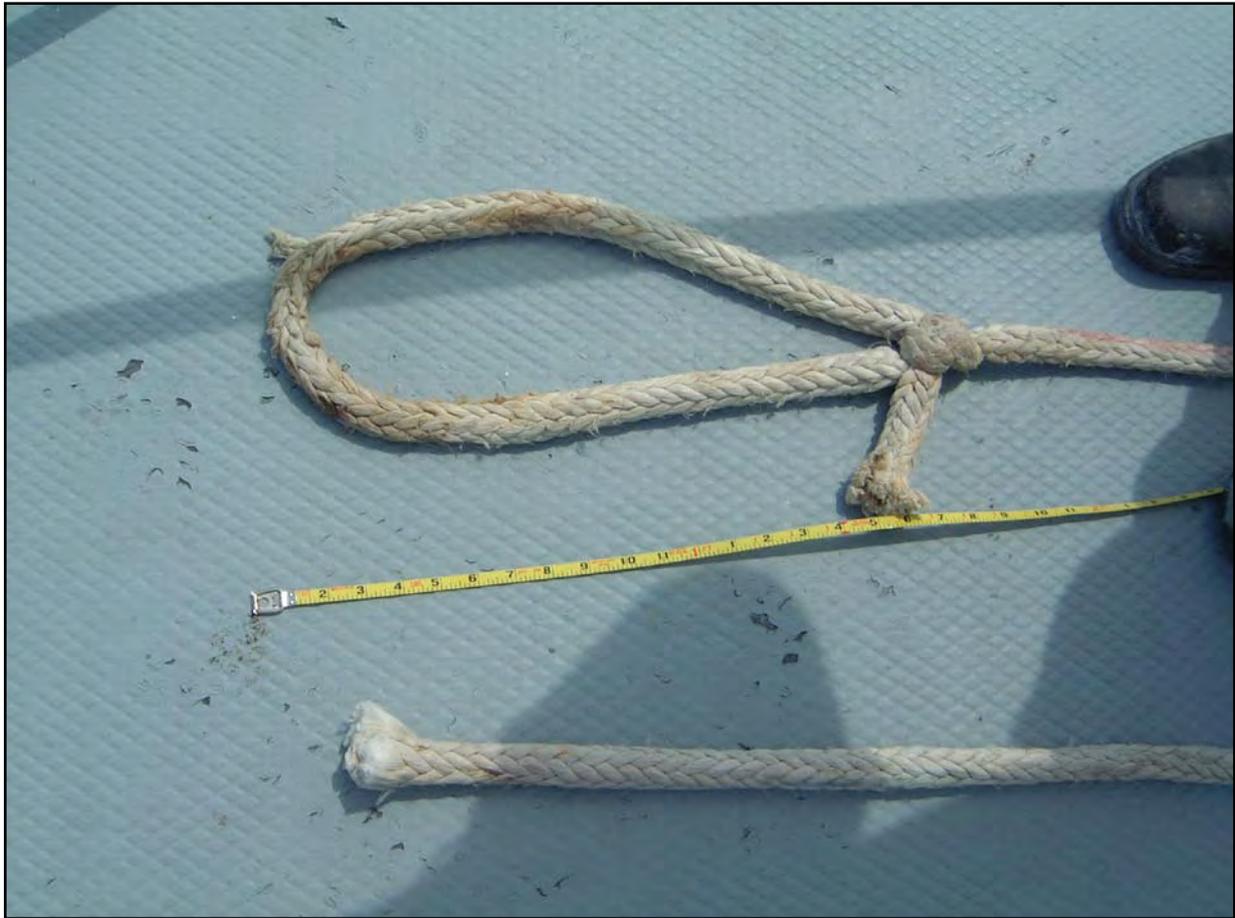
HMPE multi-plait towline

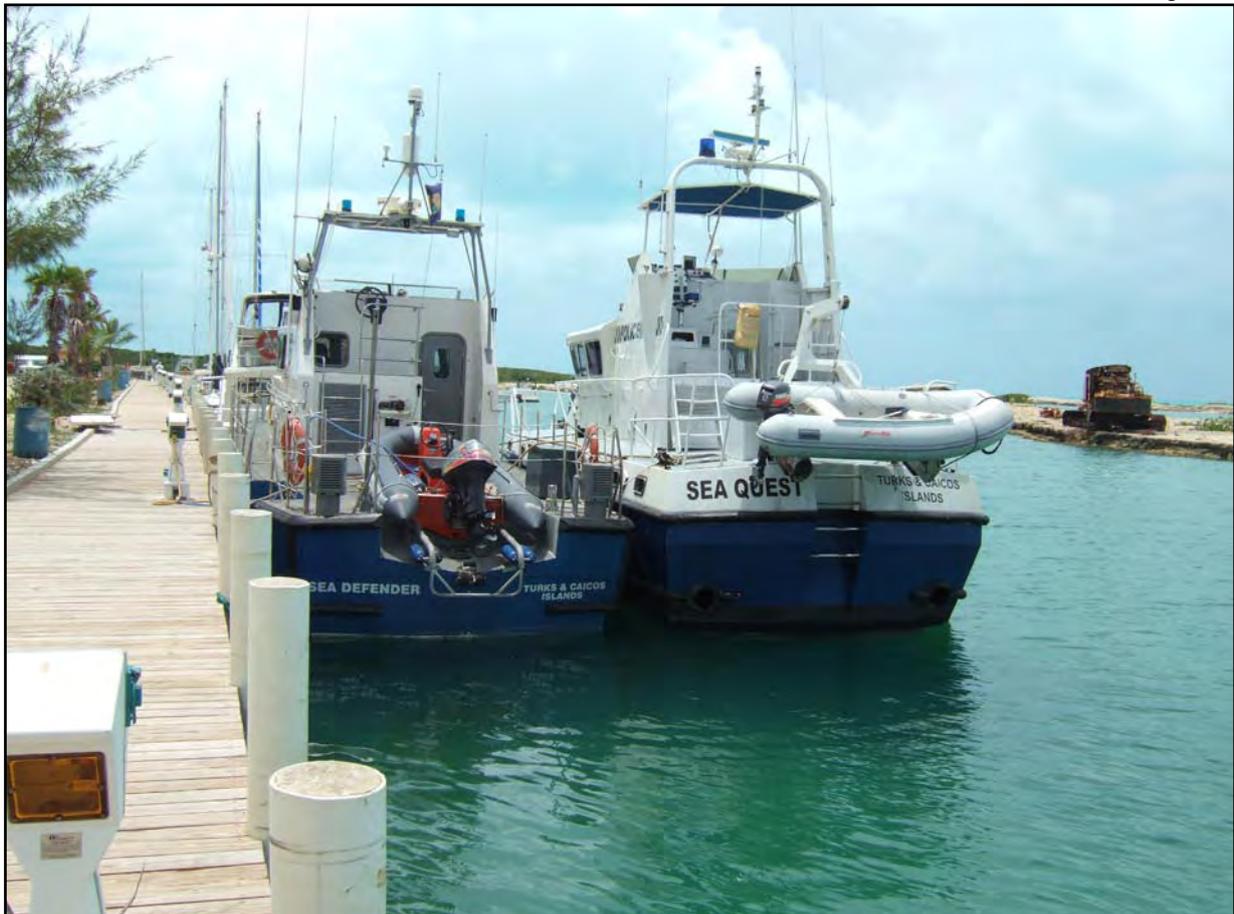
In 2006, *Sea Quest* was joined by a second Halmatic launch, *Sea Defender*. Based on the Halmatic pilot cutter hull, *Sea Defender's* hull form is considered to perform better than *Sea Quest's* in a seaway, and is designed with an internal stern ramp to assist the launching and recovery of the vessel's sea boat (**Figure 8**). When compared to the davit launched system fitted to *Sea Quest*, the ramp system potentially provides greater flexibility to launch and recover the boat, and could be used as a simple boarding platform to assist people from the water.

Sea Defender (left) and Sea Quest (right) showing differences in rescue craft and landing arrangements

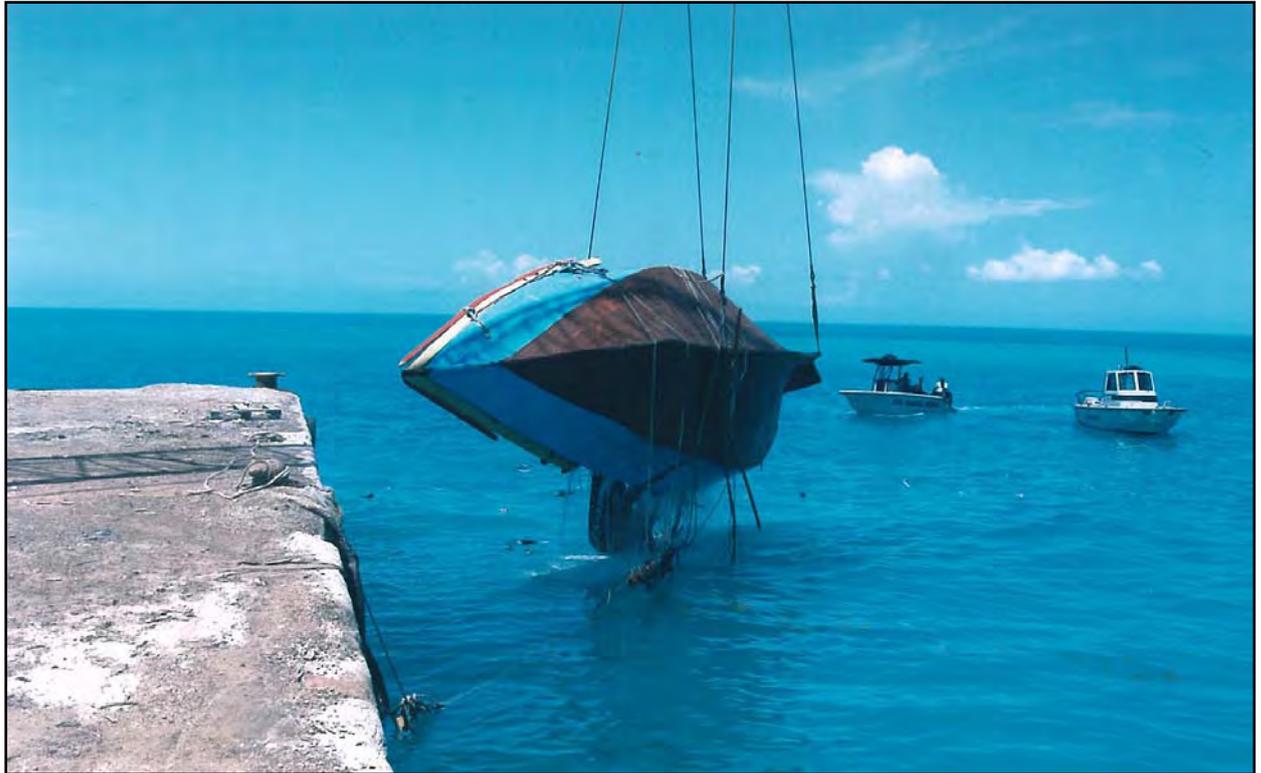
Figure 9

On the morning of Friday 4 May 2007, an initial attempt to recover the sloop was made by *Sea Quest* using the original tow line which was still attached to the hulk. However, the police launch experienced great difficulty in towing the capsized sloop, and a Haitian trading vessel at South Dock was finally used to manoeuvre the sloop alongside under the dock crane. Slings were then rigged under the sloop, which was finally lifted ashore at 1145 (**Figure 9**).

Haitian sloop being lifted ashore

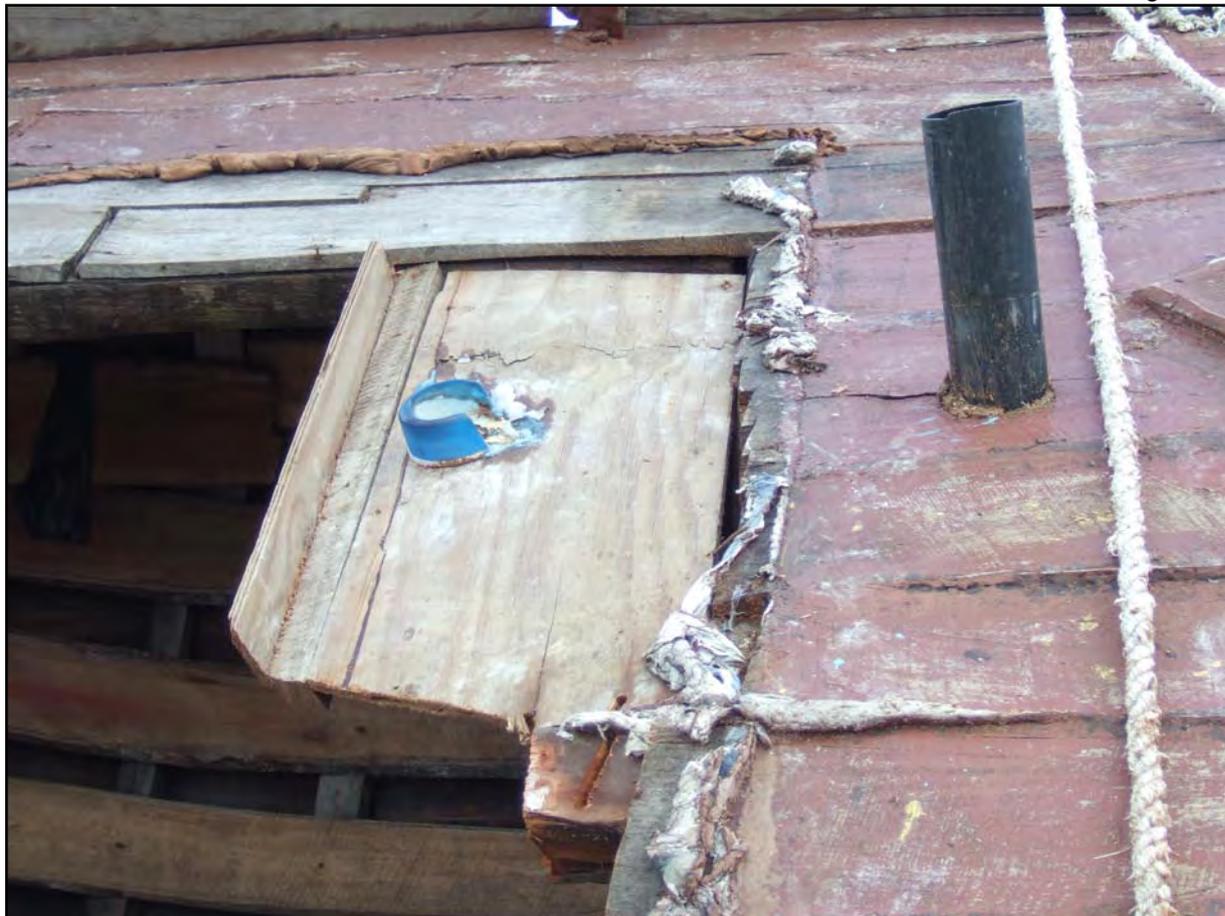
Candle holder to illuminate compass

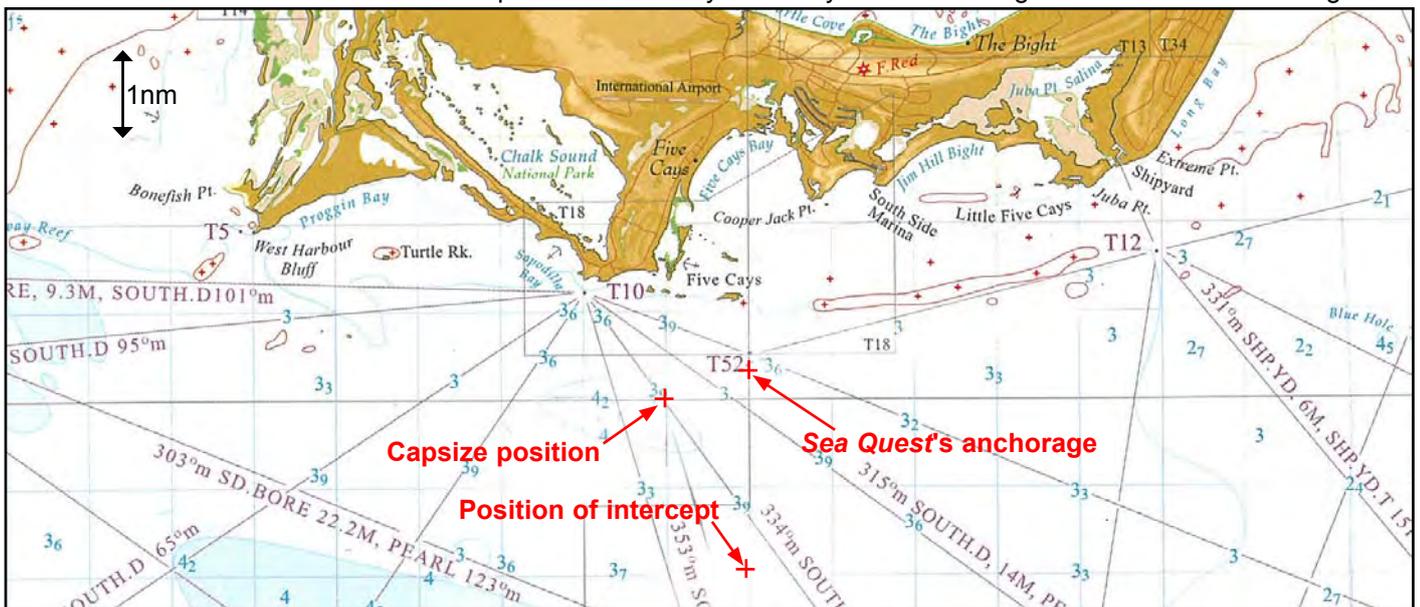
Figure 18

The MPU carries out overnight patrols on a daily basis. The standard routine consisted of sailing from Caicos Marina, *Sea Quest's* permanent mooring, at around 1600. The short patrol was then conducted before the launch anchored at about 1830, usually to the south of Bay Cay (**Figure 18**).

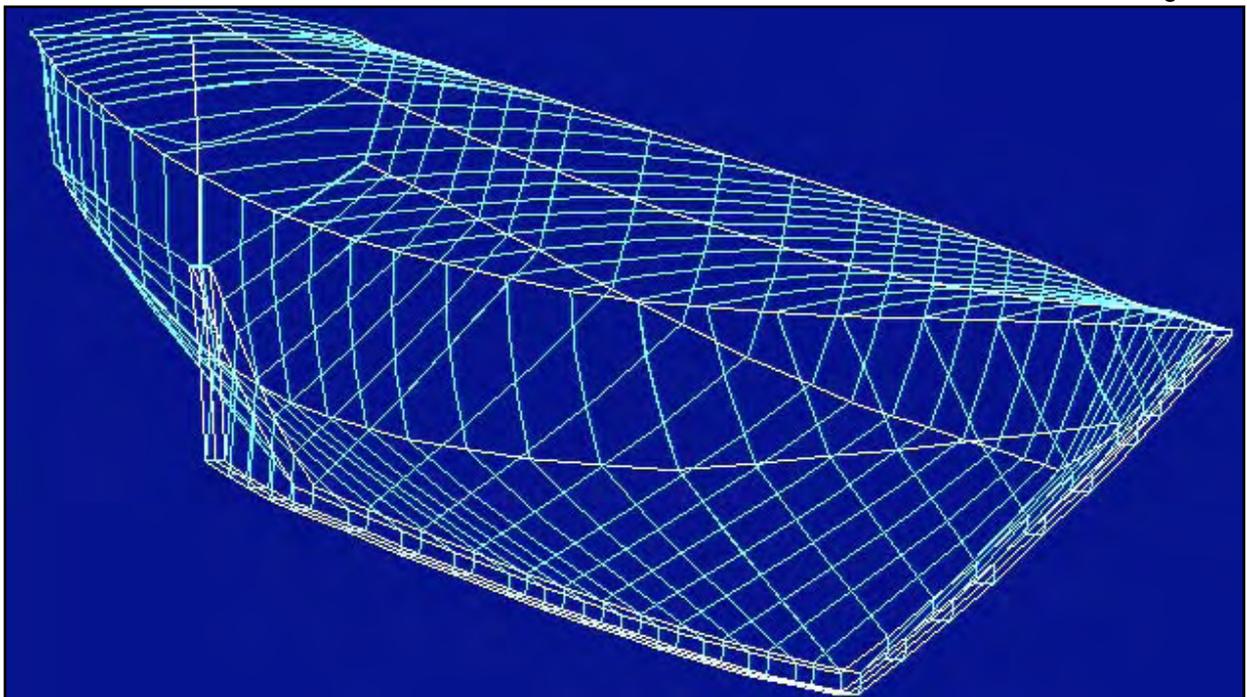
Figure 19

The loss of the Haitian sloop due to capsizing raises questions about the vessel's stability. An assessment of the vessel's stability performance was therefore made though, for the following reasons, only an approximate estimate was possible. To conduct a full stability assessment requires: an accurate lines plan; the precise state of loading must be known; and the vessel must undergo an inclining experiment afloat to derive its centre of gravity. None of this was possible, so a degree of estimation was used in deriving centres of gravity and weights. An approximate lines plan was developed from measurements taken from the sloop from which a computer model was generated. **(Figure 19)**.

Stability model used in analysis

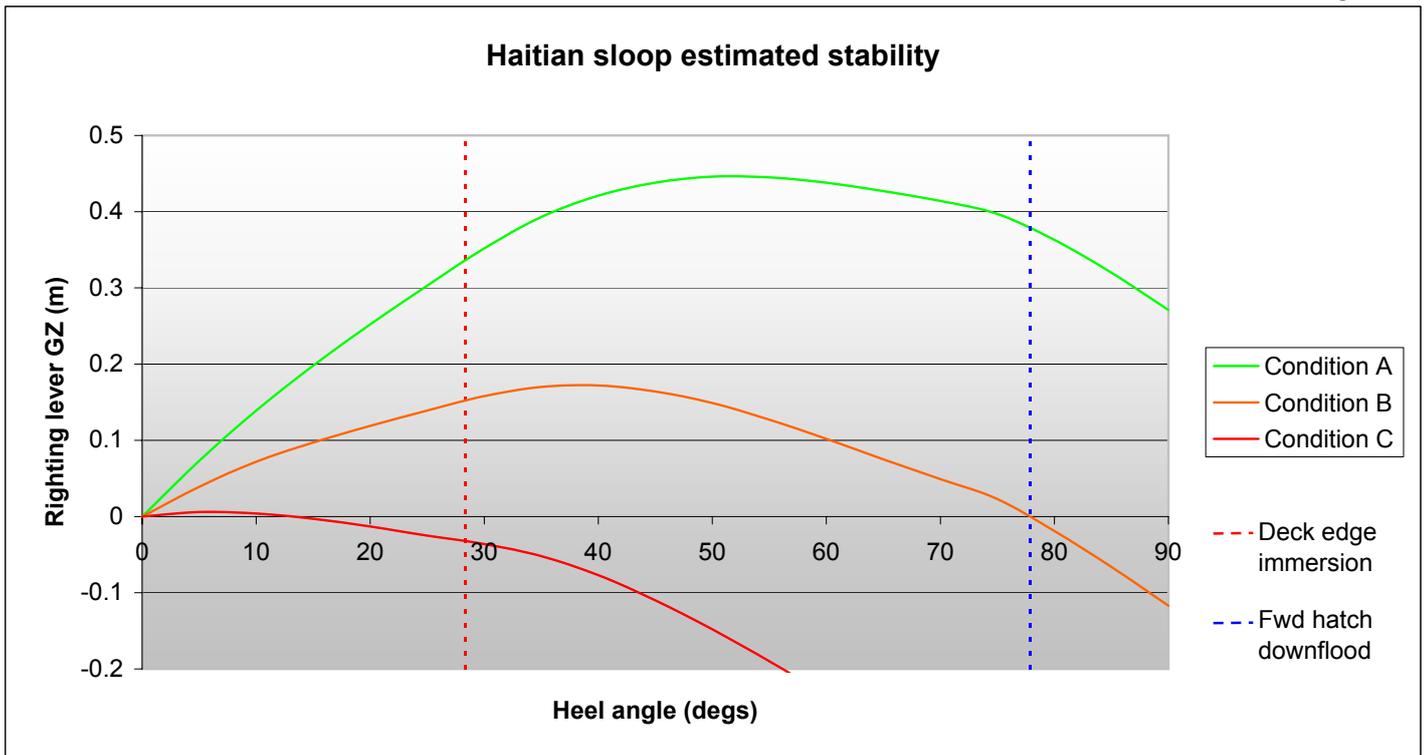
In Condition B, when half of the passengers are placed on deck, the sloop's stability diminishes significantly. The area under the GZ curve is less than half of that of Condition A. Extrapolating to the point where 125 passengers are placed on deck, Condition C, the sloop has no stability and hence no resistance to capsize. The smallest external influence, for example wind or wave action, or even the movement of some passengers on deck to one side, would cause the sloop to capsize.

This analysis only provides an indication of the implications of moving a large number of passengers on to the main deck; it does not determine precisely what happened. In reality, the sloop, with the passengers on deck, might have had a greater level of stability than MAIB's assessment indicates, but still not enough to prevent a real risk of capsizing being present.

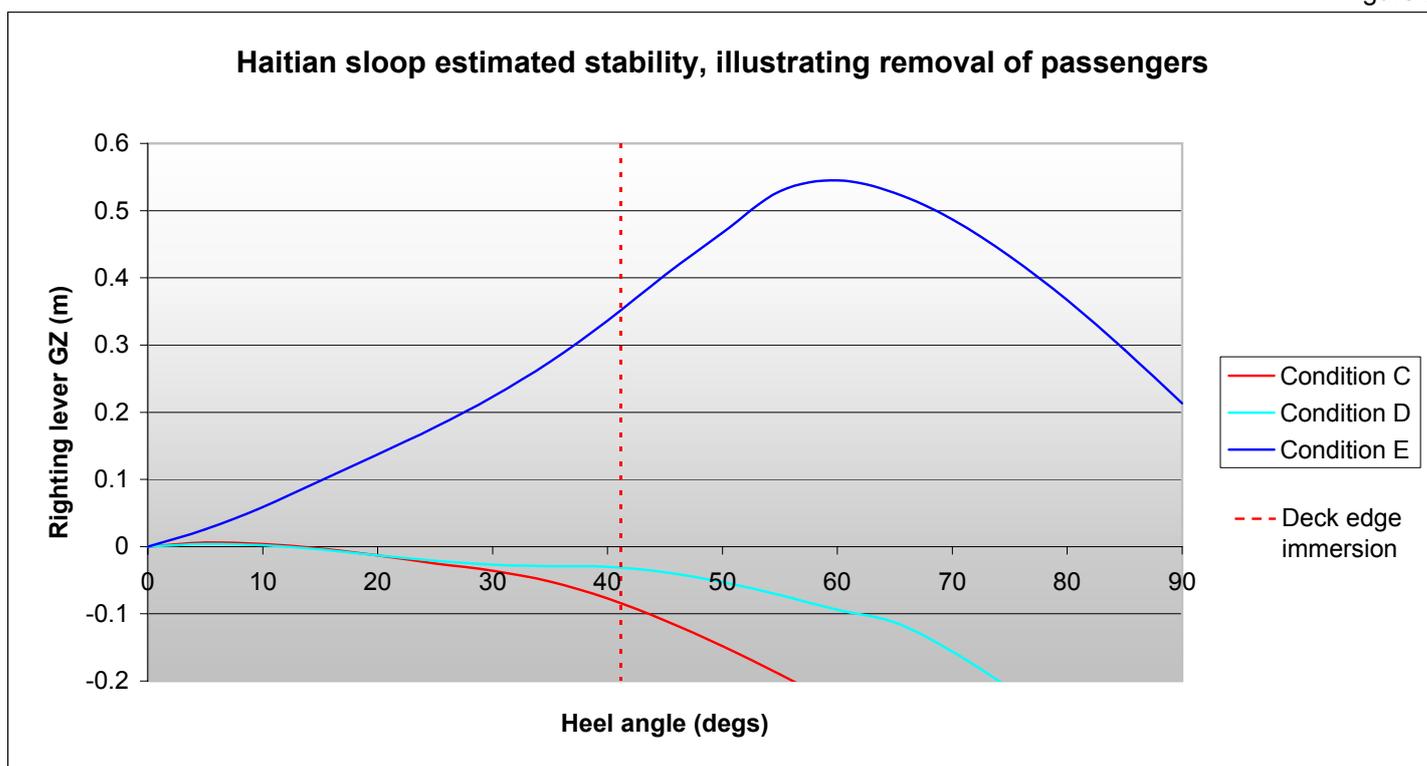
Using the stability data above, assessments were made of the sloop's stability with some of the passengers removed (**Figure 21**). Two conditions were calculated: Condition D, with 60 passengers removed (for example had *Sea Quest* alone embarked 60), and Condition E, with 120 passengers removed (*Sea Quest* and *Sea Defender* each embarking 60).

In Condition D, removal of 60 passengers and assuming the remaining 90 were then on deck did not improve stability from the worst case assumption of Condition C (125 on deck, 25 below). The sloop would still have had minimal residual stability and would have been highly susceptible to capsize. When a further 60 passengers were removed, Condition E (using two patrol launches), leaving 30 passengers on deck, the sloop's stability improved significantly.
