Failure of the controllable pitch propeller of the chemical tanker *Key Bora*, resulting in heavy contact with the jetty in the port of Hull 20 December 2013

SUMMARY

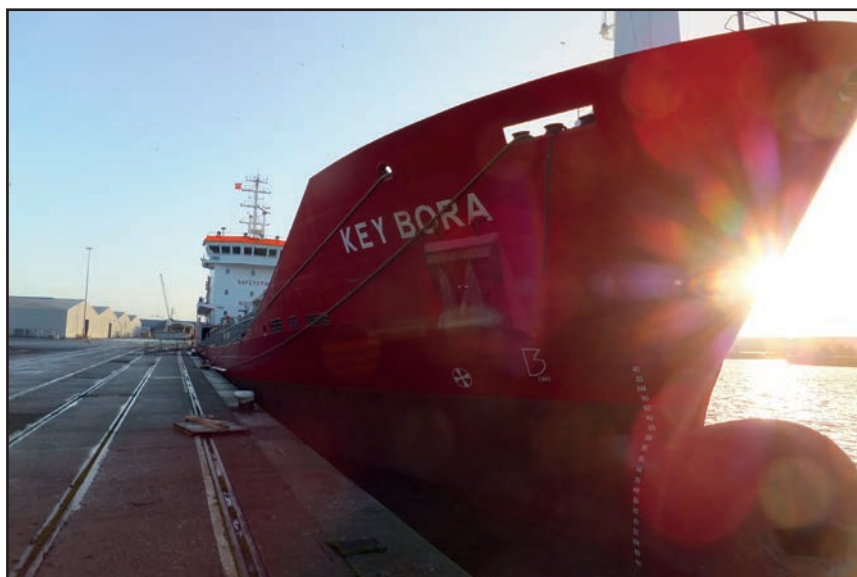
The impact caused a hole, approximately 90cm in diameter, in the bulbous bow 1m above the waterline (**Figure 1 inset**). There was no pollution but the jetty suffered damage to the wooden fenders and piling on the west lead-in section.
