Report on the investigation of heavy weather  
encountered by the cruise ship

***Pacific Sun***

on 30 July 2008

**Report No 14/2009**  
**June 2009**

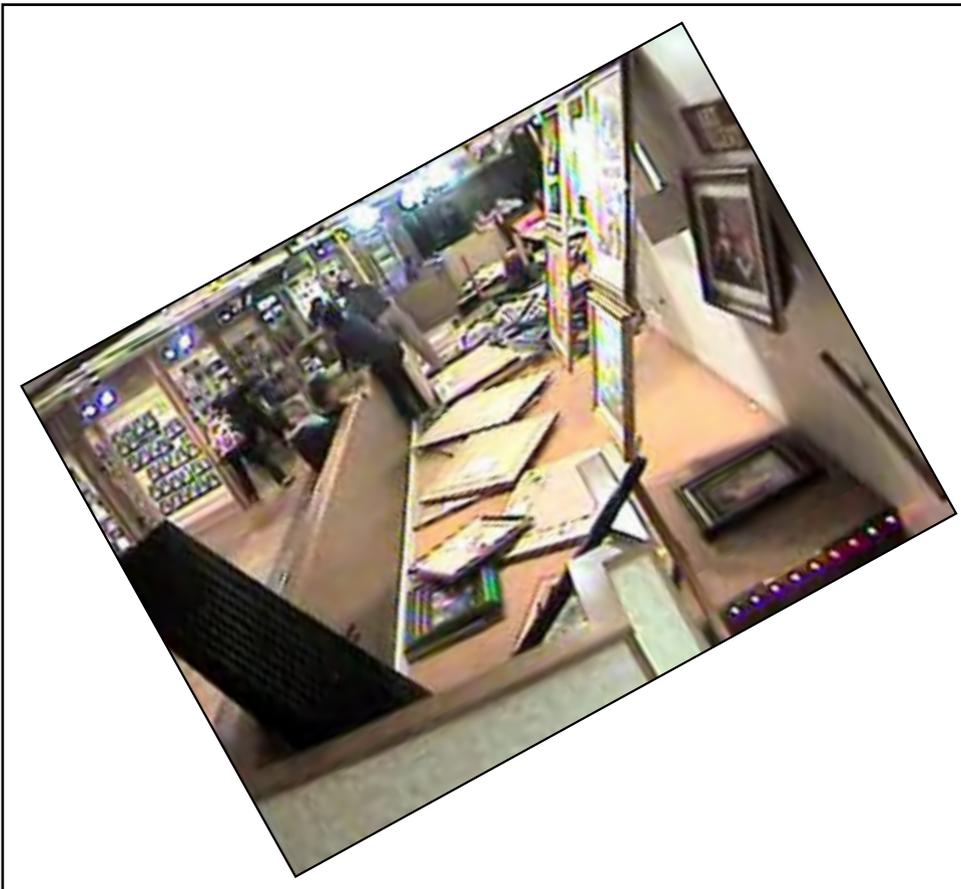
At 1937 the master used the PA system to announce to the passengers that he was about to turn the vessel to reduce the rolling. He warned that this might result in her rolling and pitching. The master took over the conduct of the ship from the OOW and, at 1938, ordered 10° port rudder. As he did so, but before the rudder had been applied, the ship started to pitch moderately and rolled heavily to starboard to around 23°. The ship continued to roll heavily three times; the final and largest roll heeled *Pacific Sun* to an estimated 31° to starboard as the heading was altered to 260°.

How the vessel would have appeared at 31°

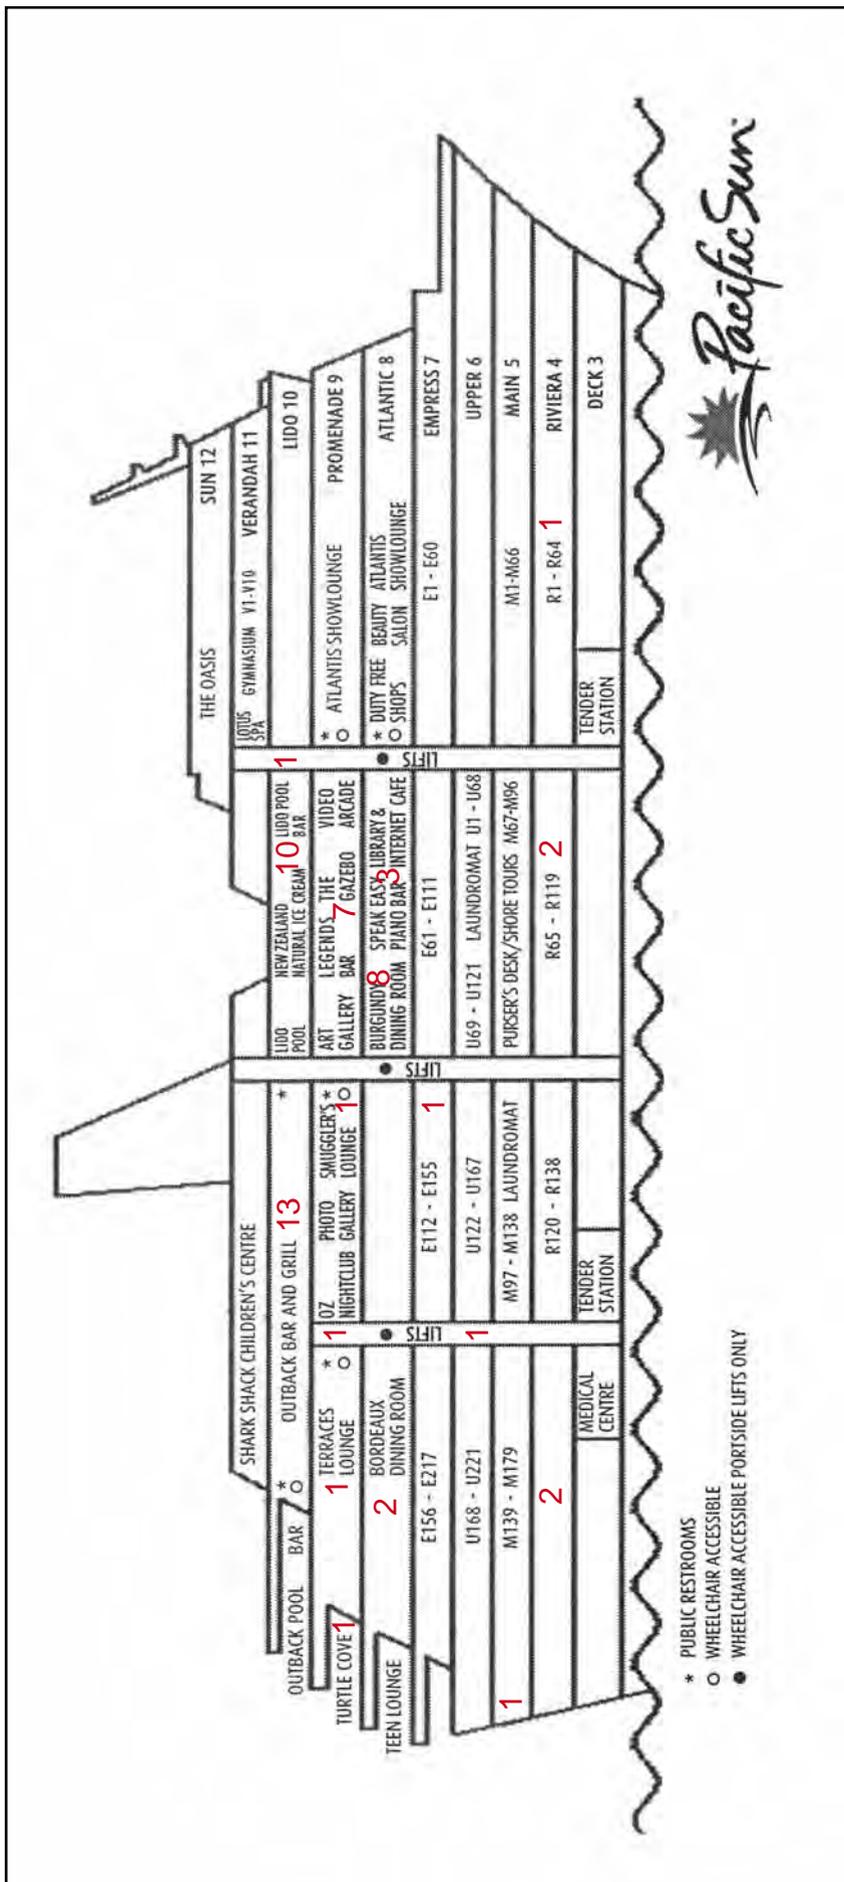
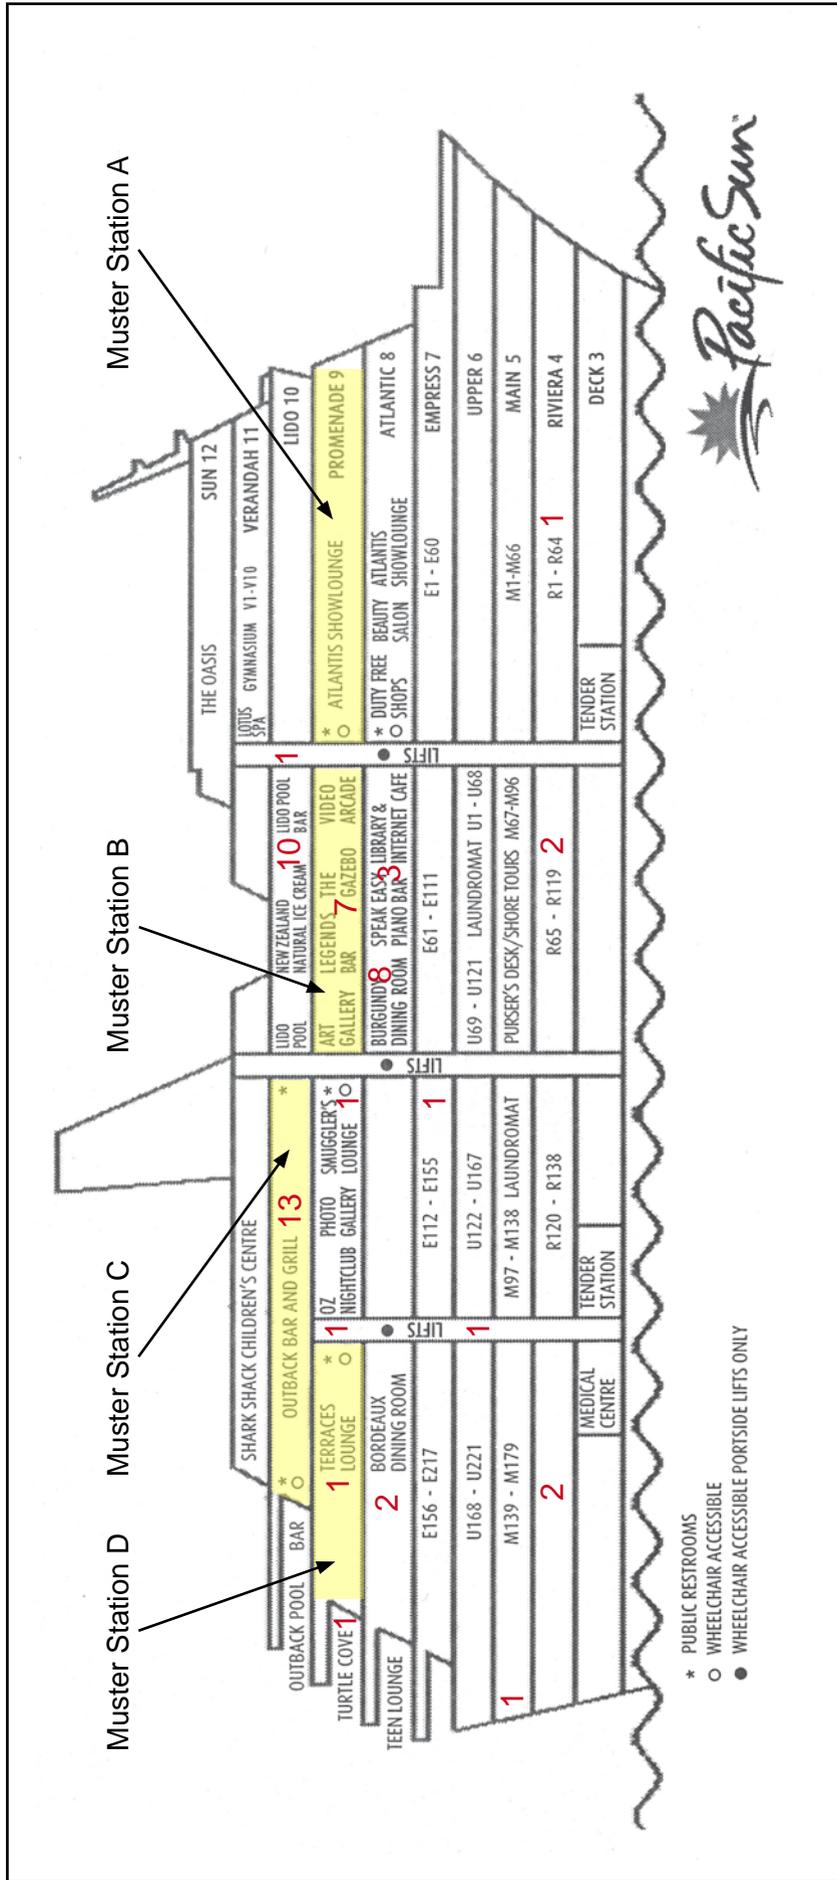
Figure 7

The locations where passengers sustained injuries, in so far as these could be identified, are shown at **Figure 7**. The majority of injuries occurred on the busy upper decks, in the public spaces, bars and restaurants with all the serious injuries occurring on decks 8, 9 and 10.

The deck 8 furniture consisted mainly of banquette seating and secured tables and chairs that remained secure with the exception of one fixed table that broke free. Only a few passengers were in this room at the time, and no major injuries were reported.

Location of injuries to passengers and crew - where known

Location of injuries, where known, and Muster Station locations

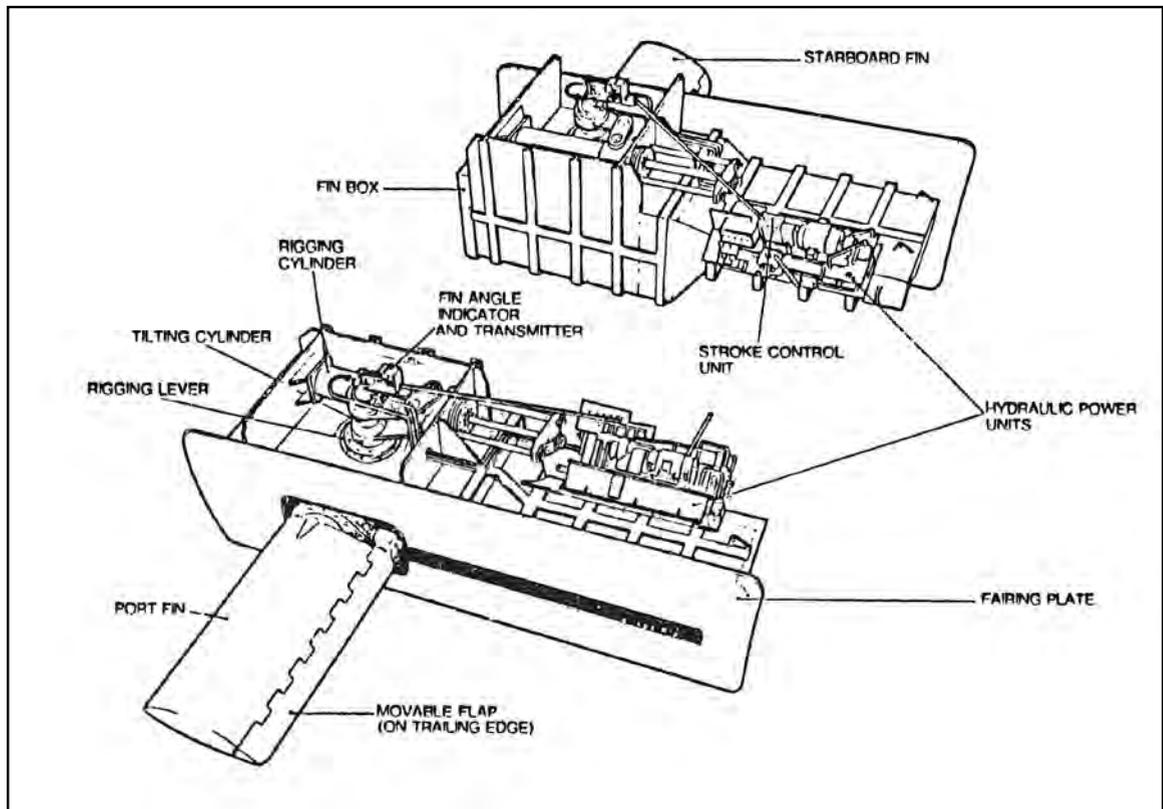
Figure 17

*Pacific Sun* was fitted with a pair of Sperry Marine Gyrofin roll stabilisers. In calm conditions the stabilisers were housed within the ship's hull. When required one, or both, is extended hydraulically depending on the extent of the rolling (**Figure 17**). Stabilisers have no effect in reducing a ship's pitching motion.

Typical stabiliser machinery unit as fitted to *Pacific Sun*

*Pacific Sun's* port stabiliser was inoperative because parts of the system were heavily worn and could not be replaced until the next period in dry dock. Her starboard stabiliser was operating in angle control mode due to a failure of the lift transducers required for the lift control mode. This was caused by salt water entering the transducer compartment. An overhaul of both the stabilisers had been scheduled for the vessel's previous dry dock maintenance period, in Brisbane in 2004. However, Brisbane's dry dock was insufficiently wide for the stabilisers to be withdrawn, and the overhaul was postponed to the forthcoming 2008 dry dock.

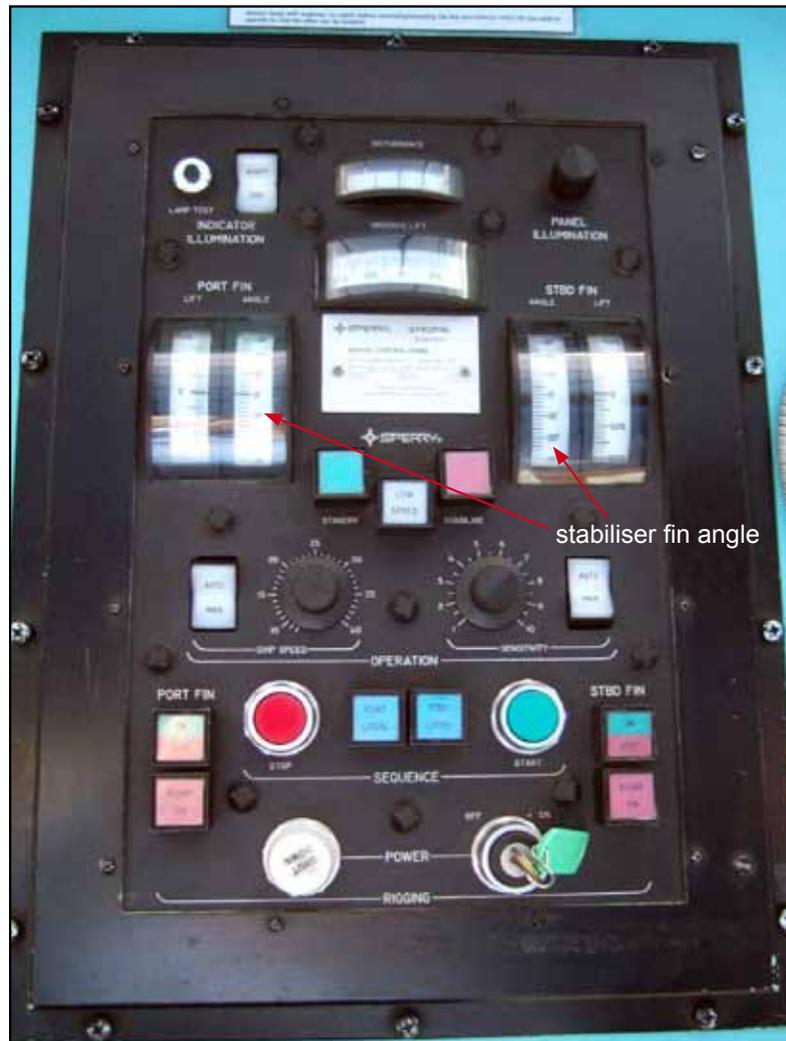
The control surfaces on stabilising fins work in the same way as aircraft wing ailerons. When tilted down, they deflect the water flow downwards and, in doing so generate lift. Similarly an upwards tilt produces a downward pressure. A gyro sensor will detect rolling torque and so move the fin control surface to oppose a roll before the ship has started to heel over. Active gyro fin stabilisers are operated in either the angle control or lift control modes, the lift control mode producing maximum fin efficiency. The operation of the stabilisers could be seen from a panel located on the bridge (**Figure 18**), but no audible alarm was fitted to indicate that an operating stabiliser had failed.

Bridge Gyrofin control unit
