Report on the investigation into the contact
made by the tanker
Vallermosa,
with the tankers
Navion Fennia and ***BW Orinoco***
at the Fawley Marine Terminal
on 25 February 2009

Marine Accident Investigation Branch
Mountbatten House
Grosvenor Square
Southampton
United Kingdom
SO15 2JU
Report No 23/2009
November 2009

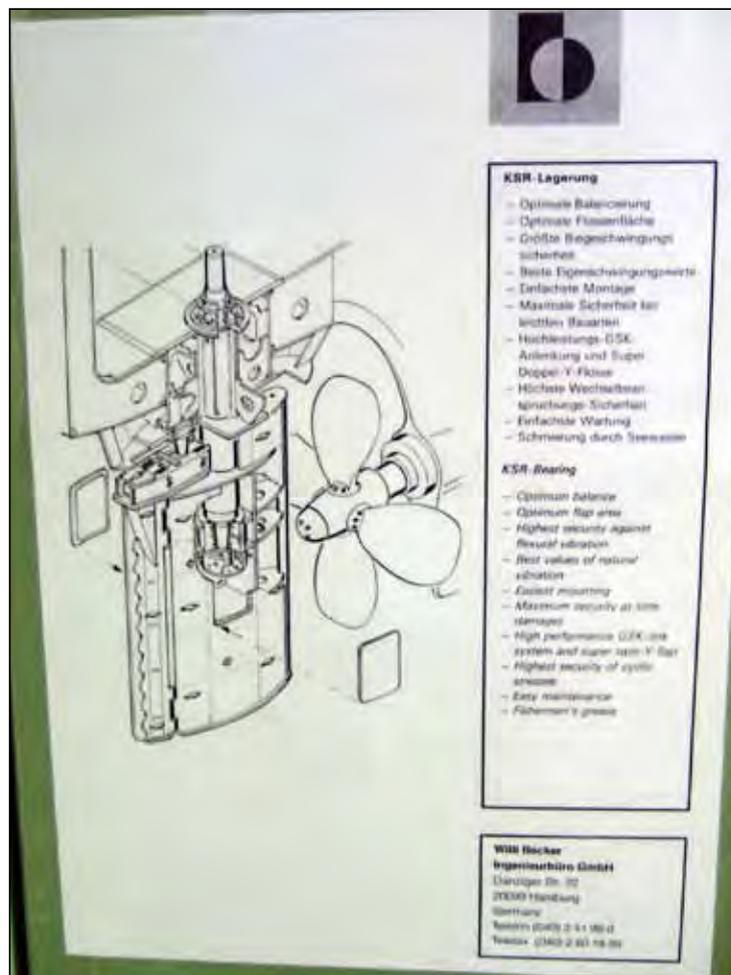
Figure 12

Vallermosa was designed and fitted with a Becker rudder. The main advantage of the Becker rudder (**Figure 12**) is that it generates greater lateral forces than conventional rudders at small rudder angles. The flap at the trailing edge of the rudder turns to almost twice the angle of the main rudder blade. The maximum lateral force was achieved at a main rudder angle of about 35° with the flap at an angle of around 70° from amidships.

Photograph of Becker rudder information

The manufacturer estimated that the Becker rudder was three times as effective as a conventional rudder. The advice posted at *Vallermosa's* steering position (**Figure 13**), located beneath the helm and obscured from the pilot's view warned:

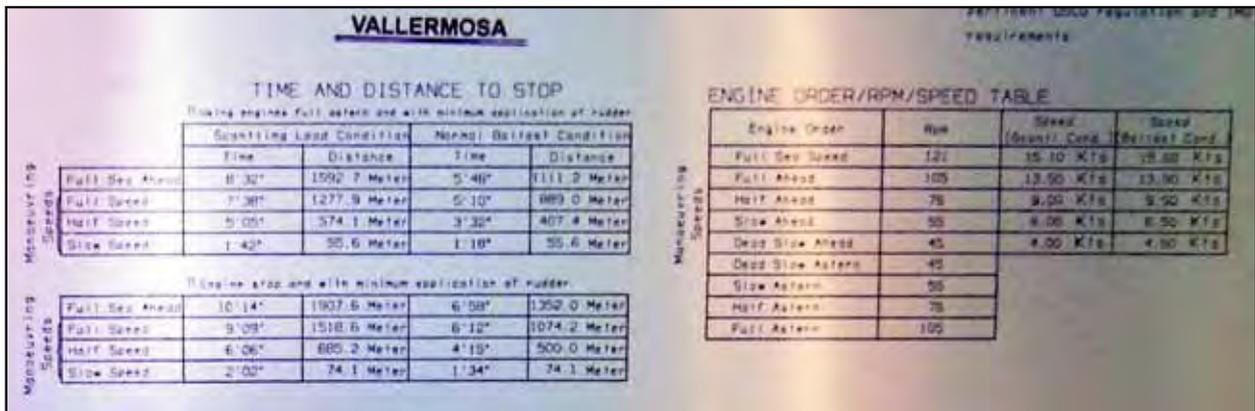
Figure 14

Vallermosa's manoeuvring data was provided to the pilot during the pilot / master exchange discussion held when he arrived on board, and on the pilot card (**Figure 3**). Additional data was available on the bridge, located below the forward bridge window, but the pilot was unaware of it. The stopping data (**Figure 14**) indicates that, for example, with an ahead speed of 9 knots in the loaded condition, had the main engine operated full astern, *Vallermosa* would have stopped in 574.1m (3.1 cables). The effect on the heading, on a vessel which is directionally unstable, is not shown.

Stopping data from *Vallermosa*

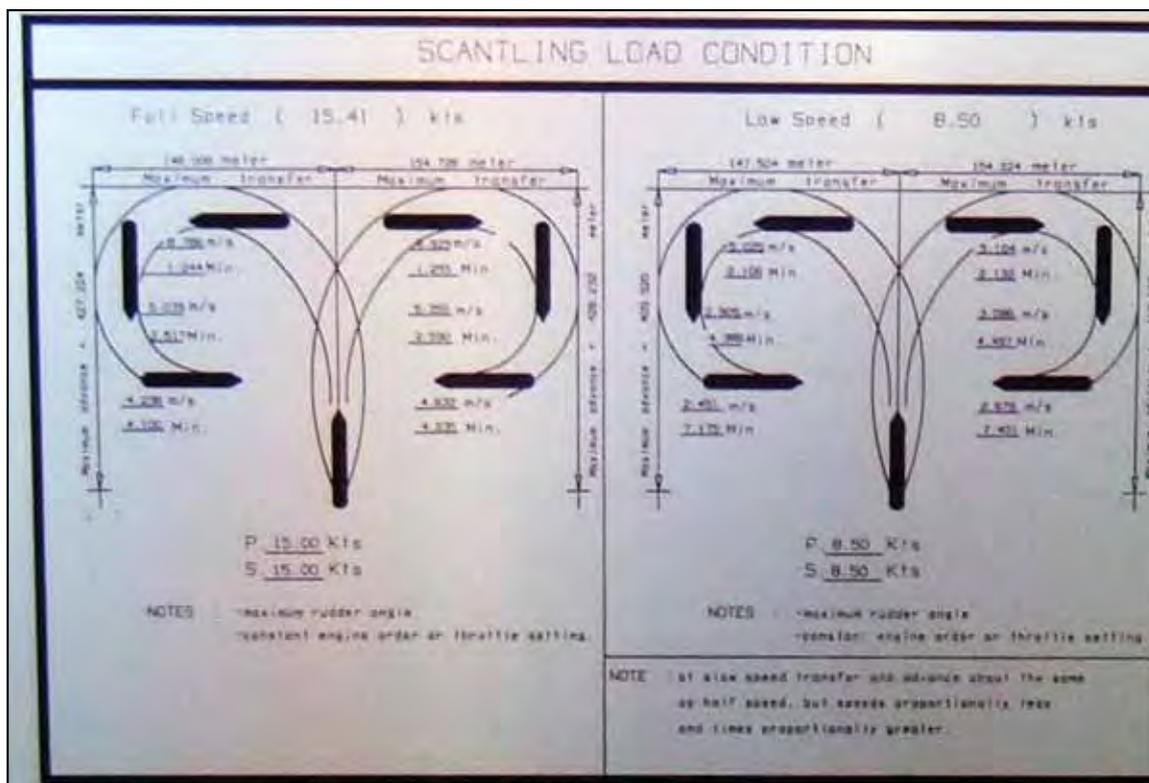
The turning data (**Figure 15**) indicates that in the loaded condition at 8.5 kts with maximum rudder angle and constant engine speed, *Vallermosa* would advance by a maximum of 410m (2.2 cables) and transfer 150m (0.8 cables) during a full round turn. This distance would be affected by the environmental conditions; notably, the advance and transfer could have increased due to the depth of water.

Turning data from *Vallermosa*

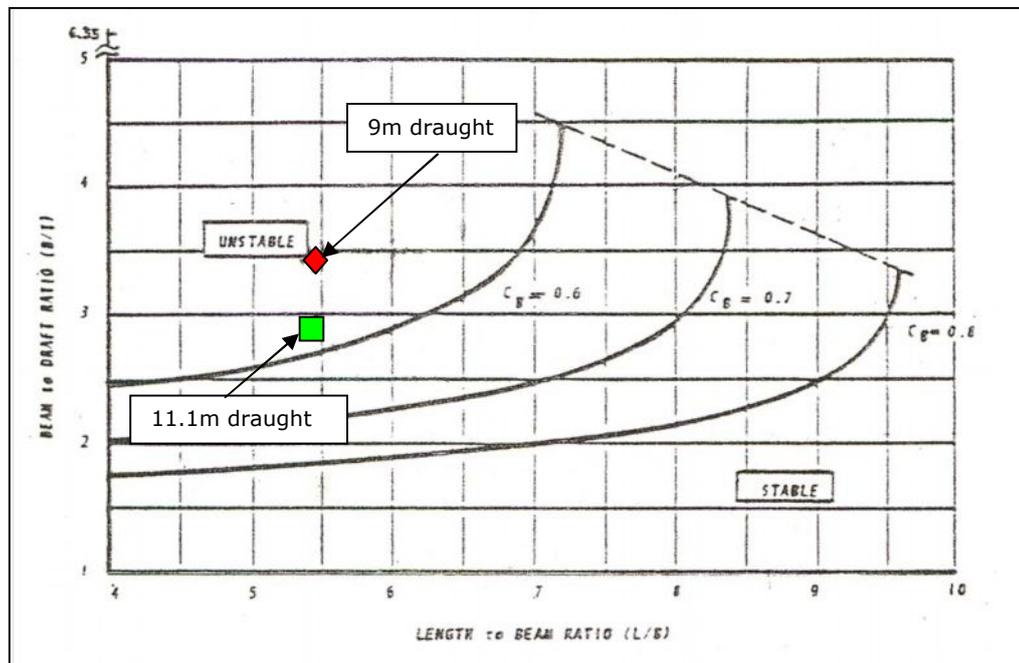
Figure 2: Directional Stability Check 1 from Reference 1

The first plot is shown in Figure 2 and is taken from Reference 1. Boundary lines are plotted as stability boundaries with the "stable" and "unstable" regions marked. It is seen that the ship as originally designed fell on the "unstable" side of the boundary for block coefficients around 0.8 and was improved at the deeper draught, although still classed as unstable.

These two plots suggest that the Vallermosa at the time of the incident may have had a tendency to directional instability as is often the case with ships having block coefficients in excess of 0.8 and length/beam ratios less than 5.5.

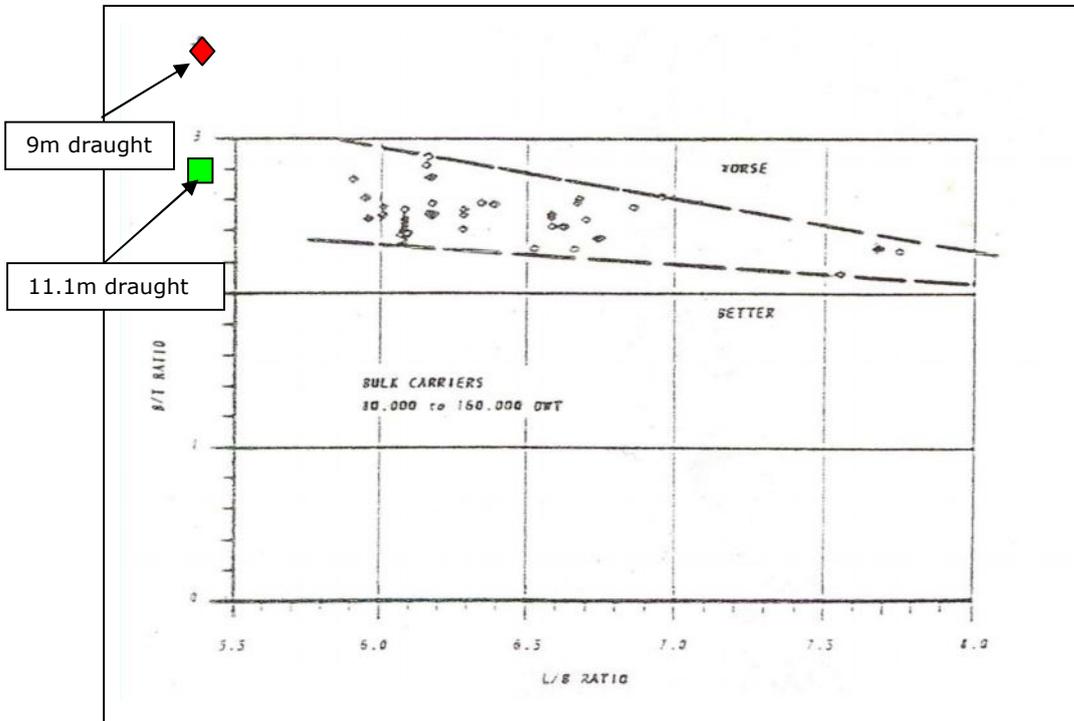
Figure 3: Directional Stability Check 2 from Reference 2

Figure 3 shows an alternative plot from Reference 2 which shows the Vallermosa to be more stable (and just on the stability margin) at the deeper load draught, by virtue of its smaller beam/draught ratio.

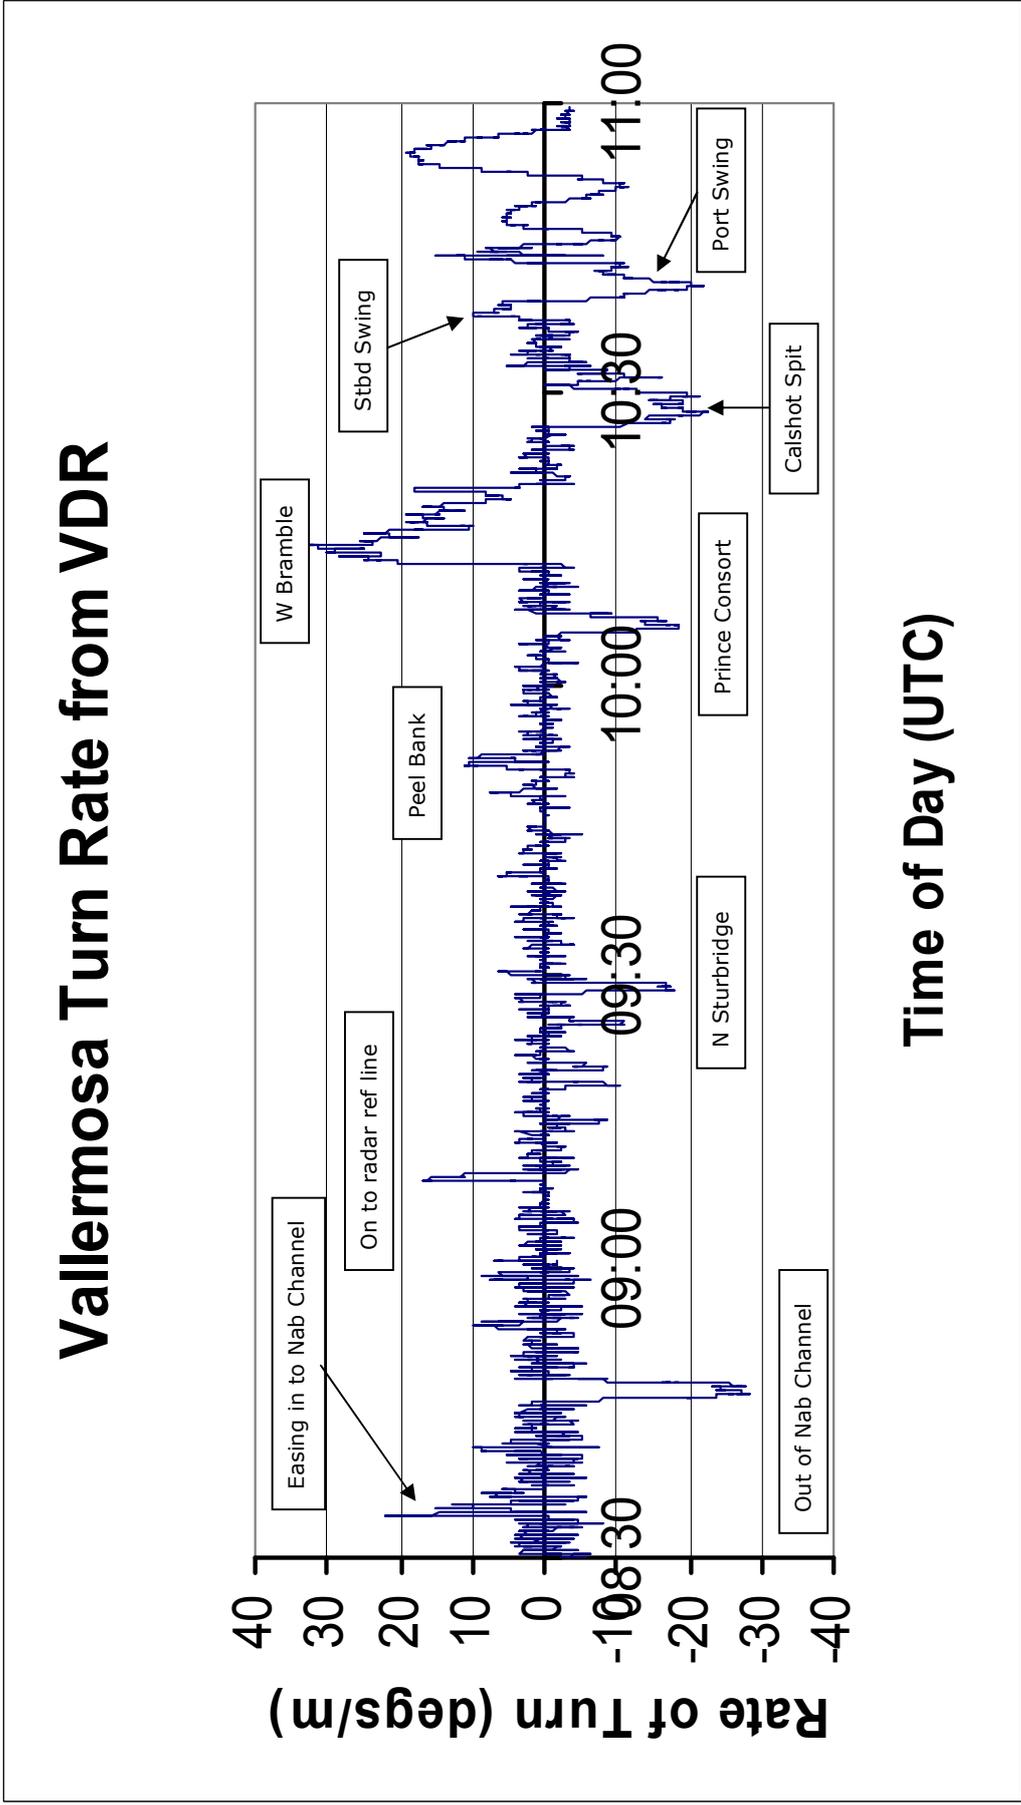
Figure 6: Rate of Turn Measurements from Vallermosa VDR

Passage from 08:30 to 10:00 took the vessel from entry to the Nab Channel to Ryde Middle. It is seen from Figure 1 that the track shows no anomalies and the transit over this part of the passage appears quite normal. Figure 6, however, reveals a continuous turn rate variation about zero which reinforces the comment, made in Section 5.2 above, that the ship was not able to steady on a course on a day when the weather was benign. Any turns appear to be hesitant with a number of incremental heading changes, a feature which is seen frequently in the whole passage.

Once again the number of changes in the rate of turn plot in Figure 6 suggests a ship that was slightly course unstable and liable to wander off course if not checked.
