# MAIB

## FLYER TO SHIPPING INDUSTRY

### **YEOMAN BONTRUP: RADIATION HAZARD IDENTIFIED FOLLOWING A FIRE**

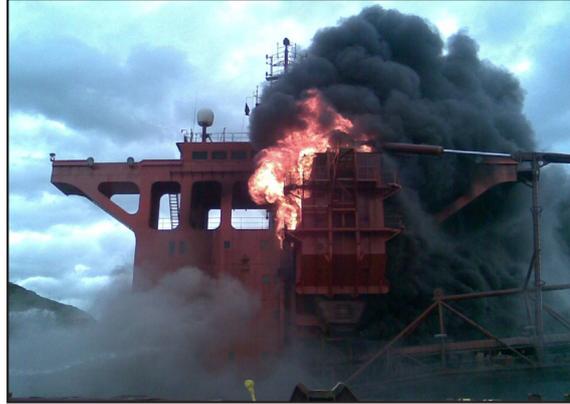
On 2 July 2010, a fire was discovered on the vertical cargo conveyor belt of the self-unloading bulk carrier *Yeoman Bontrup* while the cargo hopper was being repaired. The crew tackled the fire from the conveyor tunnels under the holds, but it quickly spread throughout the cargo handling area and into the accommodation. The fire also spread into the engine room by heat transfer through the bulkheads and via an open connecting door, and then to the steering gear compartment which contained a number of hydraulic systems as well as stocks of oils, greases, and ship's-use chemicals. There, the fire caused a large explosion that blasted the entire poop deck into the air and onto the funnel deck (**Figures 1 & 2**). Fortunately, there were only minor smoke inhalation and bruising injuries.

The fire was most likely caused by hotwork repair debris falling from the cargo hopper at the top of the tower into the flammable side curtain of the vertical conveyor belt.
