Vessel: M/V Kithira

Maersk Safety Flash 01/2009

Movement/Inspections on deck during heavy weather

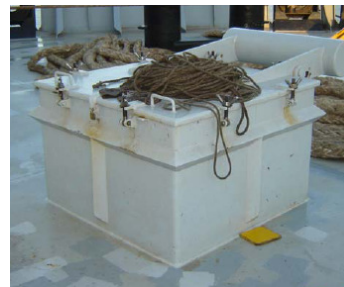
It appeared to the C/O's and the C/E's that there was a leakage from the forward store hatch. The C/O & C/E informed the bridge that the situation forward seemed favourable enough and that they would assess on deck whether the weather would allow further securing of the hatch once the vessel was steadied.

Once the vessel was steadied for about ten minutes, both the C/E and C/O made the decision to go up to the maindeck entrance, which is situated some 15 metres aft of the gulfbreaker on the foc'sl, to check out the weather circumstances.

As the weather was considered favourable from there, it was decided to go up forward to tighten the dogs of the hatch. After completing the task, both men intended to go back to the entrance of the lower passageway, when they noticed that the S/B anchor lashing (ocean lashing) had become slack as well.
