# MAIB

## FLYER TO THE FISHING INDUSTRY

### *Shark*: MAJOR FIRE

### *Royalist*: FOUNDERING

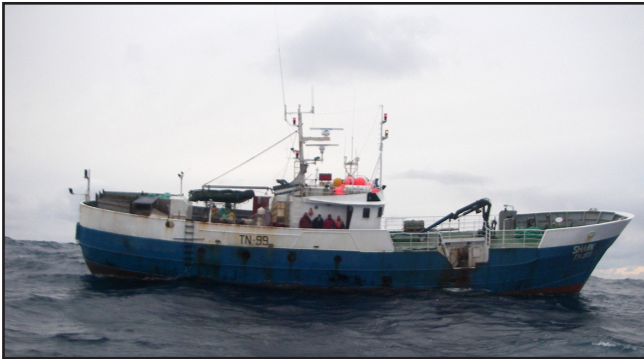
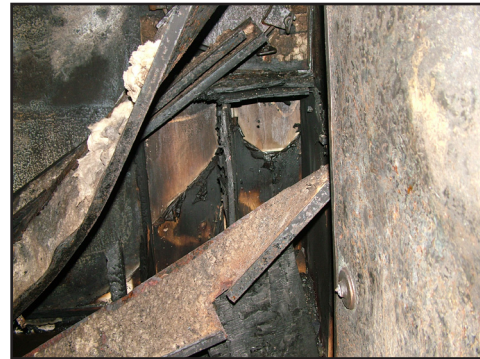
Figure 1

On 19 January 2008, a fire broke out on board the 33 metre, UK registered fishing vessel *Shark*, which at the time was engaged in long-line fishing approximately 74 miles west-north-west of Malin Head, Ireland. Initial attempts by the crew to fight the fire were hampered by a loss of fire-fighting water when electrical supplies were burnt through and because the emergency fire pump was defective. The emergency services were eventually called and a lifeboat, rescue helicopter, patrol aircraft and an Irish naval patrol vessel responded. A fire party from the patrol vessel subsequently extinguished the fire and *Shark* was then escorted to Killibegs, where she berthed the following day. Fortunately there were no injuries to the crew, however the vessel's accommodation suffered extensive fire damage (**Figure 1**).

- There should be procedures to regularly maintain and test emergency safety equipment.
- Fire detection systems should always be fully functional. They should be tested regularly, especially before sailing, and defects should be repaired immediately.

- A “closed door” policy will help to prevent the spread of fire, and doors fitted with self-closing arrangements should be fully functional and should not be latched back.

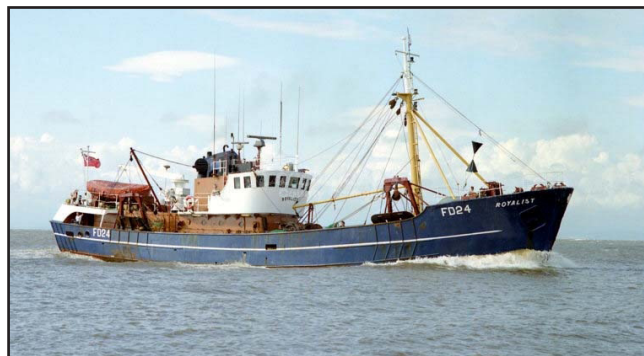
On 23 January 2008 *Royalist*, a 36 metre UK registered fishing vessel, flooded and sank during fishing operations when approximately 180nm off Dingle, Ireland. *Royalist* was about to shoot her nets when she was hit by a large wave on her port side, which caused her to heel to starboard. The vessel was starting to return to the upright when she was hit by a second wave. She immediately took on a permanent list due to the amount of water which had accumulated on her main working deck and within an accommodation alleyway. The list increased as water continued to wash over the vessel's submerged starboard gunwale in way of an open net hatch, and was able to progress into the accommodation and engine room via an open weathertight door. Although the crew attempted to stem the flow of water by closing the net hatch, the vessel started to sink.

The skipper sent distress messages on Inmarsat C and VHF radio. He also ordered his crew to don immersion suits and abandon the vessel. About 50 minutes later, *Royalist's* 18 crew were recovered from her two liferafts by another vessel fishing nearby. *Royalist* sank by her stern shortly afterwards.

- All weathertight openings must be kept closed at sea when not in use, regardless of the weather and sea conditions.
- All electrical equipment and associated cabling should be properly installed and inspected at regular intervals.
